United States Department of the Interior

FISH AND WILDLIFE SERVICE

MEMORANDUM

Subject: Assessment of West Fish Lift at Conowingo Hydroelectric Project (FERC #405) on May 2, 2013 in support of re-licensing activities

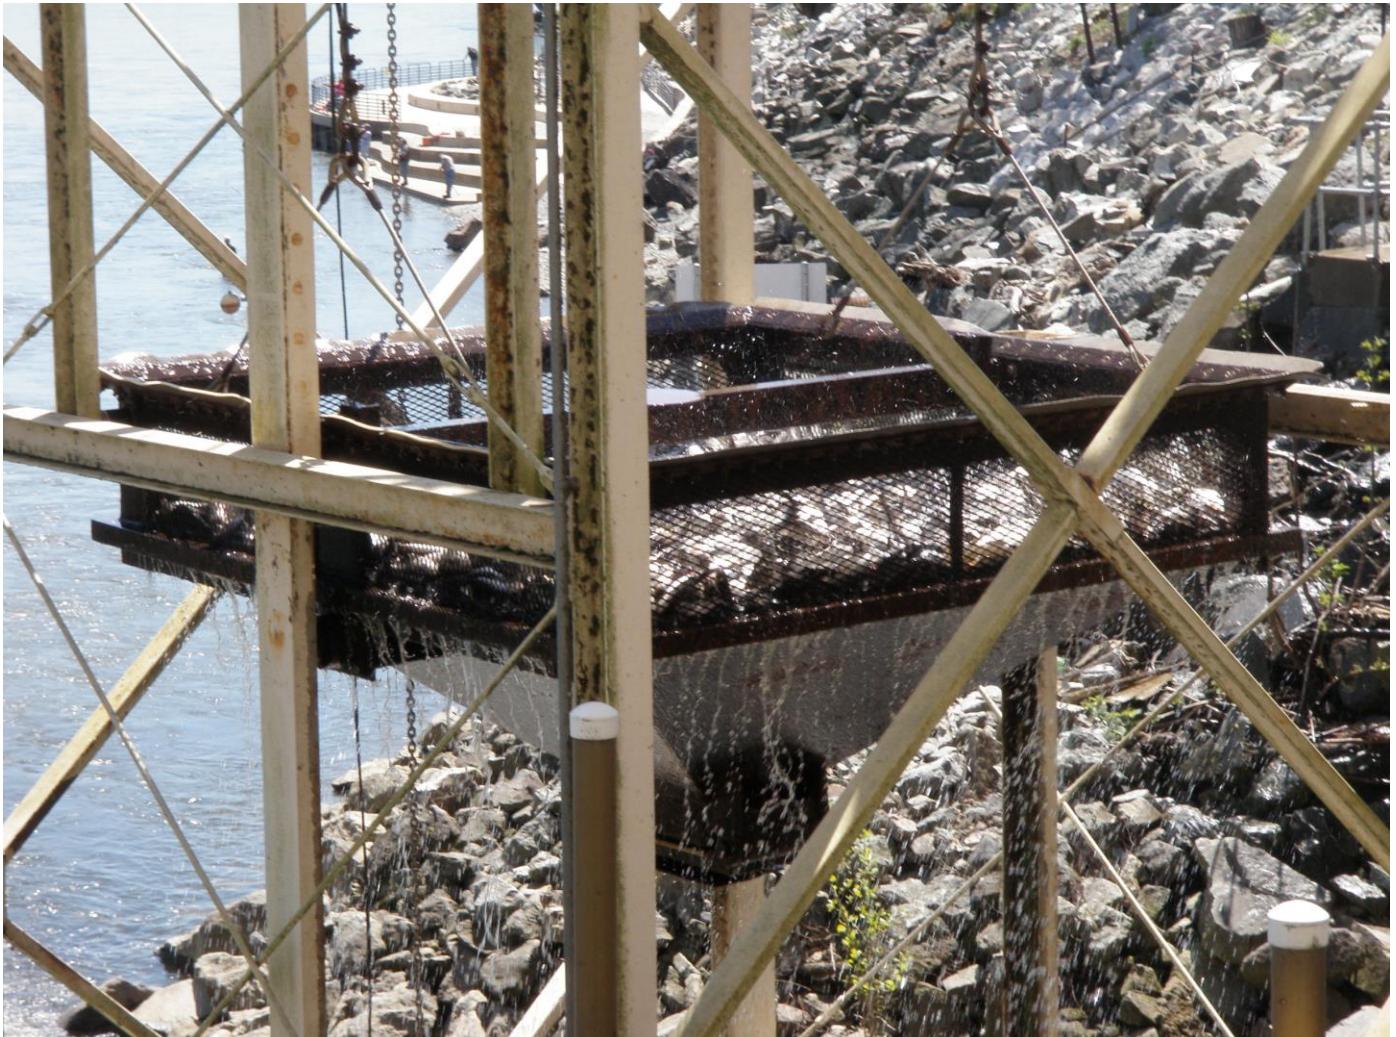
1. Insufficient water inside the hopper. As soon as the hopper starts lifting, water spills out of the bucket, leaving the bucket with less than the USFWS criteria of 0.1 cubic feet per pound of fish. During a lift we were able to observe the fish lying on top of each other while being lifted. The

Appendix section shows a picture of a lift in progress, and the lack of water for the top layer of fish being lifted.

2. Risk for injury. Because of the way the fish are being transferred from the bucket into the holding tank, Fish Passage Engineering is concern about potential injuries caused by the rusty square-shaped gate at the bottom of the bucket. A completely new hopper with safer and fish-friendly features is recommended.
3. Entrance channel hydraulics. Based on visual evidence, water velocities in the area over the hopper and at the holding pool look to be lower than the required velocities by USFWS criteria (1 to 3 fps). Also, false attraction flow at the 90-degrees turn upstream from the entrance gate is delaying the fish that enter the fishway by having them face the wrong direction for long periods of time.

West Fish Lift bucket during a lift on 05/02/13. This image shows the fish being lifted by the current hopper, and very little water available for them during the lift. The lift lasts around 4 minutes, during which the fish lie on top of each other. The exit sluice out this hopper is the bottom gate that opens and discharges the fish into an almost empty holding tank. See video of it captured on the same day of the site visit.
