United States Department of the Interior

FISH AND WILDLIFE SERVICE

Subject: Assessment of West Fish Lift at Conowingo Hydroelectric Project (FERC #405) on May 2, 2013 in support of re-licensing activities

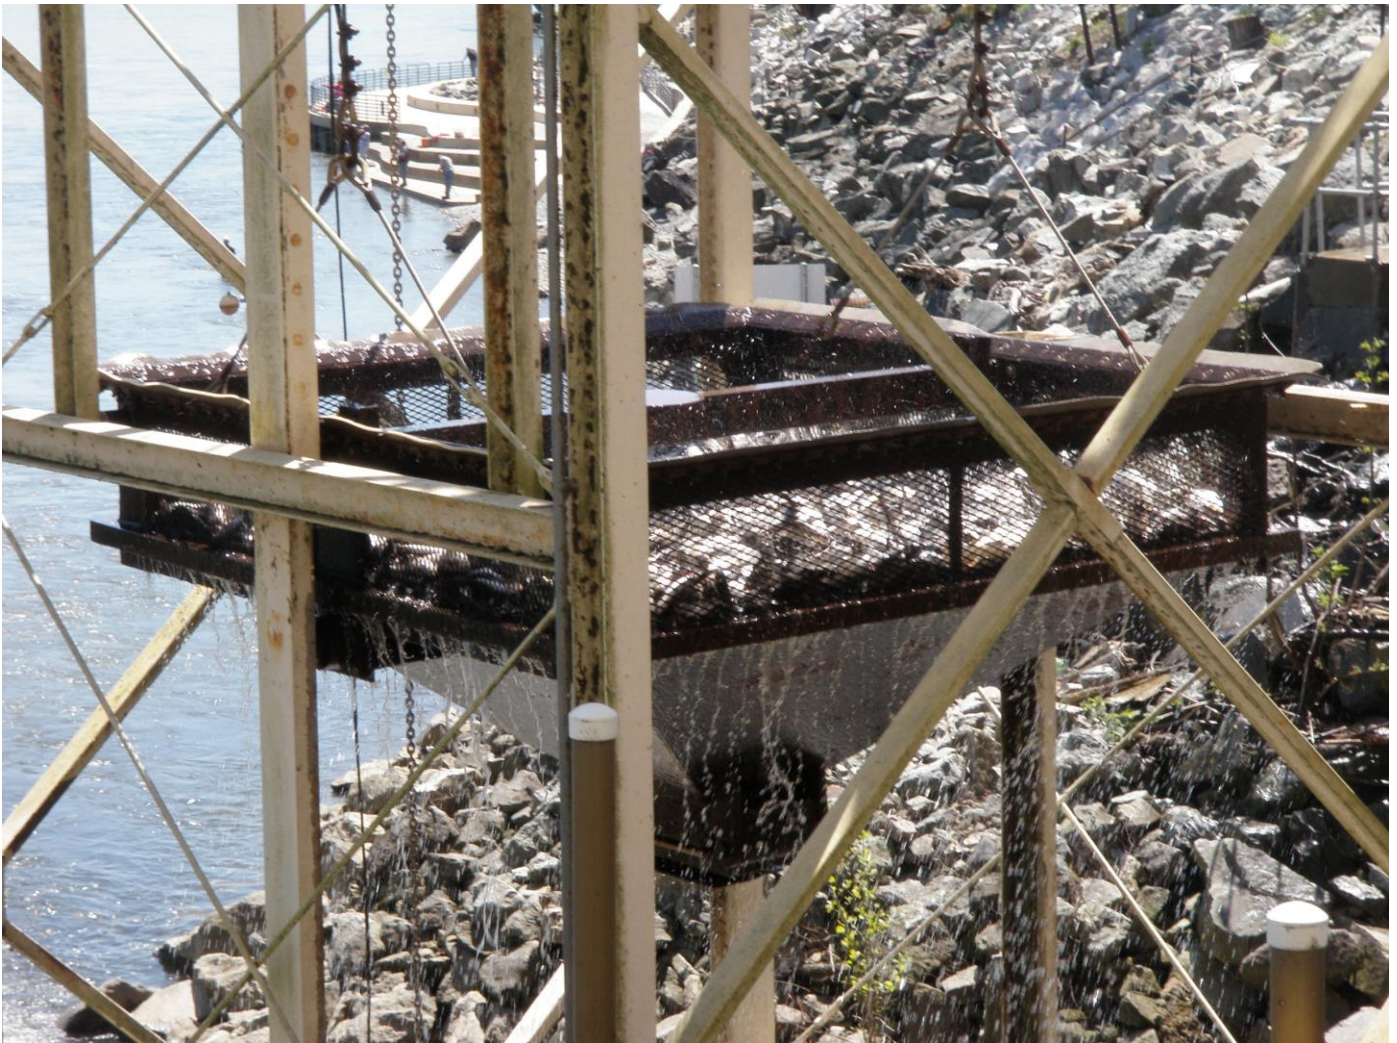
1. Insufficient water inside the hopper. As soon as the hopper starts lifting, water spills out of the bucket, leaving the bucket with less than the USFWS criteria of 0.1 cubic feet per pound of fish. During a lift we were able to observe the fish lying on top of each other while being lifted. The

Appendix section shows a picture of a lift in progress, and the lack of water for the top layer of fish being lifted.

2. Risk for injury. Because of the way the fish are being transferred from the bucket into the holding tank, Fish Passage Engineering is concerned about potential injuries caused by the rusty square-shaped gate at the bottom of the bucket. A completely new hopper with safer and fish-friendly features is recommended.
3. Entrance channel hydraulics. Based on visual evidence, water velocities in the area over the hopper and at the holding pool look to be lower than the required velocities by USFWS criteria (1 to 3 fps). Also, false attraction flow at the 90-degree turn upstream from the entrance gate is delaying the fish that enter the fishway by having them face the wrong direction for long periods of time.

West Fish Lift bucket during a lift on 05/02/13. This image shows the fish being lifted by the current hopper, and very little water available for them during the lift. The lift lasts around 4 minutes, during which the fish lie on top of each other. The exit sluice out this hopper is the bottom gate that opens and discharges the fish into an almost empty holding tank. See video of it captured on the same day of the site visit.
