United States Department of the Interior

FISH AND WILDLIFE SERVICE

November 12, 2015

Subject: Inspection of fishways at the Safe Harbor Hydroelectric Project (FERC #1025)

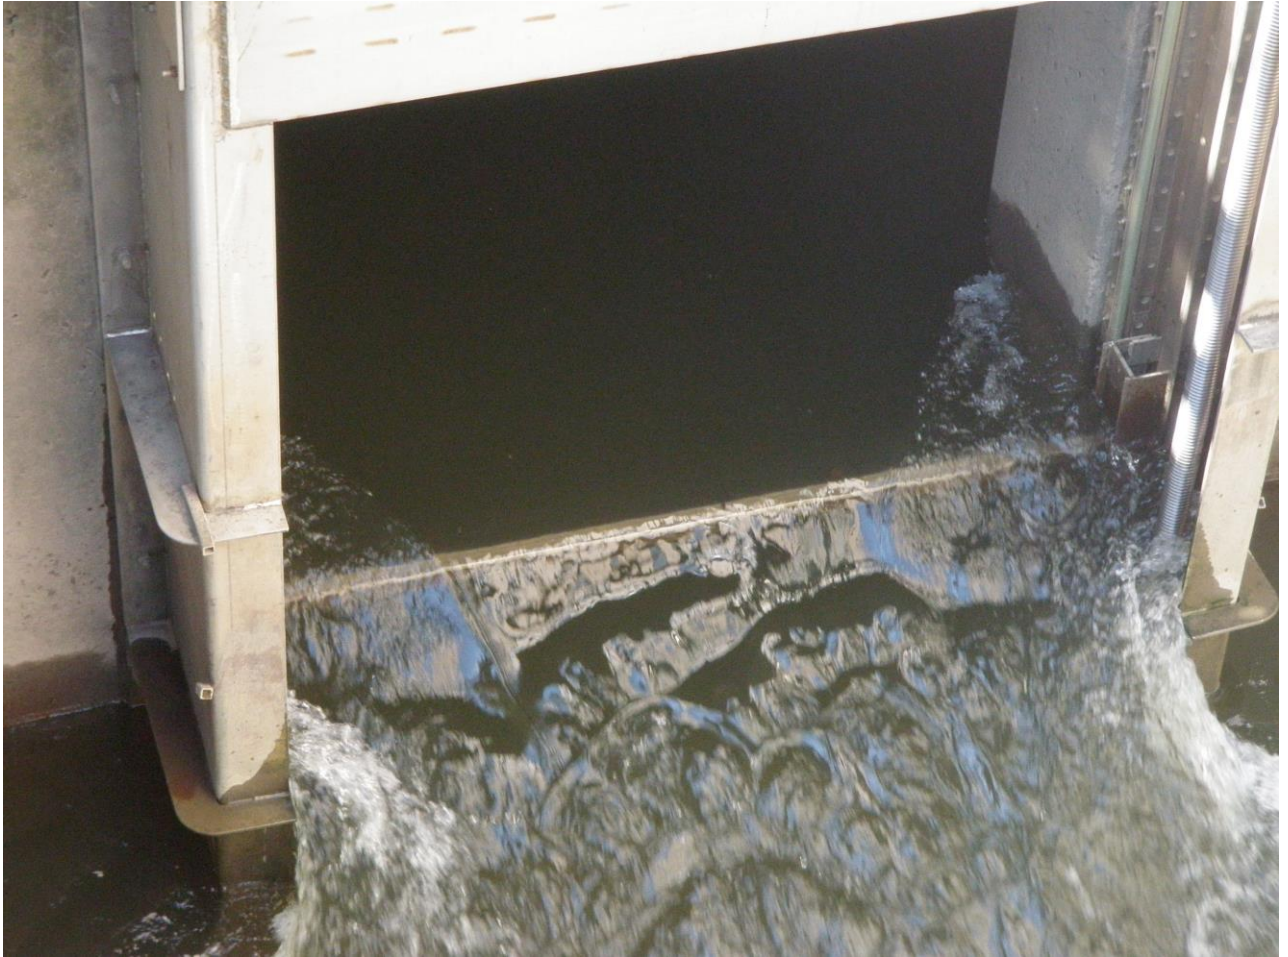
- Horizontal steel bars continue to be present at the openings of entrance gates A and C. USFWS Fish Passage Engineers have previously requested these bars to be removed in order ensure safe passage to all migratory fish entering the lift. The location of the bars causes them to protrude into the flow path of the fish. The Service preference is that fish not be exposed to protrusions, sharp edges, and other objects in the flow path that could cause injury. As noted by the Project managers, removing these bars would compromise the structural stability of the gates. Able to identify a large number of other fish passage facilities with gates that don't have horizontal bars in the flow path of the fish, the Service once again requests that the licensee removes or relocates

these bars above and outside of the water column. Figure 1 in the Appendix shows the steel bar at gate C.

Figure 1: Gate C steel bar crossing through the water column, right at the path that fish would use to move into the fishway
