# United States Department of the Interior

## FISH AND WILDLIFE SERVICE

Subject: Inspection of fishways at Safe Harbor Hydroelectric Project (FERC #1025) on April 26, 2017

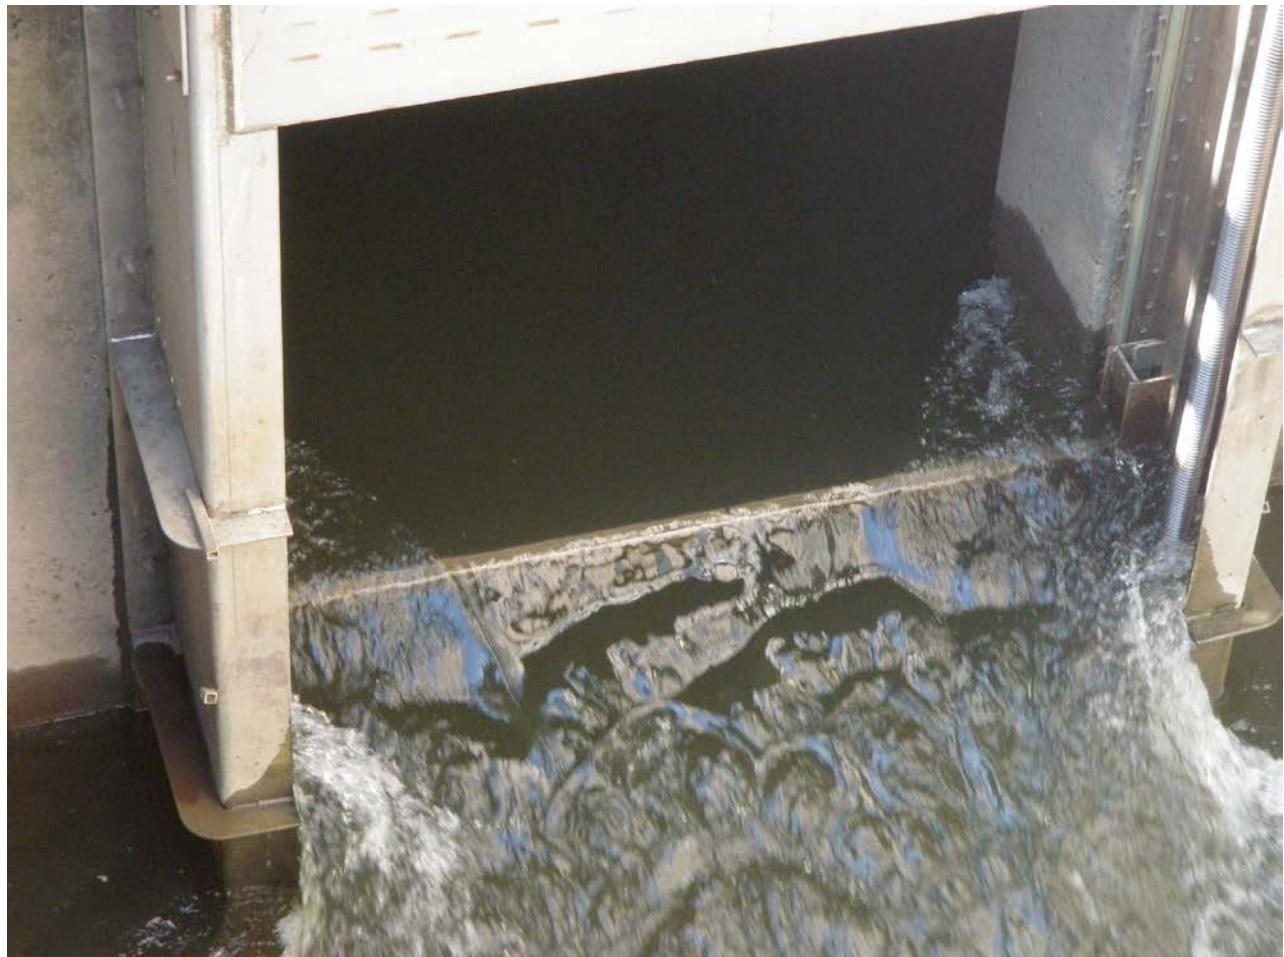
- Horizontal steel bars continue to be present at the openings of entrance gates A and C. On a September 26, 2016 report, Brookfield submitted to USFWS a structural analysis into the functionality of these horizontal crossbars, also referred to as top stabilizing members. The report was developed by Providence Engineering Corporation. Providence Engineering explains that these stabilizing members were originally intended to be “temporary in nature”, and that “the middle and lower leaf extension channels are sufficient in capacity to act alone without the top stabilizing members”. The structural analysis was completed with a loading safety factor of 2.0 and a presumption that there is no hydrostatic pressure aiding in the stability of the member, which there is. Providence Engineering goes on to conclude that even though the leaf extension

channels technically provide enough structural stability to the leaf gates under these extreme and conservative conditions, they would still recommend not removing the stabilizing members because “it is unclear as to the consequence the removal of the stabilizing members would have on the gates w.r.t. being lifted while racked”. USFWS believes that the safety factor and the presumption of no hydrostatic pressure aiding in the stability of the member provides enough buffer to account for most unforeseeable situations that might affect the structural integrity of the gates. Furthermore, the report does not introduce or considers any potential alternatives that could replace these temporary top stabilizing members (e.g., increasing the size of the leaf extension channels, or reallocating the stabilizing members to a higher elevation so that they’re always positioned outside of the water column). As they stand today, these stabilizing members protrude into the flow path exactly at the location over the entrance weirs where fish are swimming against the highest water velocities within the fish lift. The Service continued preference is that fish not be exposed to protrusions, sharp edges, and other objects in the flow path that could cause injury. Figure 1 in the Appendix shows the steel bar at gate C.

Figure 1: Gate C steel bar crossing through the water column, right at the path that fish would use to move into the fishway
