RE: 2019 Inspection of Conowingo Fish Passage Facilities

Subject: Inspection of Fishways at Conowingo Hydroelectric Project (FERC #405) on May 23, 2019

A seasonal inspection of the fish passage facilities at the Conowingo Hydroelectric Project (Project) was performed at 9:00 am on Thursday, 05/23/2019. The Project is owned and operated by the Exelon Corporation (Licensee). The USFWS (Service) review team was led by Sheila Eyler, and included Jesus Morales, Jessica Pica, John Wiley and Jessica Goretzke. Consultants from Normandeau Associates, and personnel from the Pennsylvania Fish & Boat Commission, the Susquehanna River Basin Commission and the Maryland Department of Natural Resources were also present during the visit. On the day of the site inspection the Susquehanna River flow was approximately 68,000 cfs, as measured by the Marietta USGS water gage.

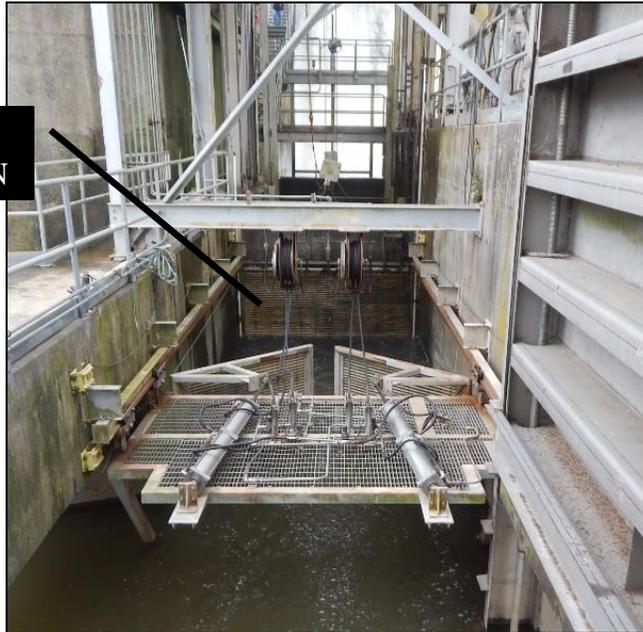
- Screen position during fishing mode - A fish exclusion screen on the downstream boundary of the hopper, designed to keep fish inside the hopper while this one is hoisted up, it's being intentionally operated in a way to keep fish from entering the area over the hopper, even during periods of "fishing mode" (Figure 1). Normally, during the fishing mode operation of a fish lift, the fish crowding mechanisms should be attempting to accumulate as many fish as possible within its holding pool/hopper area. Excluding fish from entering the area over the hopper essentially reduces the holding pool estimated capacity and could potentially become a bottleneck for the overall biological capacity of the EFL. The Service requests further discussion about the strategic choice to operate this screen in this manner.

Figure 1 - Exclusion screen in down position during fishing mode

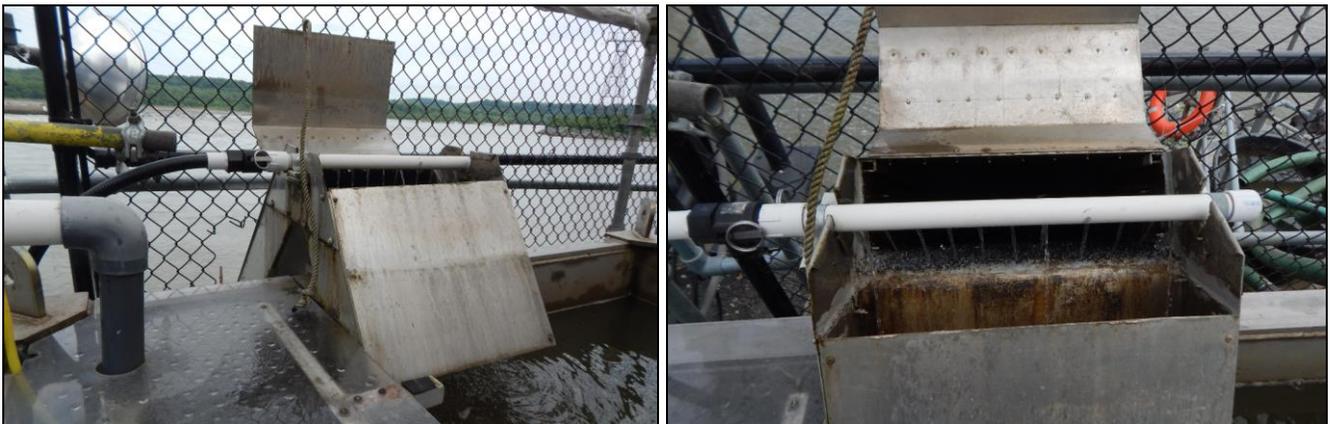
- Attraction flow enters the eel pass vertically - Service personnel noticed that the existing eel pass, located on the western river bank in the tailrace, currently introduces its attraction flow through a gravity-fed water line that discharges flow vertically above the apex of the eel ramp, near its exit (Figure 2). Traditional eel passes are typically designed to provide attraction flow through a pump-fed system, and introduce the attraction flow horizontally at the exit of the eel ramp, somewhere upstream of the apex (Figure 3). The goal of this recommended configuration is to hone into the migrating eels' motivation to move in an upstream direction, specifically at the moment when they'd be required to overcome the apex of the eel ramp. The Service believes that a closer look at eel behavior near and around the apex of the Conowingo's eel pass is warranted. Any eel reluctance or failure to move over the apex should be noted, and a different attraction flow system could be considered.

Figure 2 - Eel pass attraction flow entering the eel ramp vertically
