RE: 2019 Inspection of Safe Harbor Fish Passage Facilities

Subject: Fishway Inspection at the Safe Harbor Hydroelectric Project (FERC #1025) on May 22, 2019

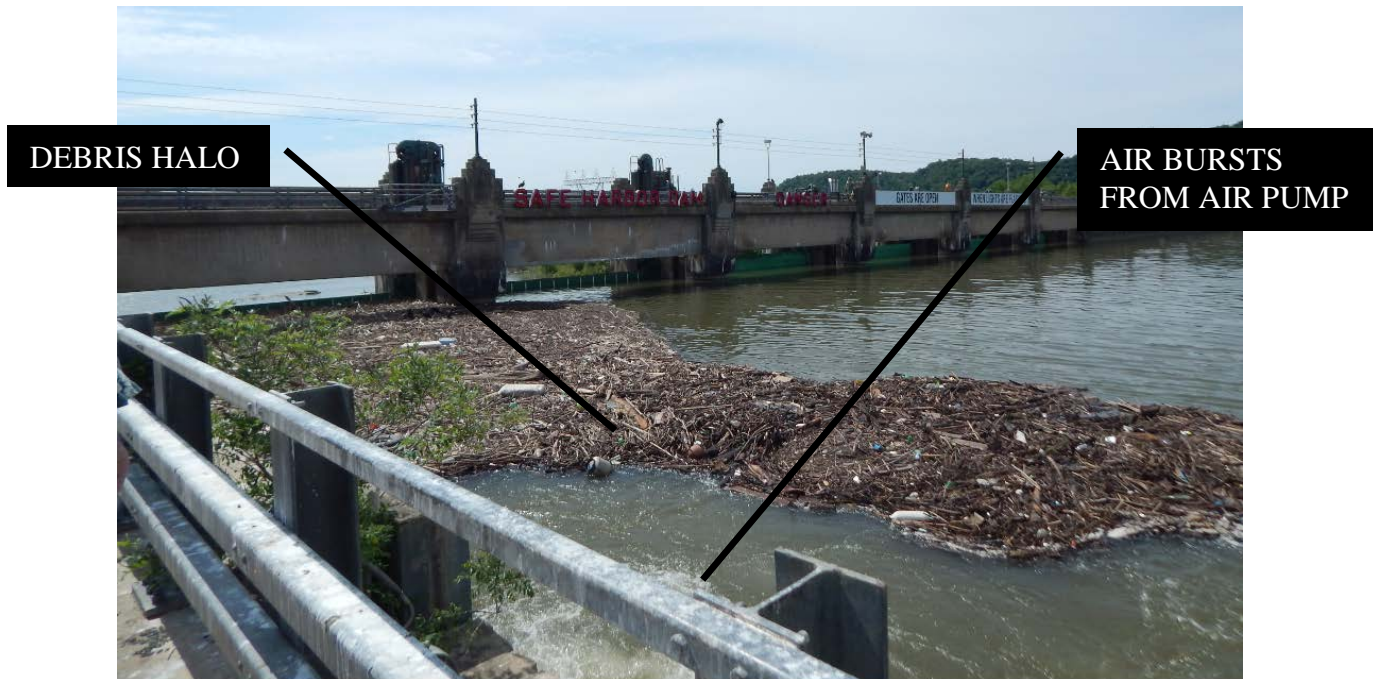
- Debris accumulation - On the day of the inspection, a significant amount of debris was observed in the vicinity of the fish lift exit channel surrounding its trash rack, on the western side of the power canal skimmer wall (Figure 1). This debris accumulation created a debris “halo” around the trash rack. There are currently no available mechanisms to flush the debris downstream at this site (e.g., trash sluice or pneumatic flash boards).
 - In an attempt to keep debris from plugging the exit channel trash rack, the Licensee has installed air pumps to push the debris away from the trash rack. The Service continues to

be concerned about the impact that these air bursts might have on the flow vectors within the zone of passage while fish exit the lift to continue their migratory journey upstream. Migratory fish rely on rheotaxis, or a fish's behavioral orientation to the water current, in order to navigate their upstream route to spawning habitat. The potential interruption of the zone of passage by these air bursts, as well as the amount of debris material surrounding the exit area, have the potential to cause delays and/or confusion to the migratory fish exiting this facility. Some type of biological evaluation (e.g., radio telemetry) could be useful to determining whether the Licensee's strategy for keeping the trash rack clean has a negative impact on migratory fish behavior or not.

Figure 1 – Debris accumulation in the vicinity of the exit channel trash rack

Attached is the report of the U.S. Fish and Wildlife Service's (Service) inspection of the fish passage facility at Safe Harbor Dam. The Service has no follow-up recommendations at this time, but would urge staff at the project to continue to make note in the annual fish passage reports if observed fish behavior in the exit channel displays avoidance of the bubble curtain.
