SUSQUEHANNA RIVER
BASIN COMMISSION

Lower Susquehanna Subbasin Survey:

A Water Quality and Biological Assessment, June - November 2005

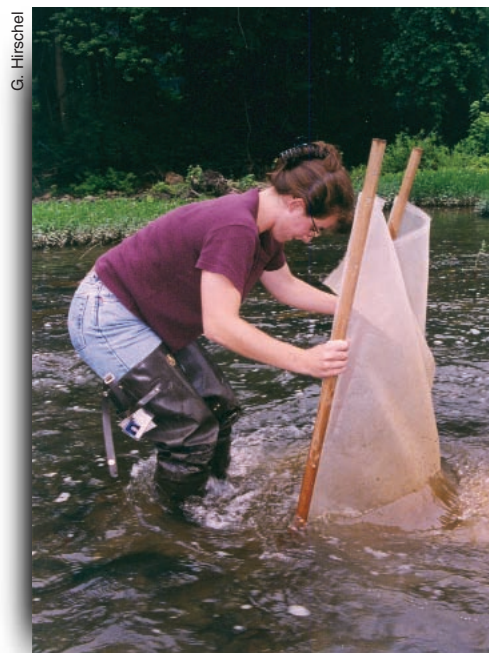
Benthic macroinvertebrates (organisms that live on the stream bottom, including aquatic insects, crayfish, clams, snails, and worms) were collected using a modified version of RBP III (Barbour and others, 1999). Two kick-screen samples were obtained at each station by disturbing the substrate of representative riffle/run areas and collecting dislodged material with a one-meter-square 600-micron mesh screen.

Kick-screen sampling of macroinvertebrates.

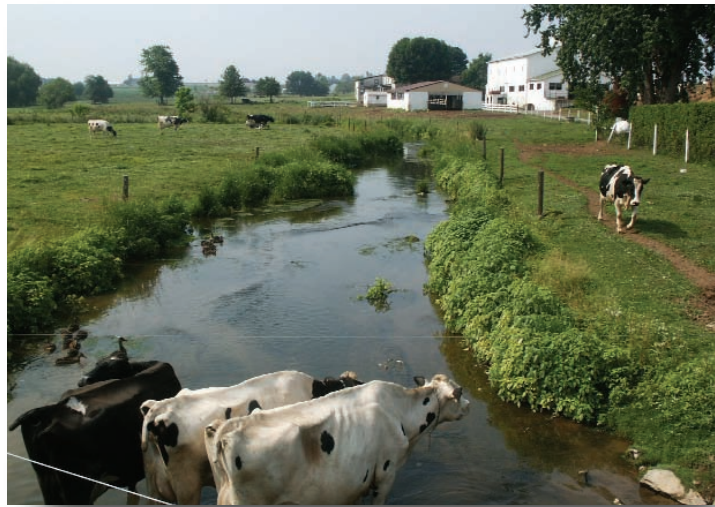
Streambank fencing with cow passageway on Muddy Creek in Lancaster County.
