**ASSESSMENT OF INTERSTATE
STREAMS IN THE
SUSQUEHANNA RIVER BASIN**

Monitoring Report No. 24
January 1, 2010 Through December 31, 2010

Publication No. 273

*Monitoring and Protection Program
Susquehanna River Basin Commission*

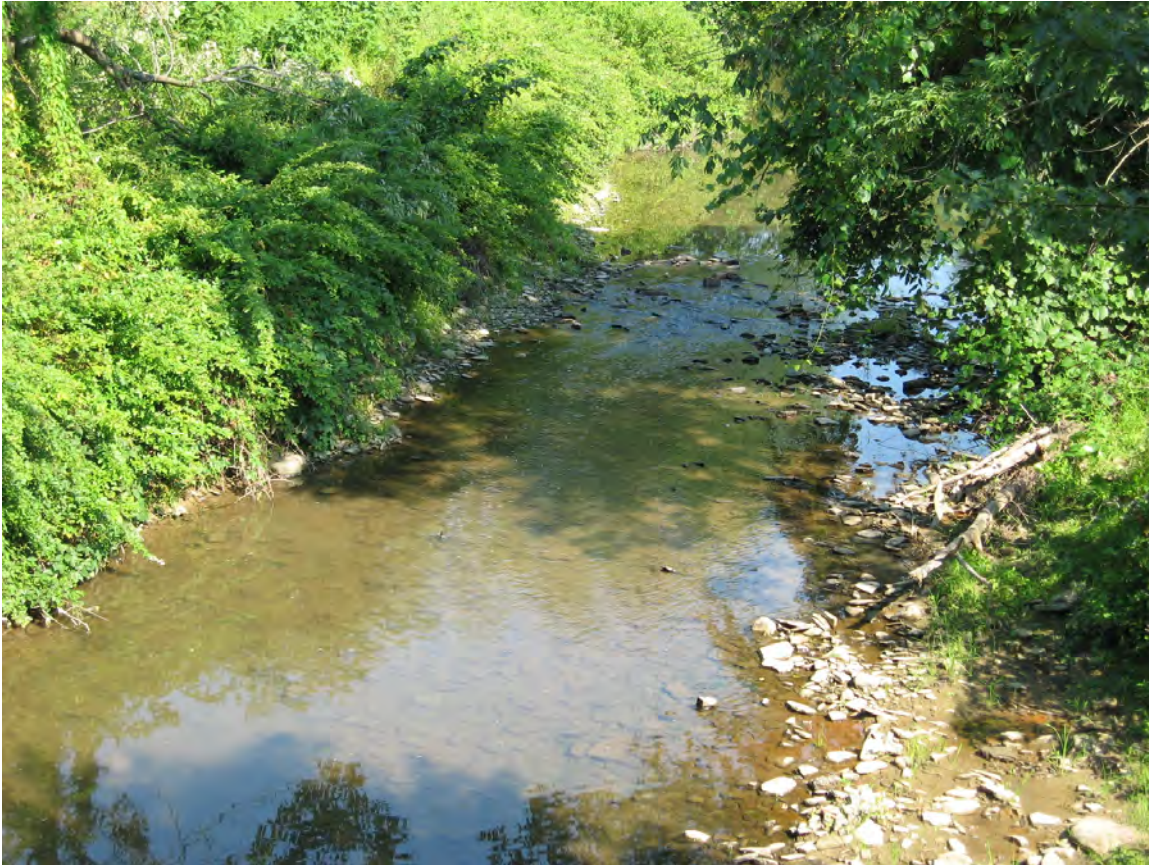
Apalachin Creek at Little Meadows, PA (APAL 6.9)

Overall physical habitat conditions received a score of 52 of a possible 220. Excessive sedimentation, poor velocity/depth regimes, and an absence of riffles led to a nonsupporting rating.

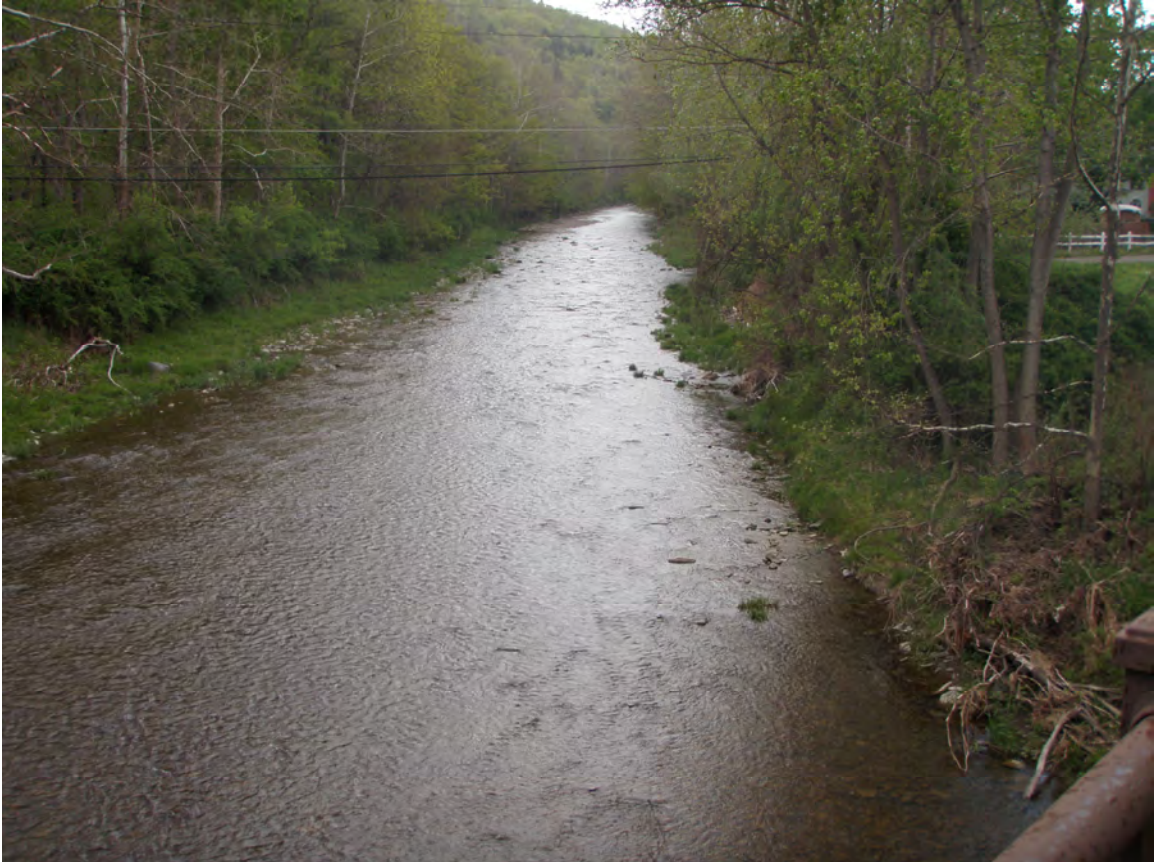
Overall physical habitat scored 134 out of a possible 220. SRBC staff noted minimal sediment deposition, little embeddedness, and good vegetation protecting both banks. Physical habitat was rated as excellent.

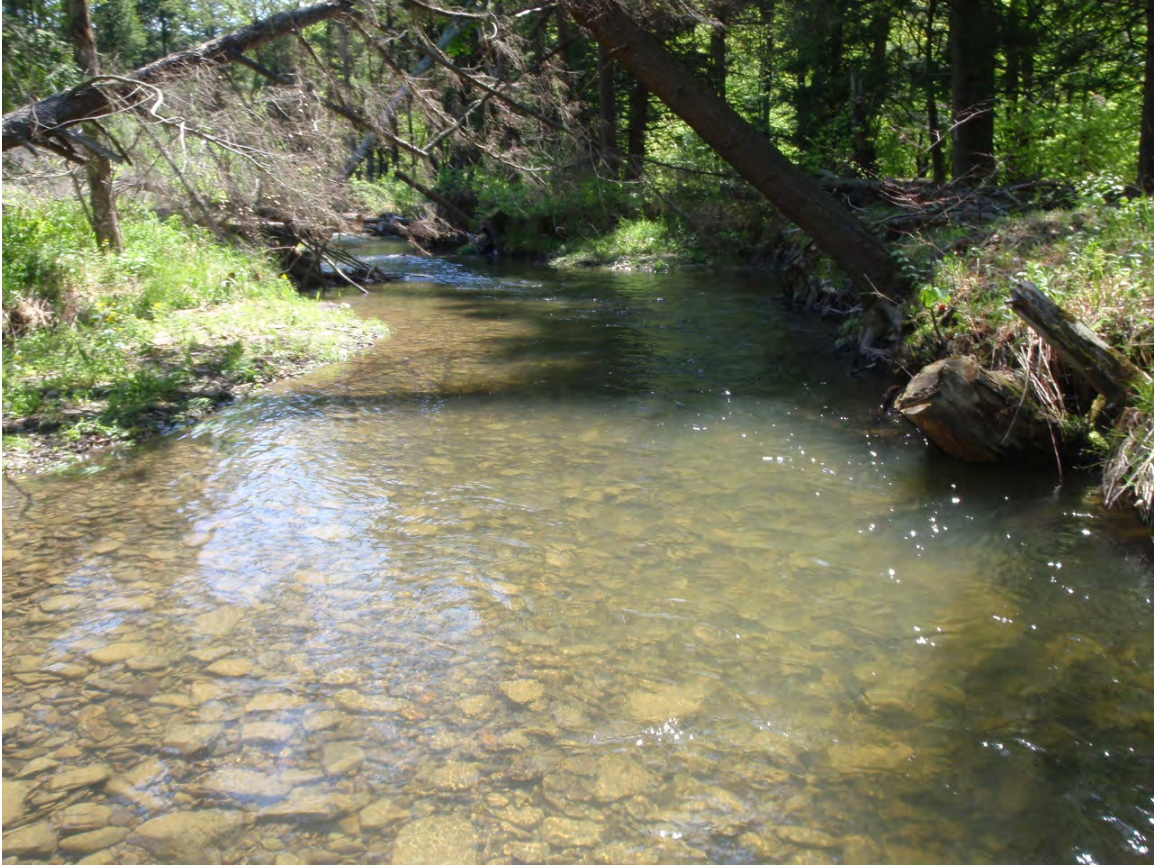
Despite low flow conditions when habitat was assessed in 2010, CASC 1.6 still received a score of 135 of a possible 220. Overall habitat was rated as excellent with wide riparian zone widths, optimal amounts of instream cover, and minimal embeddedness.

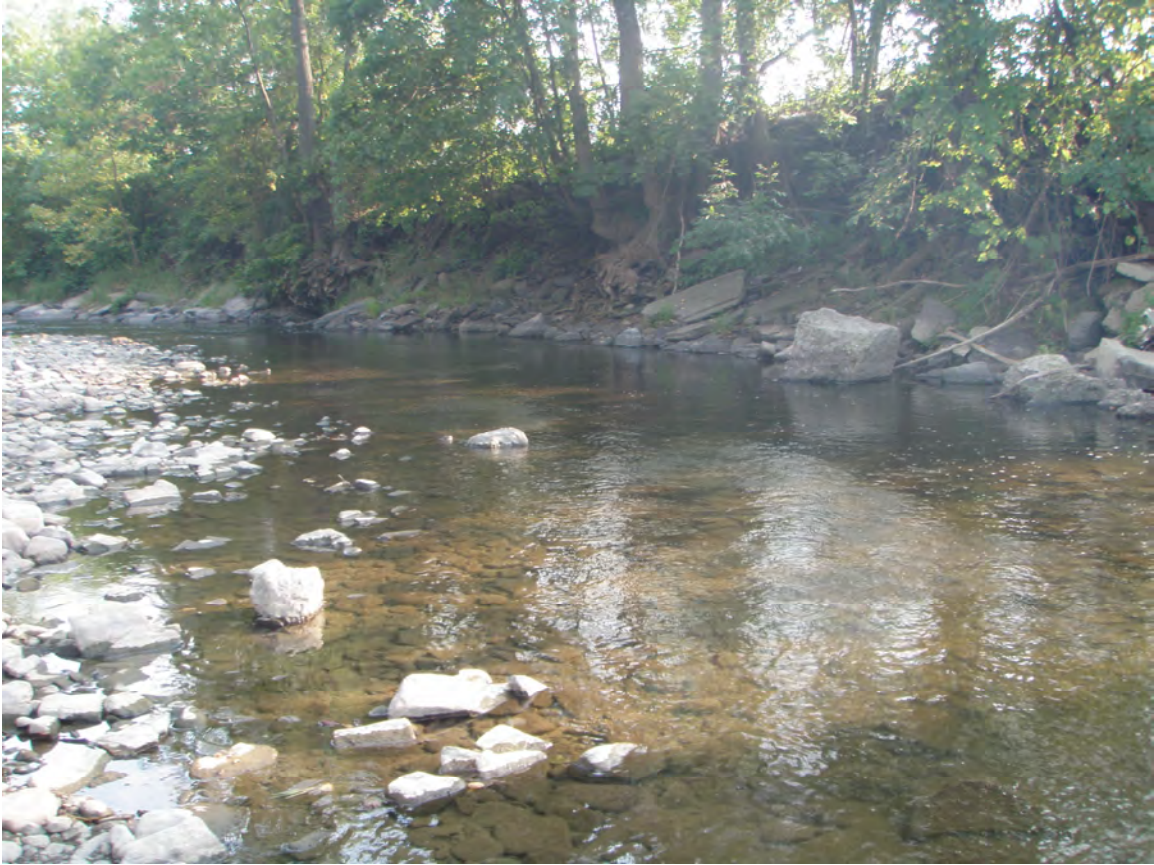
SRBC staff noted construction activities occurring within the vicinity of the sampling site in 2010. Physical habitat was rated as excellent, receiving a score of 136 of a possible 220. Epifaunal substrate, velocity/depth regimes, and instream cover were the best scoring habitat parameters.

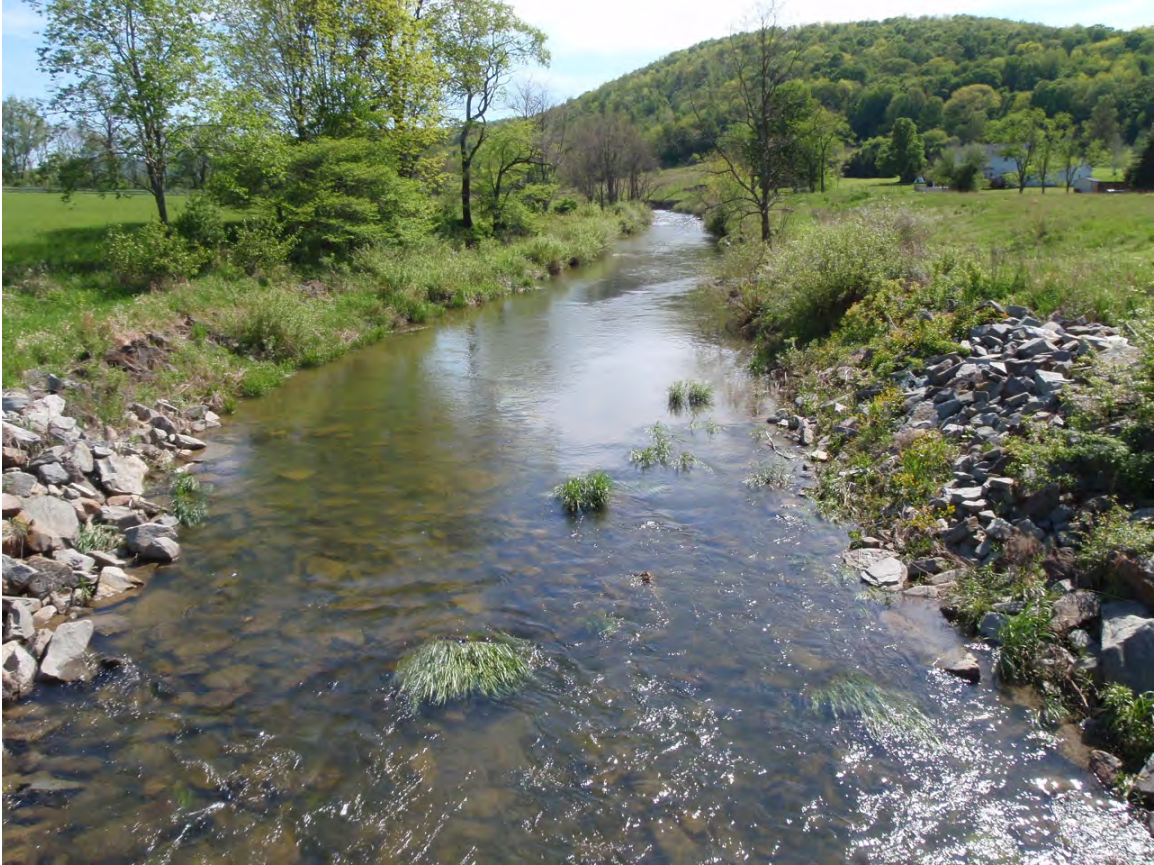
Physical habitat was rated as excellent, scoring 145 of a possible 220. This year marks an improvement as habitat was previously rated as supporting in 2008 and 2009.

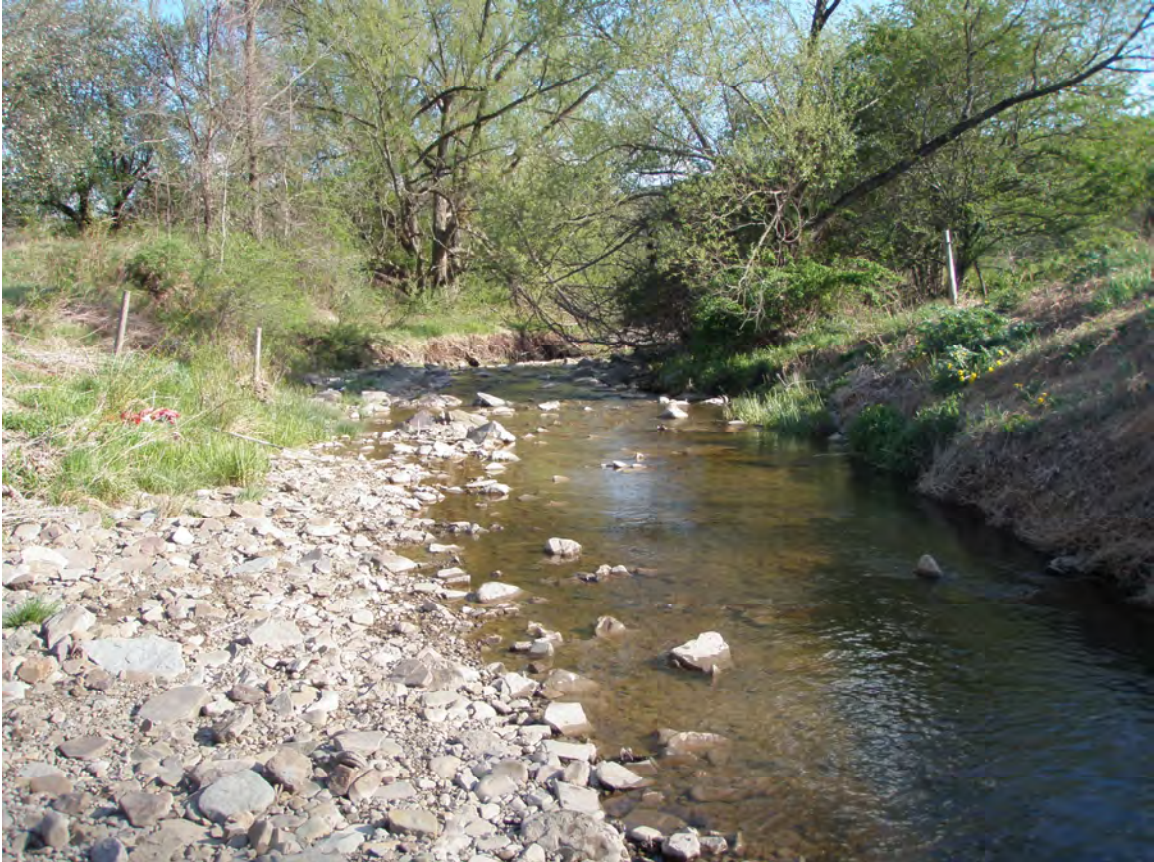
Physical habitat was deemed partially supporting, receiving a score of only 94 of a possible 220. SRBC staff noted significant issues pertaining to excessive sediment deposition. Channel flow status was also problematic with a significant portion of the available channel being dry and exposed.

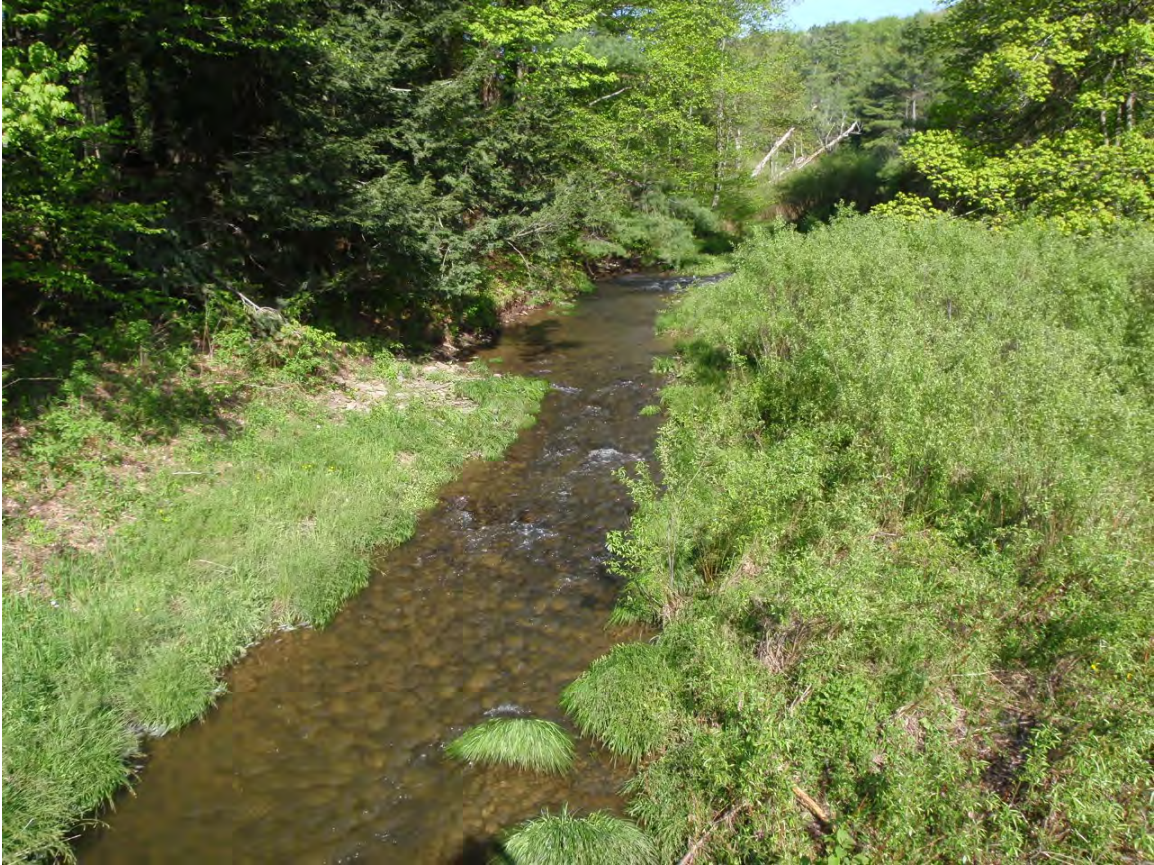
Scoring 164 of a possible 220, available physical habitat received a rating of excellent at LSNK 7.6. Due mainly to the significant amount of surrounding forest land, Little Snake Creek had the highest habitat score of all Group 1 and 2 Pennsylvania-New York border streams assessed during the 2010 sampling year.

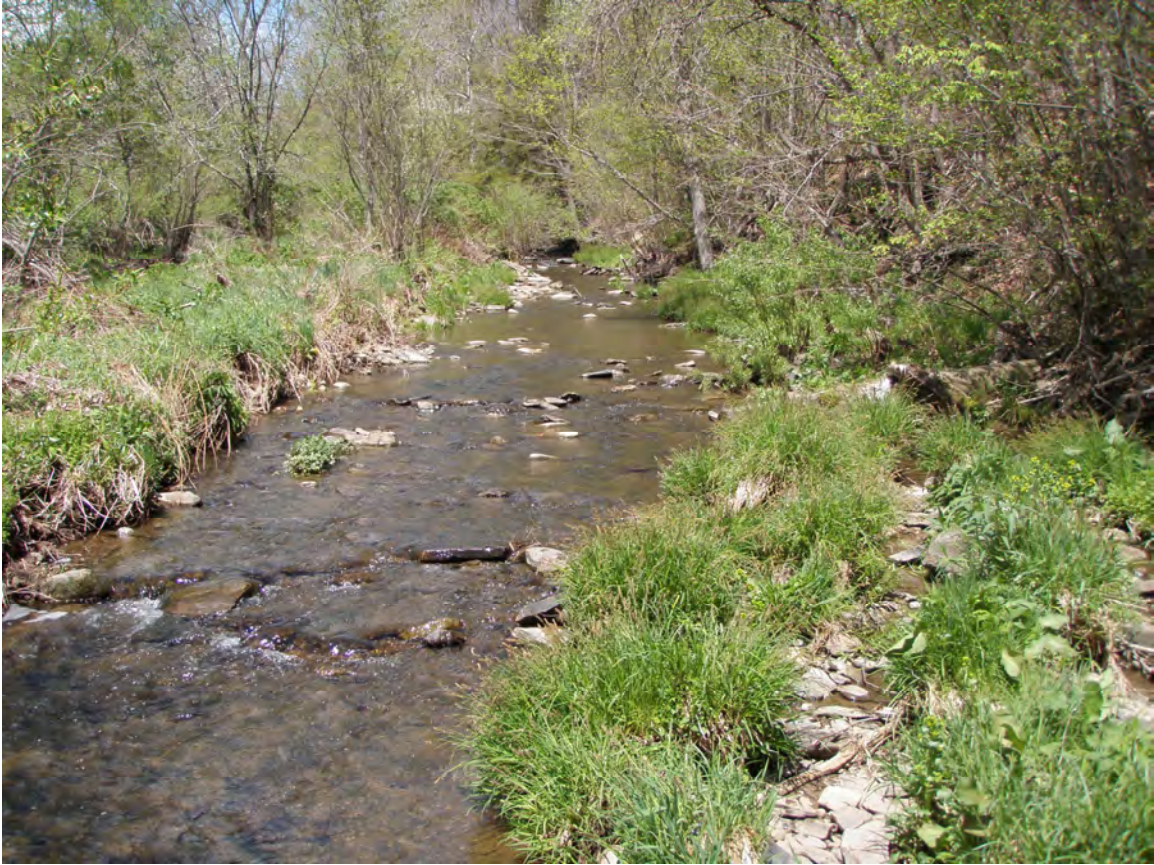
Available physical habitat was rated excellent in 2010. NFCR 7.6 scored 147 of a possible 220 points. SRBC staff noted well-protected and stable banks but marginal channel flow status with significant amounts of exposed cobble.

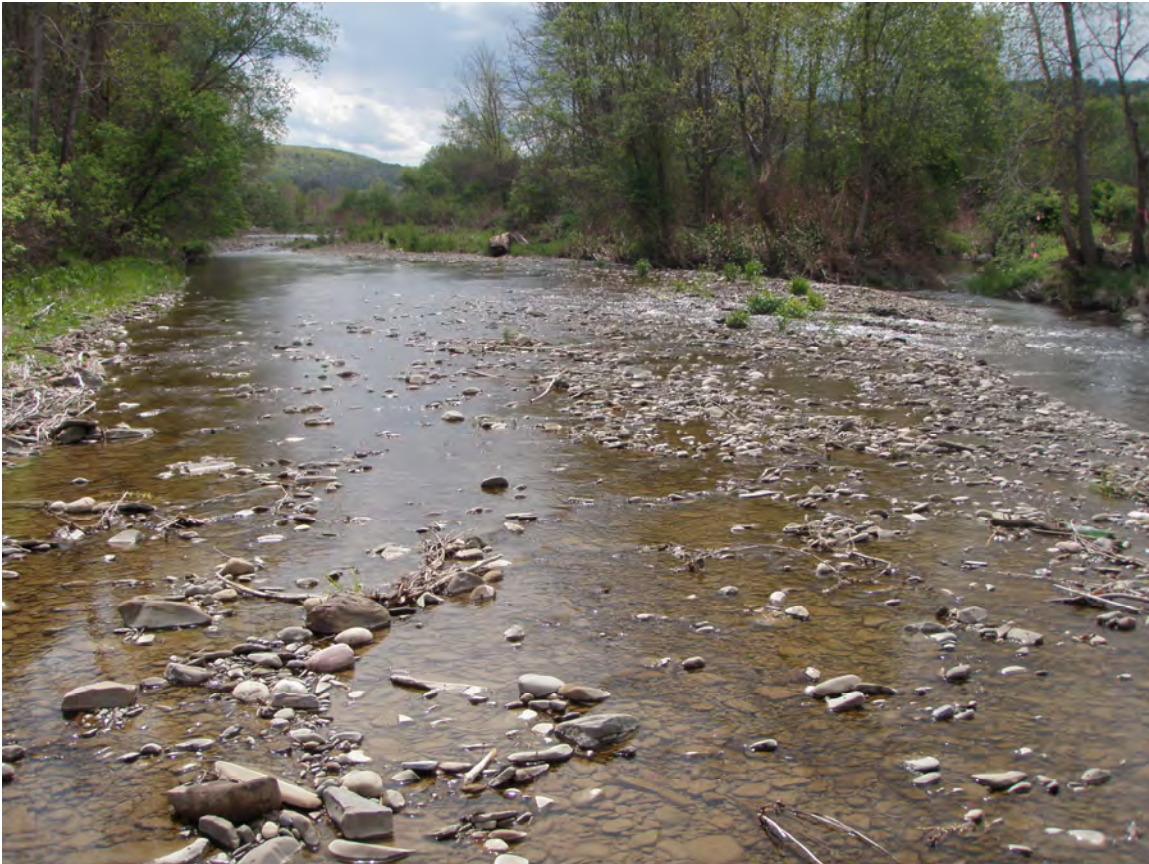
Scoring 103 of a possible 220, Seely Creek's available physical habitat was rated as supporting in 2010. Staff noted significant channel alteration and poor channel flow status.

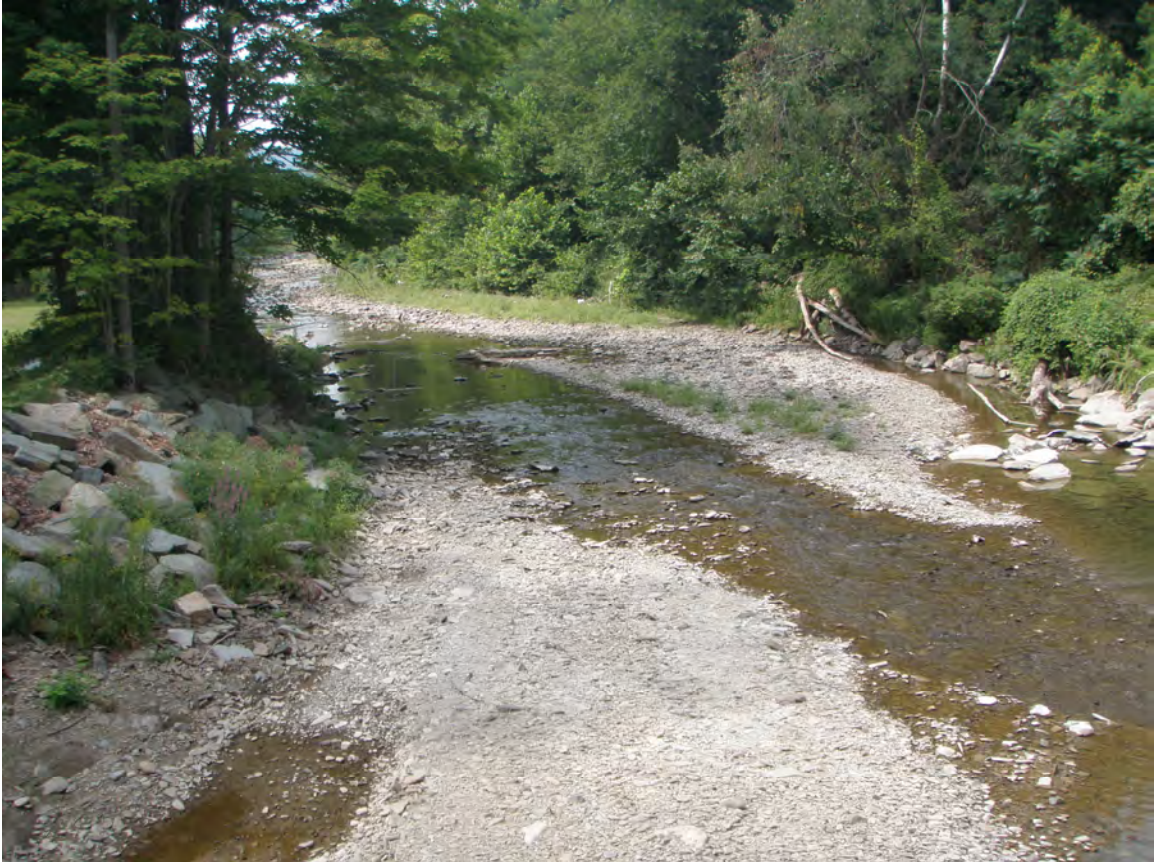
Physical habitat at Snake Creek was rated excellent in 2010. The site scored 120 out of a possible 220. The stream was limited by poor bank conditions and a noticeably bare channel. Redeeming properties were the minimal amount sediment deposition and the lack of embeddedness of the substrate.

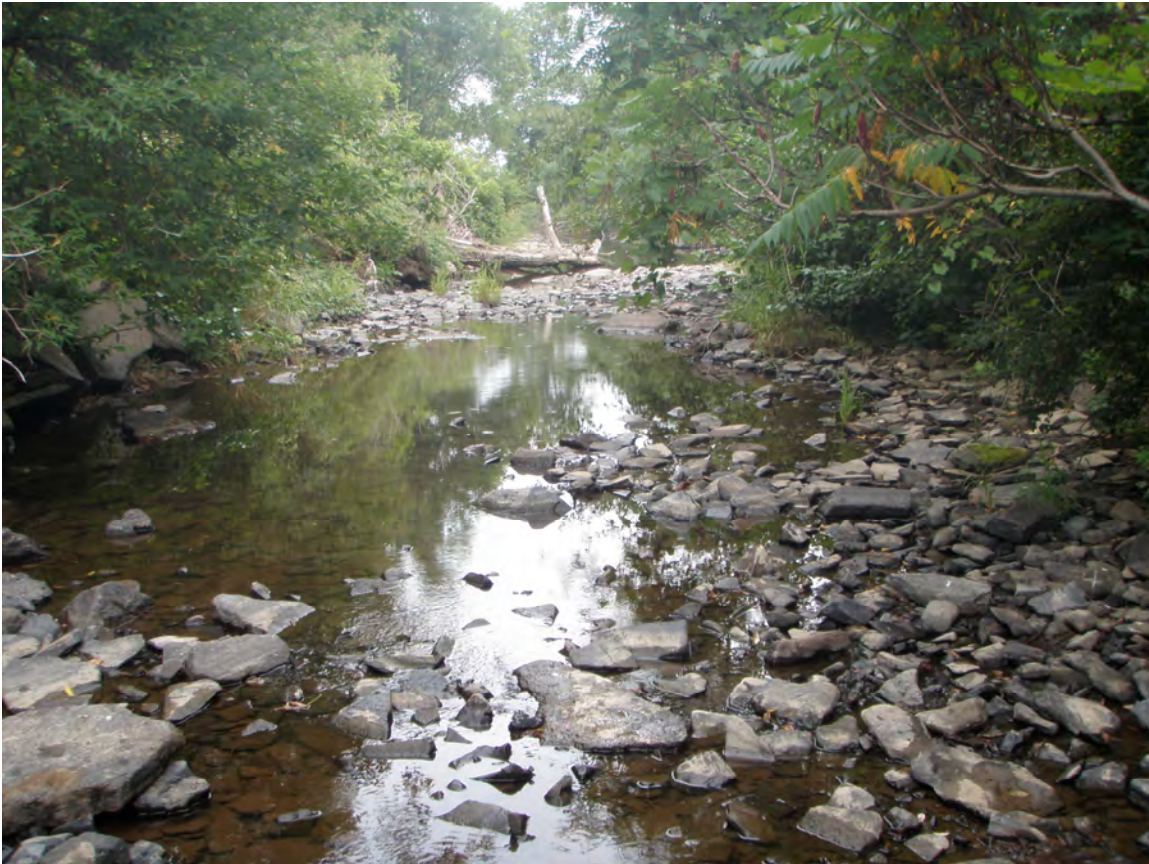
Physical habitat was classified as excellent during 2010. South Creek scored 127 of a possible 220. Limiting habitat properties were the absence of all possible velocity/depth regimes and poor channel flow status.

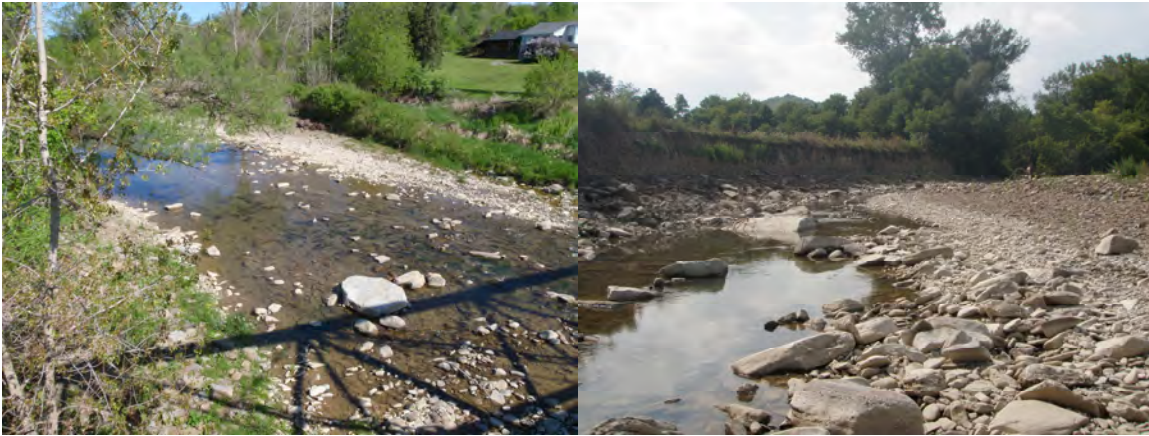
Troups Creek at Austinburg, PA (TRUP 4.5)

Scoring 107 of a possible 220, physical habitat was rated as supporting in 2010. SRBC staff noted significant issues with the available habitat as evident in the site photos. The unstable and unprotected right bank scored very poorly.

Temperature, pH, aluminum, and iron were all found to be outside of accepted water quality standards. Water quality index scores were consistently high (poor quality) across prior sampling periods.

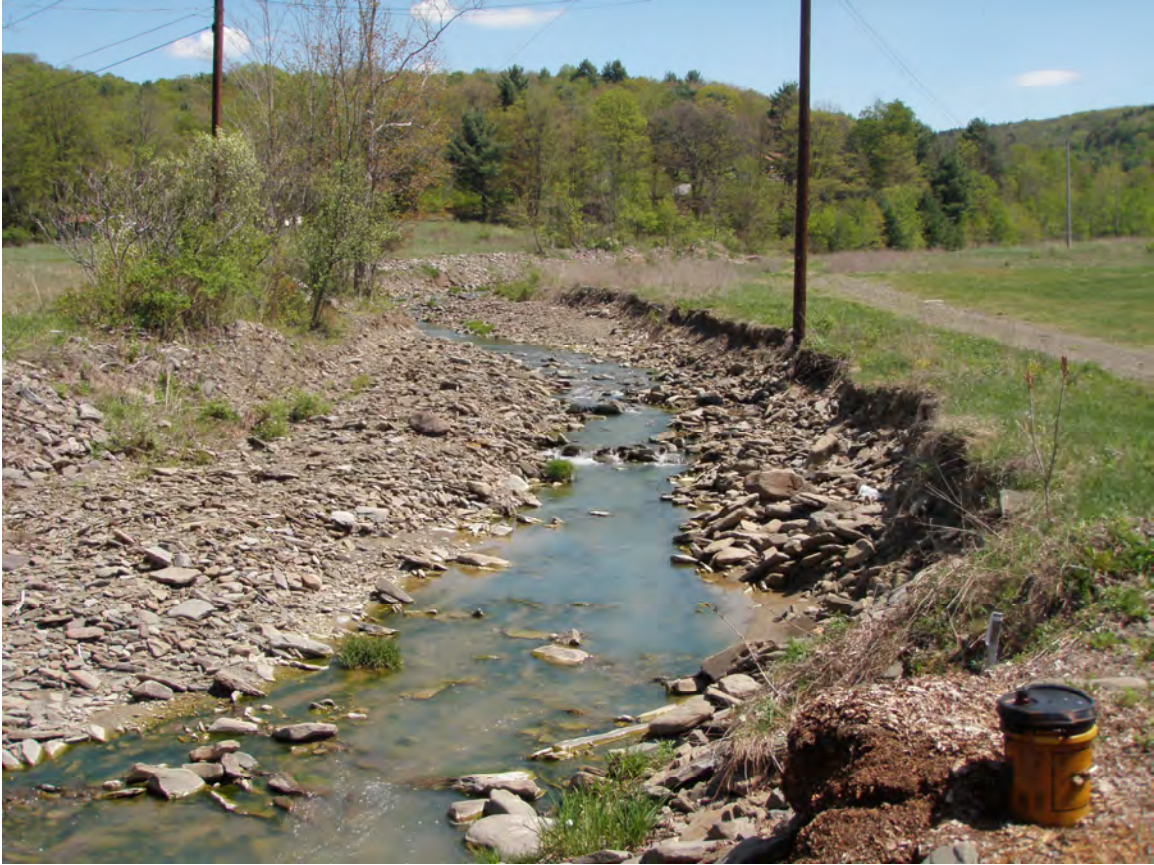
Trowbridge Creek at Great Bend, PA (TROW 1.8)

Physical habitat was rated as partially supporting. The site scored 86 out of a possible 220. Bank conditions were very poor, with little to no vegetative protection and inadequate riparian zones.

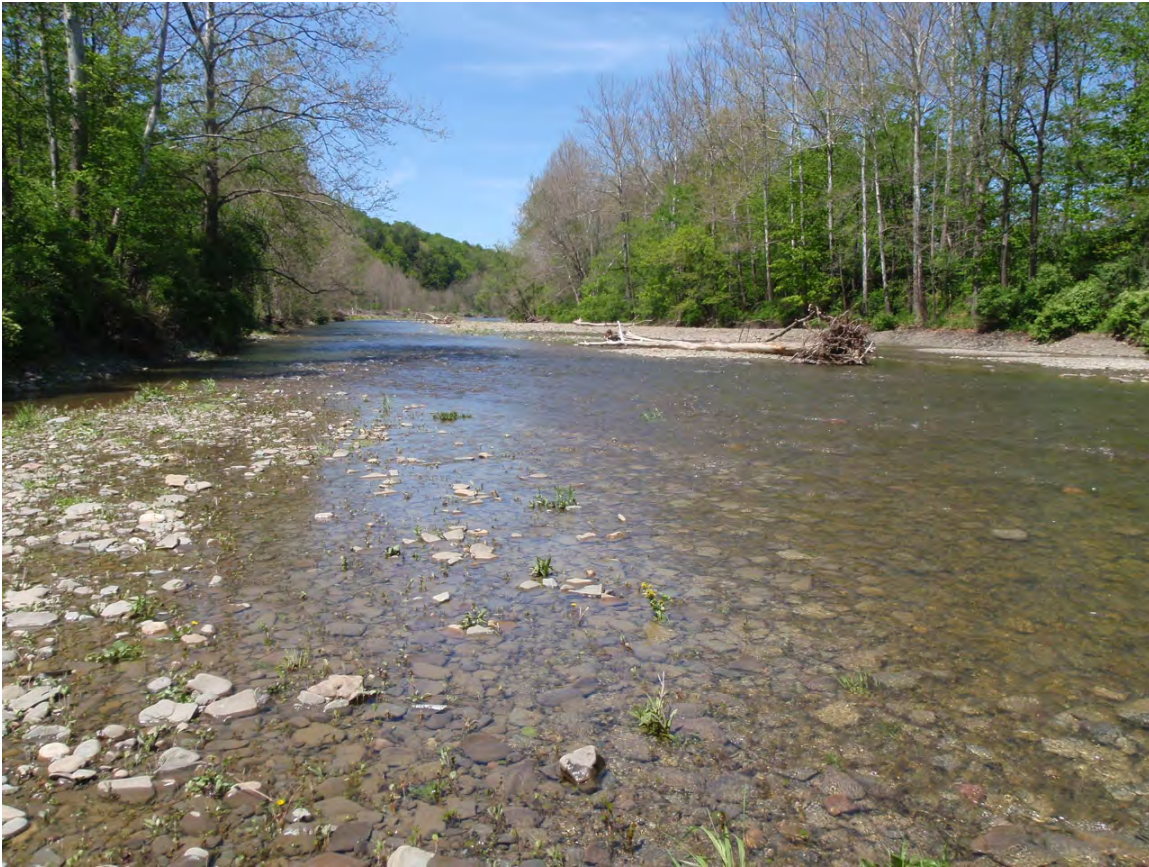
Scoring 122 of a possible 220, physical habitat was rated as excellent at Wappasening Creek. Positive attributes were stable, well-vegetated banks, minimal sediment deposition, and an unaltered channel. Staff did note a lack of instream cover and considerable alga growth along the stream edges.

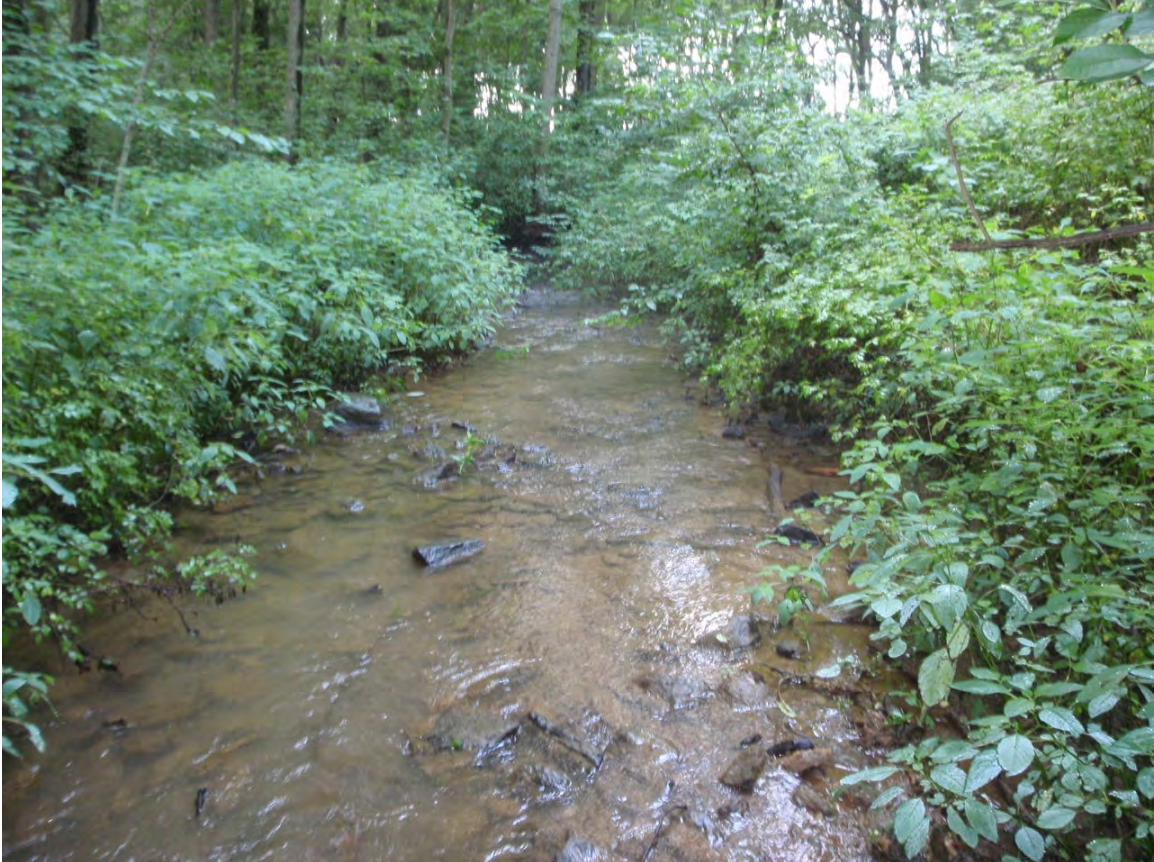
Physical habitat was rated as excellent at the station in 2010. Scoring 149 out of a possible 220, Big Branch Deer Creek possessed stable, densely vegetated banks and had a minimally disturbed channel. Staff did note increased sediment deposition relative to previous observations.

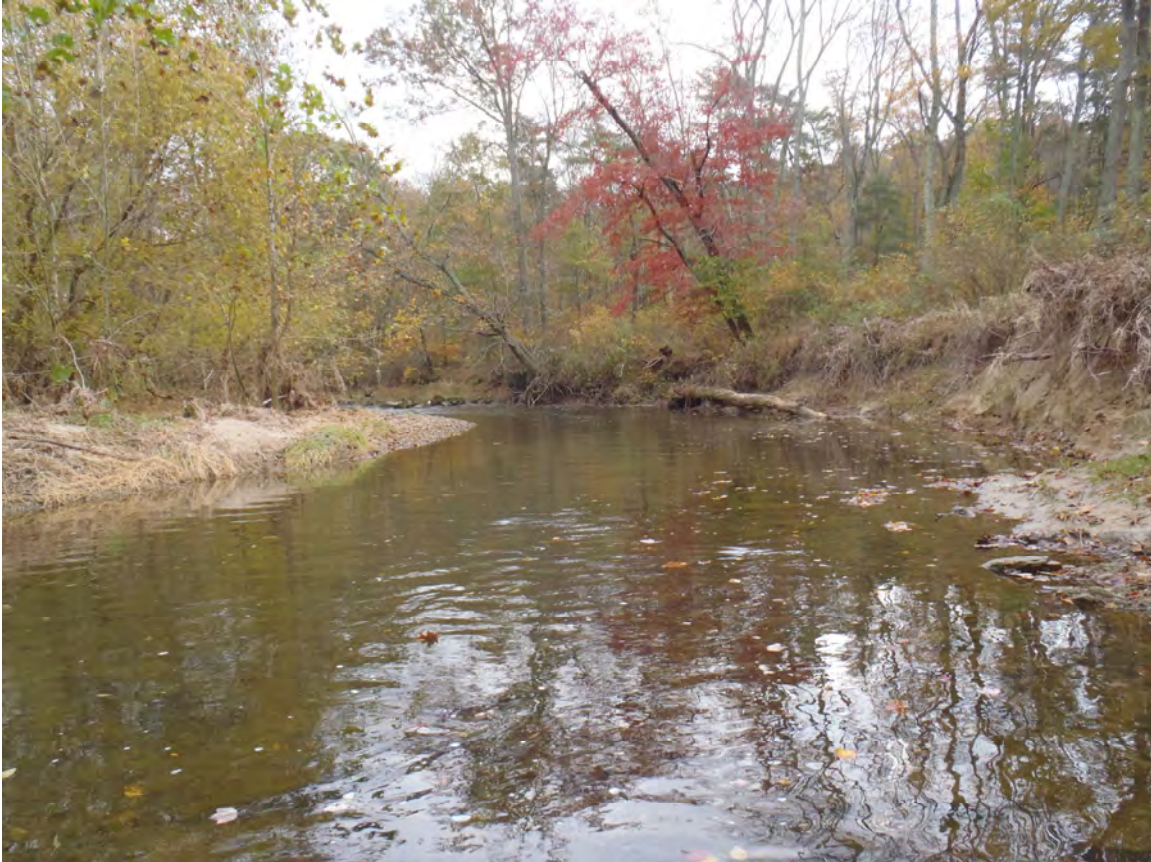
Scoring 155 out of a possible 220, habitat was classified as excellent in 2010. Conowingo Creek was limited by marginal bank conditions but possessed good velocity/depth regimes and ample instream cover.

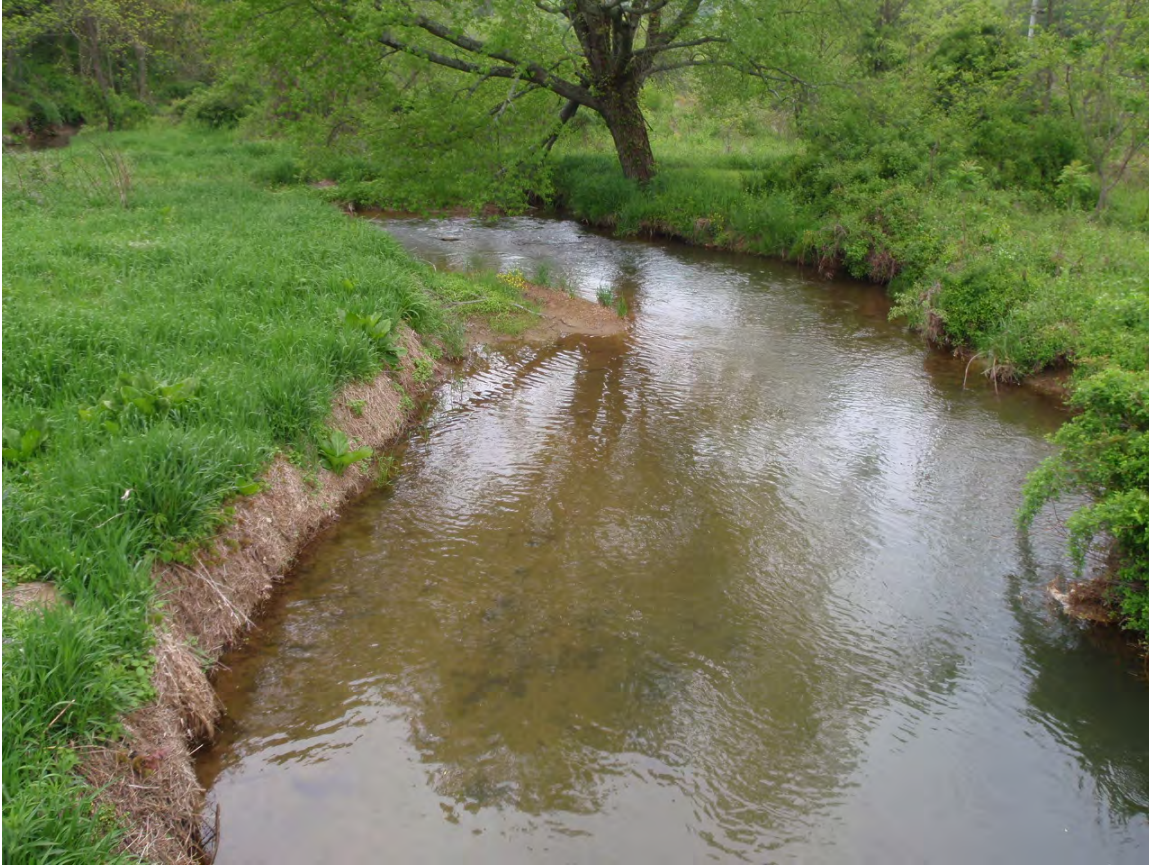
Deer Creek possessed excellent habitat conditions, scoring 165 of a possible 220. The site scored well across most categories with high scores for velocity/depth regimes and instream cover. Erosion of the left bank was noted as potentially problematic.

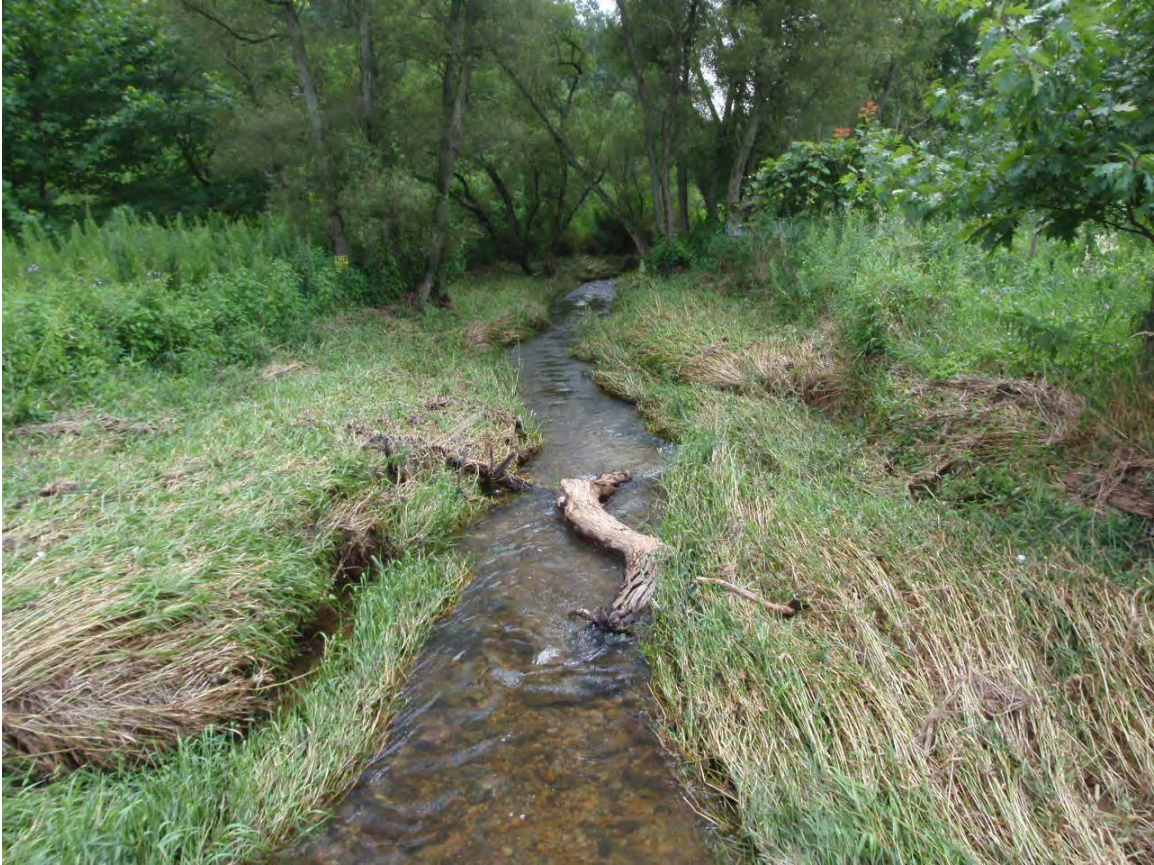
Ebaughs Creek at Stewartstown, PA (EBAU 1.5)

Available physical habitat was deemed excellent at the sampling site. Ebaughs Creek possessed the highest habitat score of all Pennsylvania-Maryland border interstate streams in 2010.

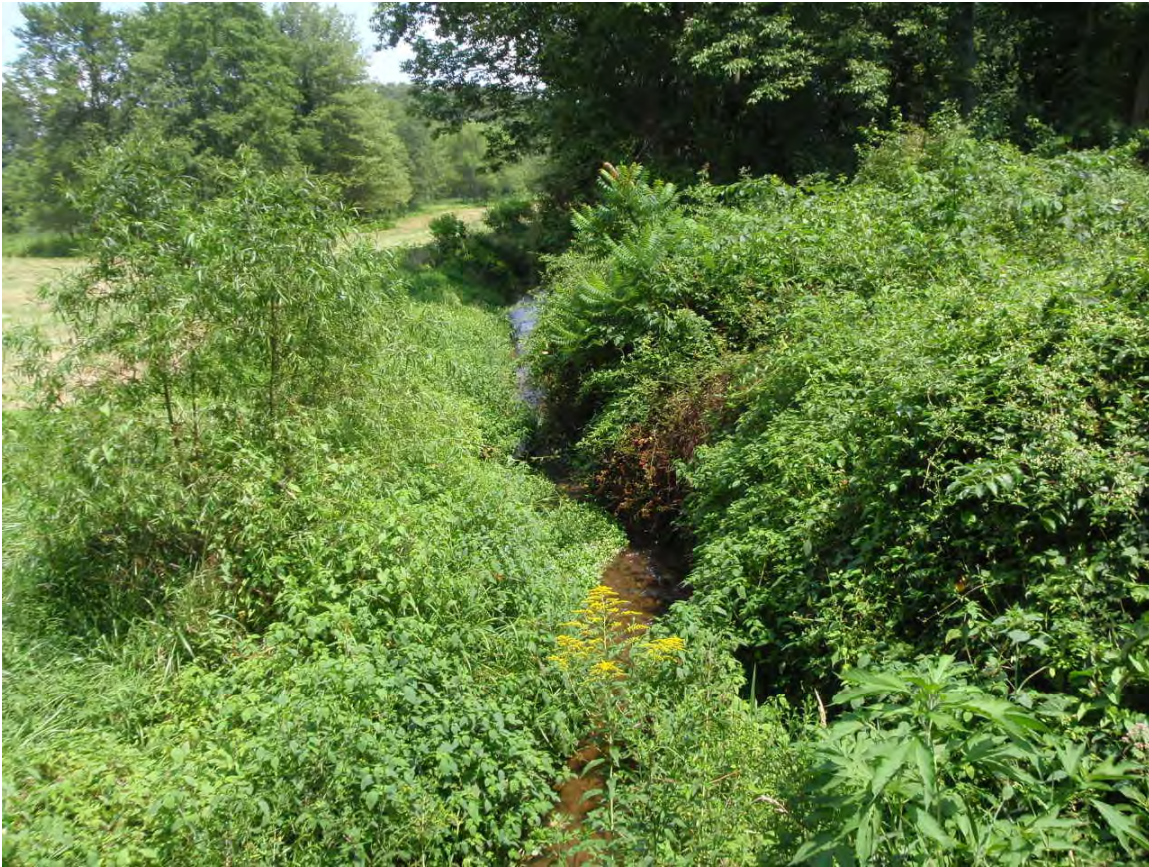
Falling Branch Deer Creek at Fawn Grove, PA (FBDC 4.1)

Scoring 165 of a possible 220, available physical habitat was classified as excellent in 2010. Sediment accumulation was one parameter SRBC staff noted as being potentially problematic at the time of assessment.

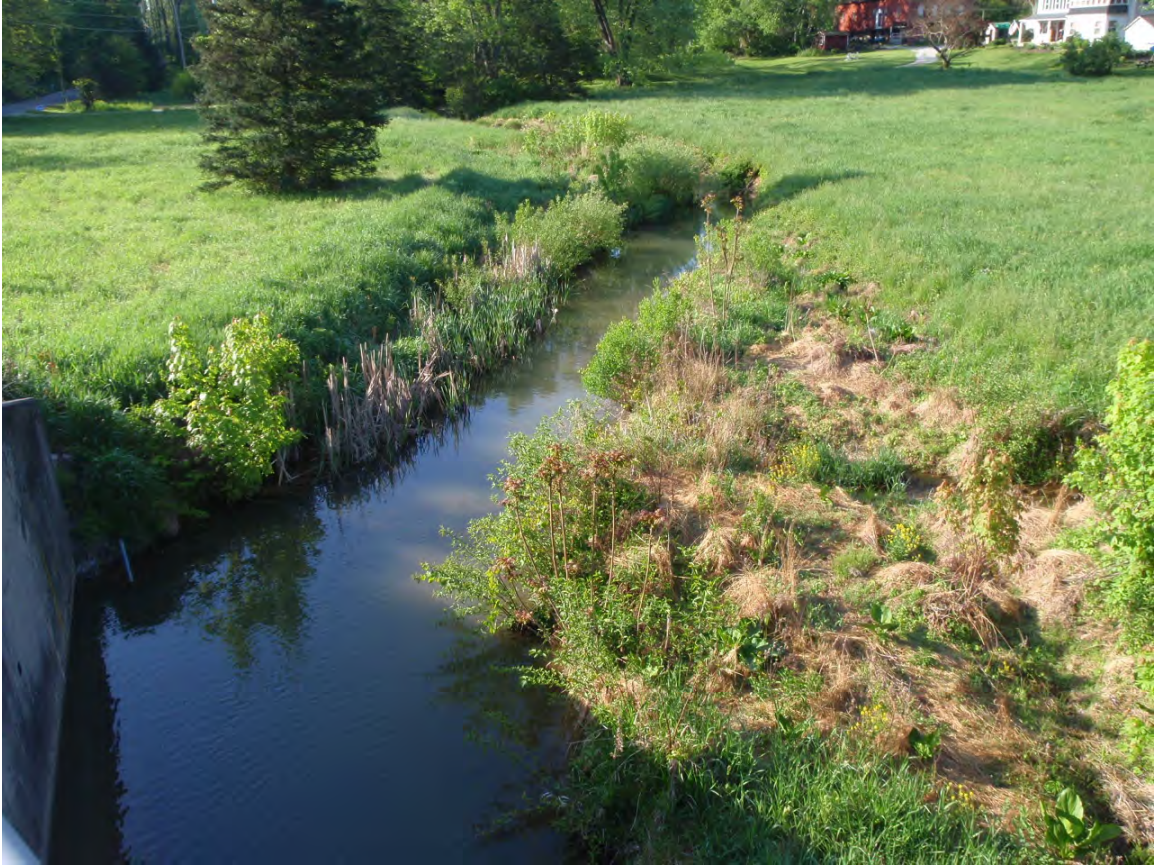
Receiving a score of 138 out of a possible 220, Long Arm Creek's physical habitat was classified as supporting.

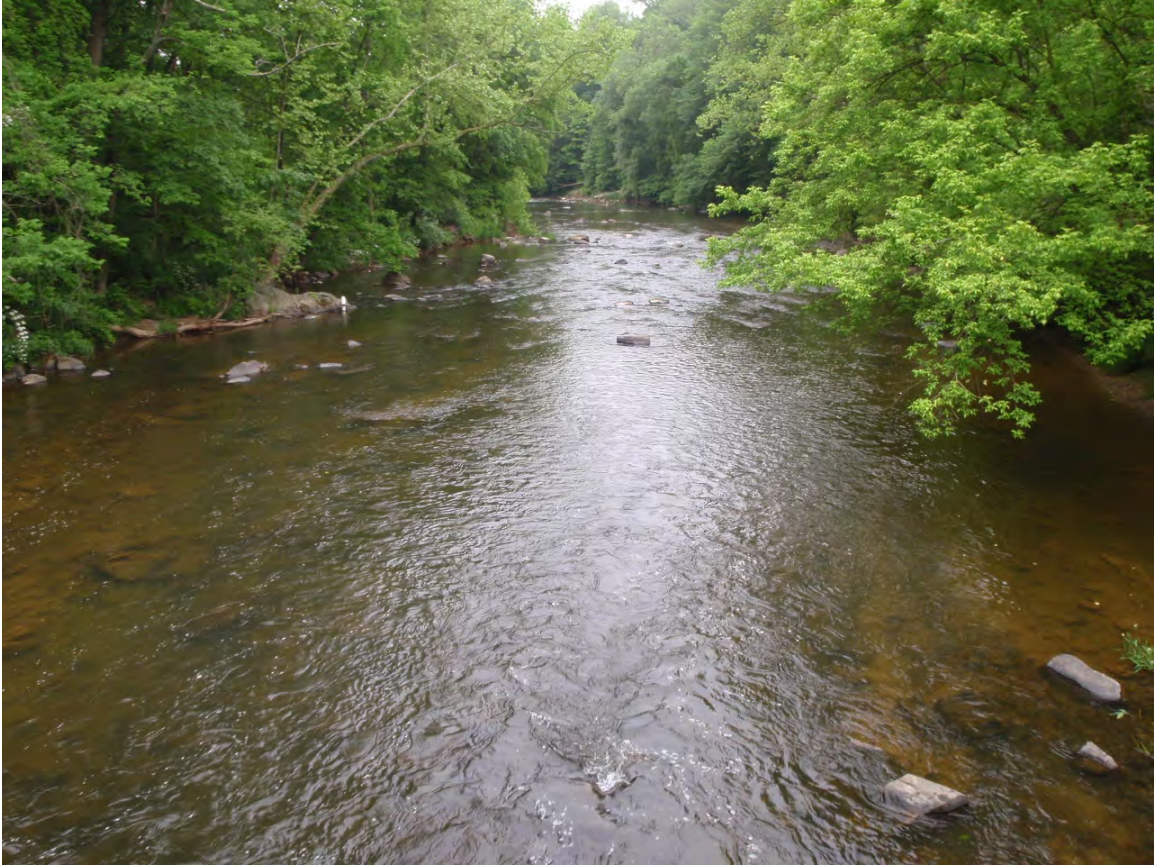
Octoraro Creek at Rising Sun, MD (OCTO 6.6)

Physical habitat at Octoraro Creek was rated as excellent, scoring 171 out of a possible 220. Optimal velocity/depth regimes, riffle frequency, and epifaunal substrate conditions were noted.

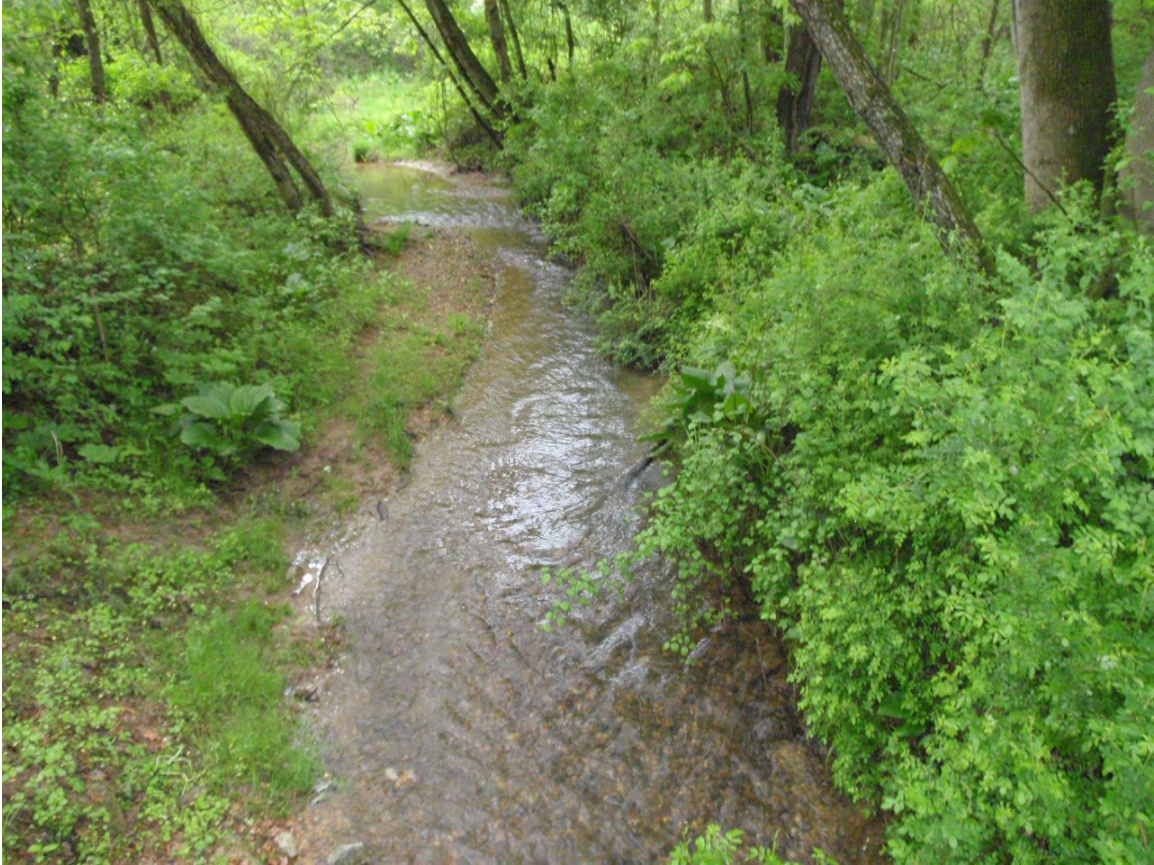
South Branch Conewago Creek at Bandanna, PA (SBCC 20.4)

Surrounded by primarily forested land, the South Branch Conewago Creek received a habitat rating of excellent in 2010. The site scored 173 out of a possible 220. Optimal riparian zone widths and abundant vegetation covering stable banks were noted.
