**ASSESSMENT OF INTERSTATE
STREAMS IN THE
SUSQUEHANNA RIVER BASIN**

Monitoring Report No. 24
January 1, 2010 Through December 31, 2010

Publication No. 273

*Monitoring and Protection Program
Susquehanna River Basin Commission*

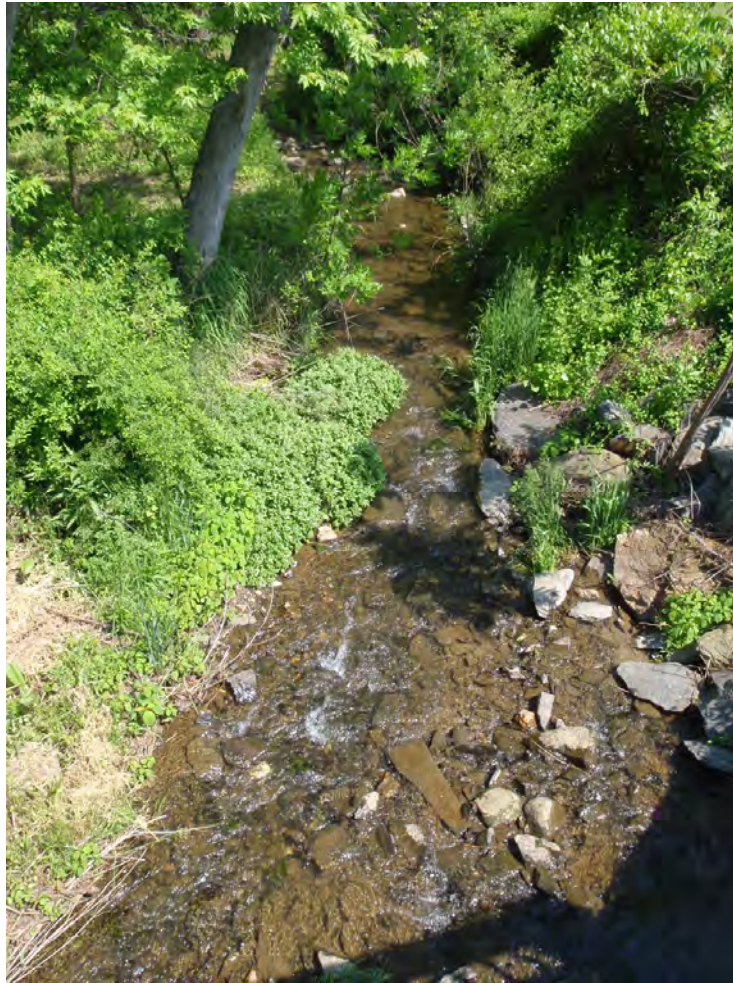
Scott Creek at Delta, PA (SCTT 3.0)

Physical habitat at Scott Creek scored 121 out of a possible 220 and received a classification of partially supporting. Staff noted a lack of riffle habitat and overall poor bank conditions.

The macroinvertebrate community was classified as moderately impaired in 2010. Scott Creek has had a declining biological condition over the past five years. The sampled fish community was rated as poor with an average metric score of only 2.5.

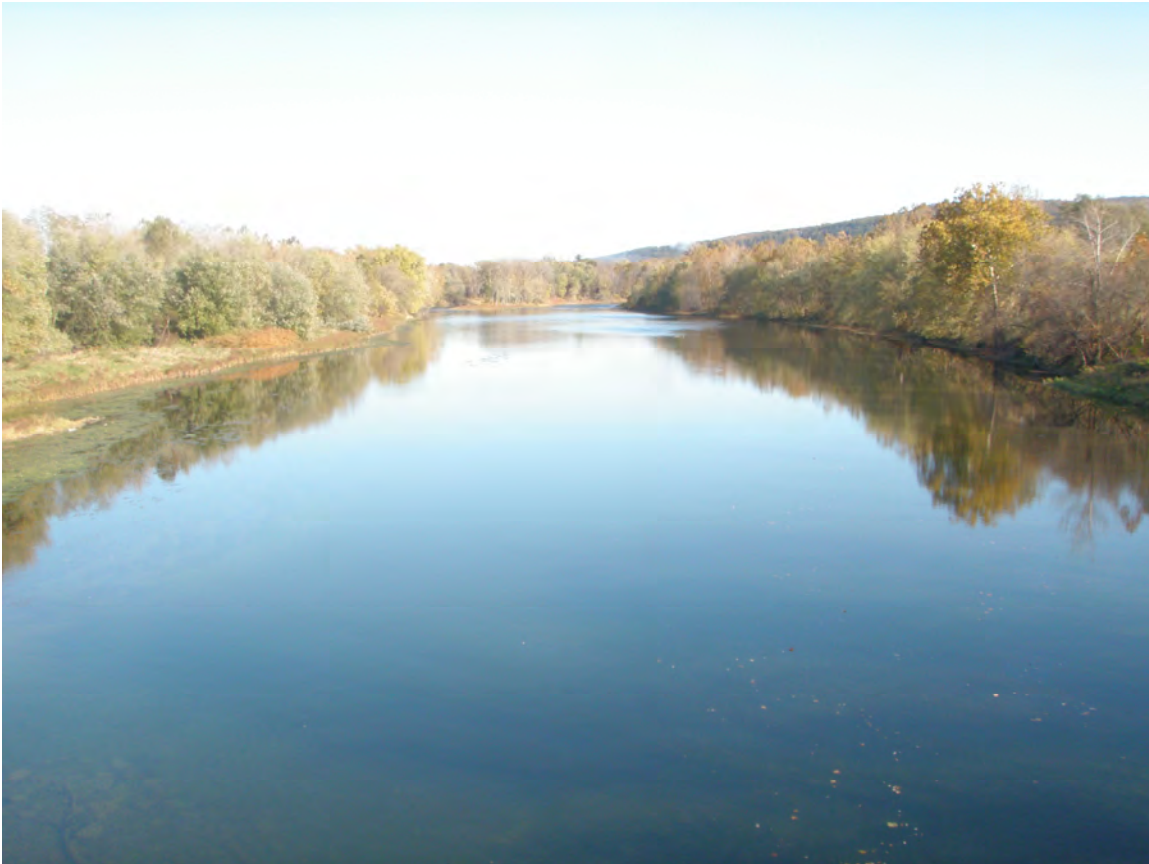
Chemung River at Chemung, NY (CHEM 12.0)

Physical habitat was rated as excellent at CHEM 12.0. The site scored 156 out of a possible 220. Staff noted optimal channel flow status and bank conditions but was concerned about sediment deposition and a lack of pool variability.

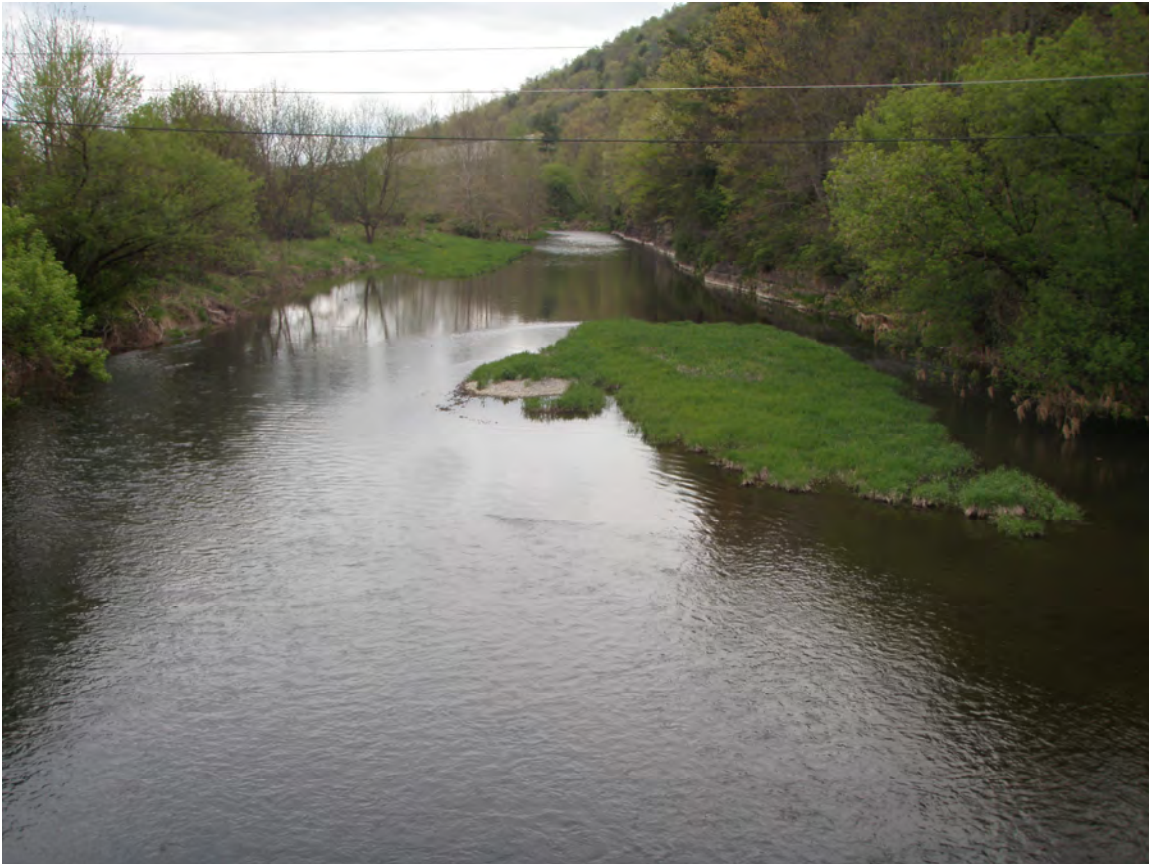
Cowanesque River at Lawrenceville, PA (COWN 1.0)

Physical habitat was classified as supporting in 2010. The site scored 128 out of a possible 220. The assessment scored was impacted by ongoing construction activities occurring directly upstream of the sampling site.

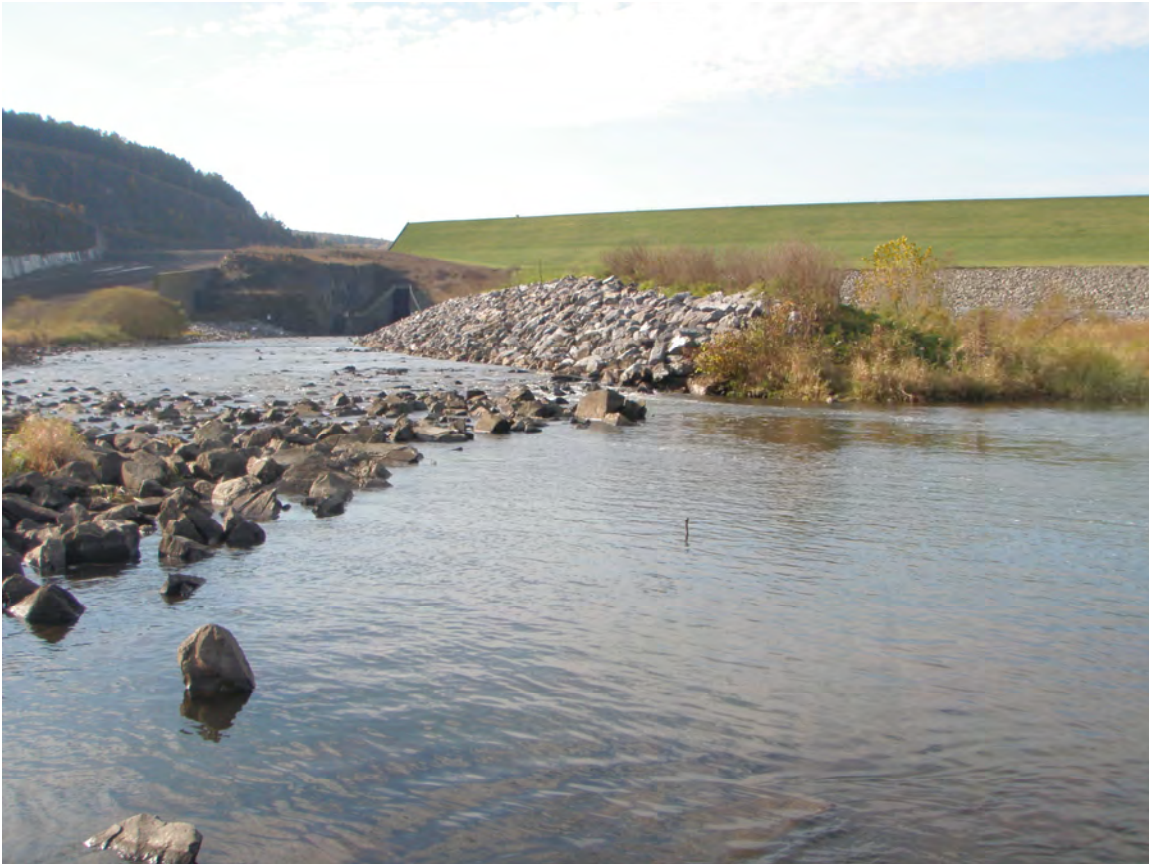
Cowanesque River at Lawrenceville, PA (COWN2.2)

Located directly below a major reservoir, physical habitat was designated as partially supporting. The site scored 112 out of a possible 220. Major channel alterations and an absence of instream cover significantly affected the overall habitat score and classification.

The biological community at COWN 2.2 was rated as moderately impaired for the fifth consecutive year. In 2010, this station received the lowest biological condition score of all large river interstate sites.

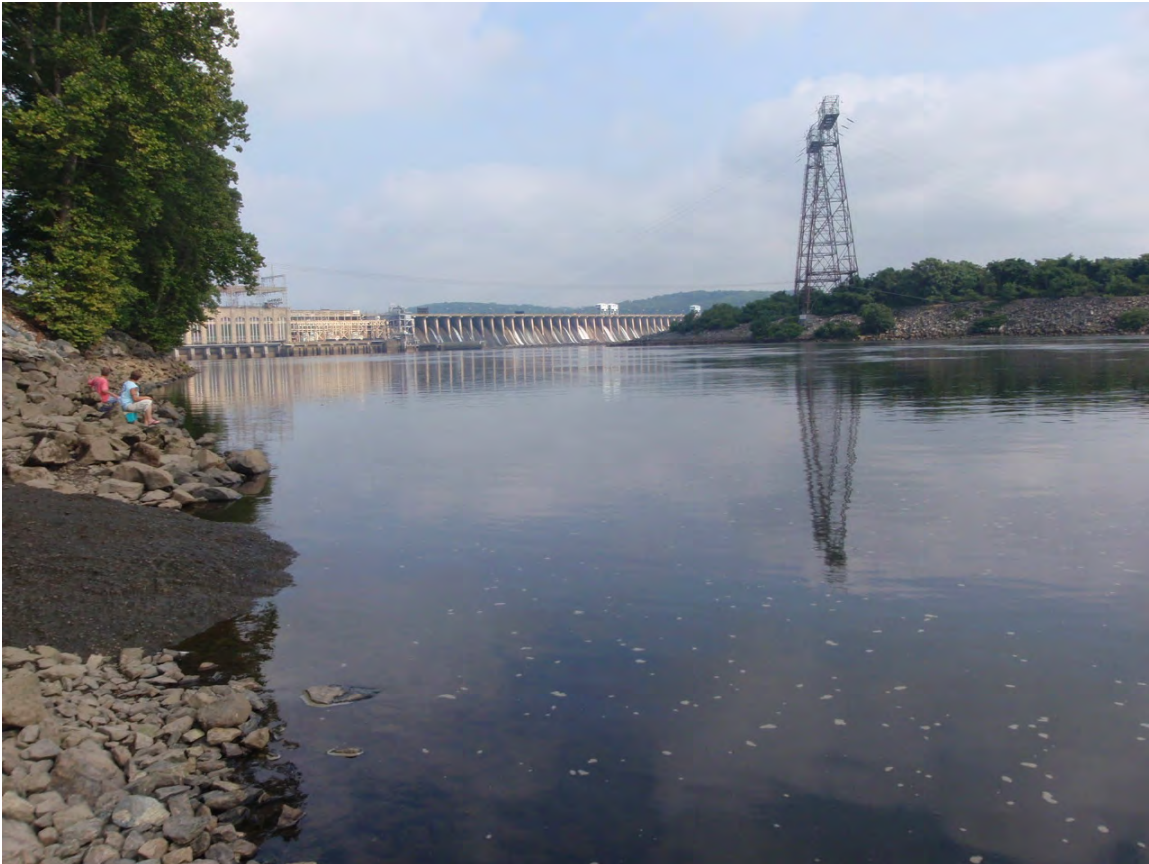
Susquehanna River at Conowingo, MD (SUSQ 10.0)

Due to the location of this sampling station, physical habitat is not assessed. The station is located directly downstream of the Conowingo Hydroelectric dam and is subject to frequent disturbances due to plant operations.

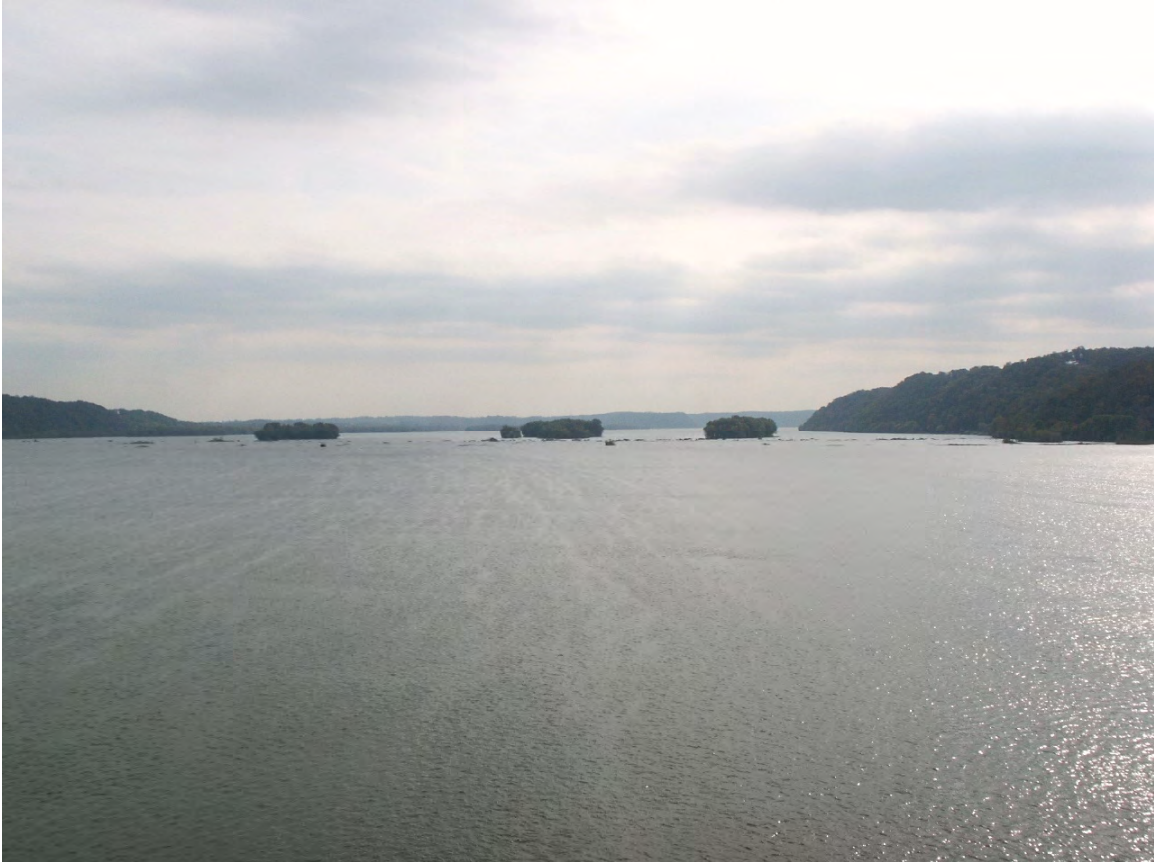
Susquehanna River at Marietta, PA (SUSQ 44.5)

Scoring 161 out of a possible 220, available physical habitat was deemed excellent in 2010. Despite being bracketed by hydroelectric facilities upstream and downstream of the sampling site, habitat conditions remain good. The Susquehanna River at this location is approximately one mile wide.

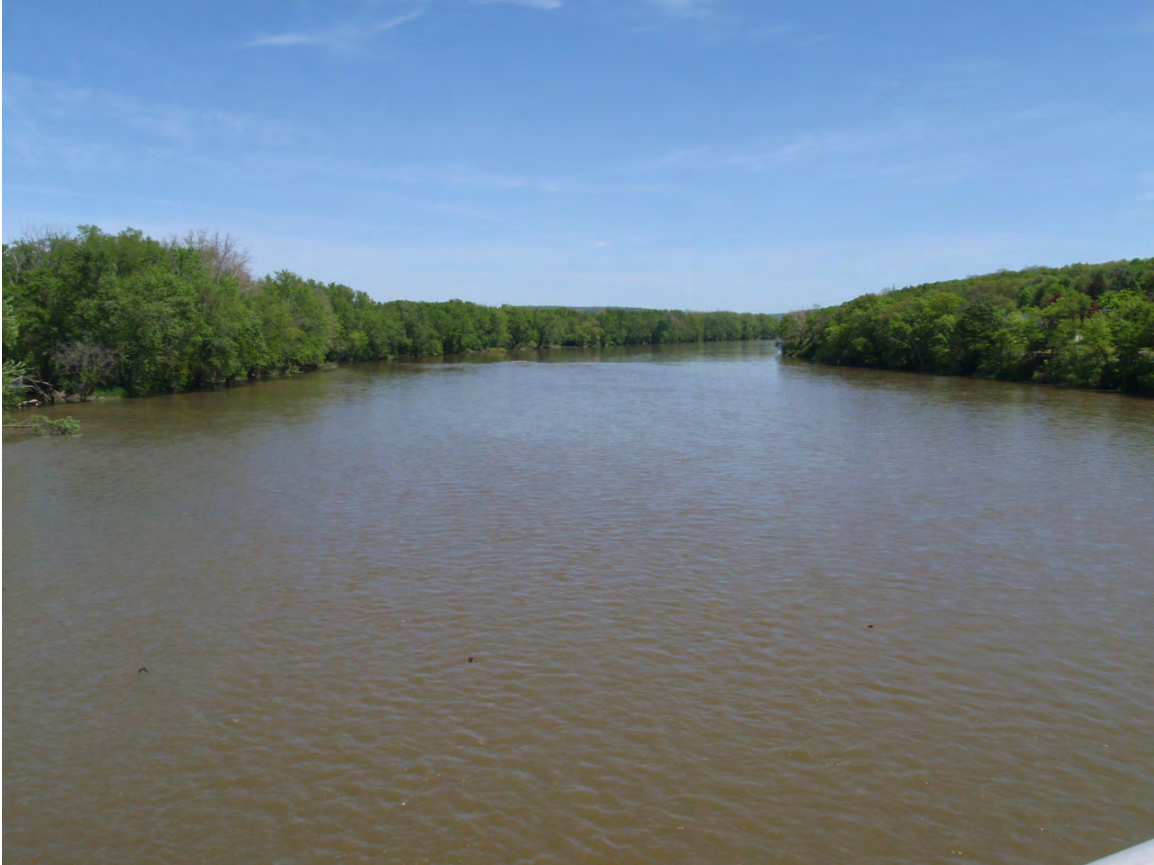
Susquehanna River at Sayre, PA (SUSQ 289.1)

Available physical habitat was classified as excellent in 2010. SUSQ 289.1 scored 155 out of a possible 220 points. Staff noted good epifaunal substrate and velocity/depth regimes.

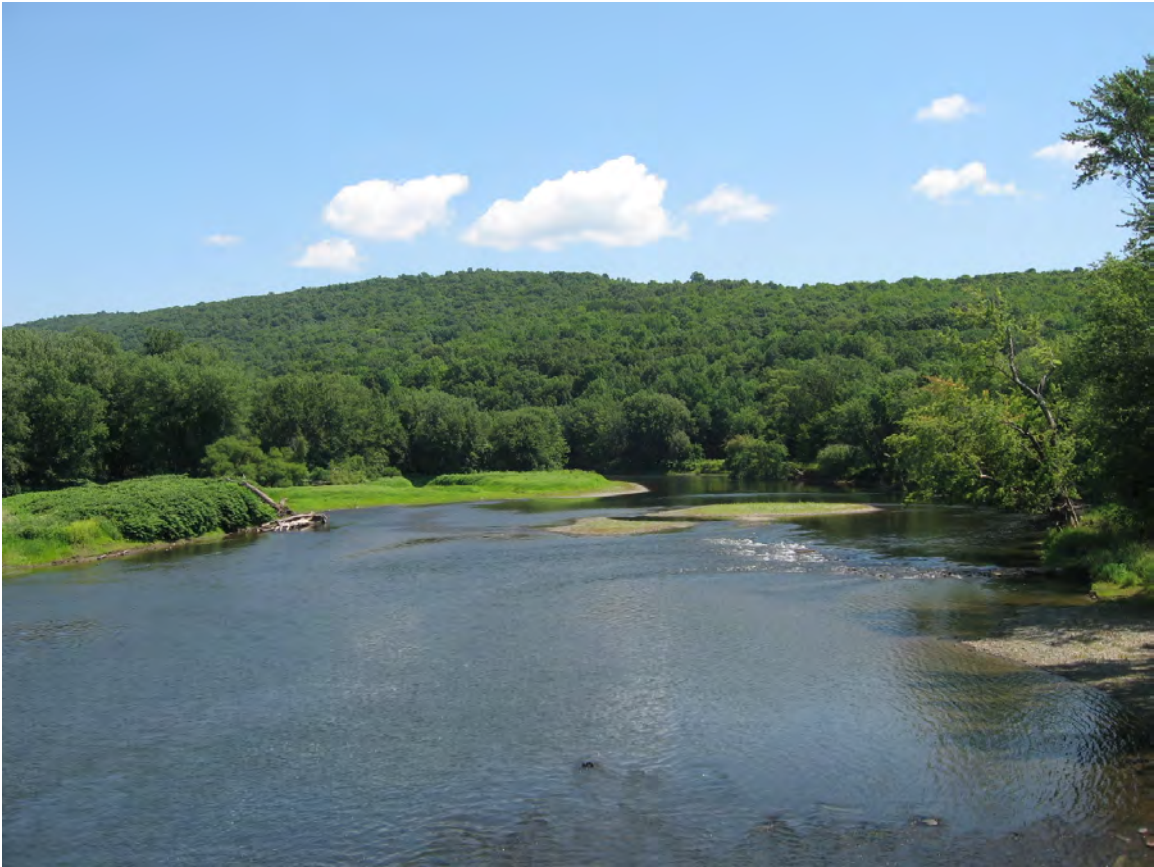
Susquehanna River at Windsor, NY (SUSQ 365.0)

Available physical habitat was classified as excellent in 2010. Scoring 176 out of a possible 220, SUSQ 365.0 possessed the best habitat score of all large river sites in the 2010 interstate project.

SUSQ 365.0 received a biological condition classification of slightly impaired. This rating marks a decline from the four previous years when the macroinvertebrate community as designated as nonimpaired.

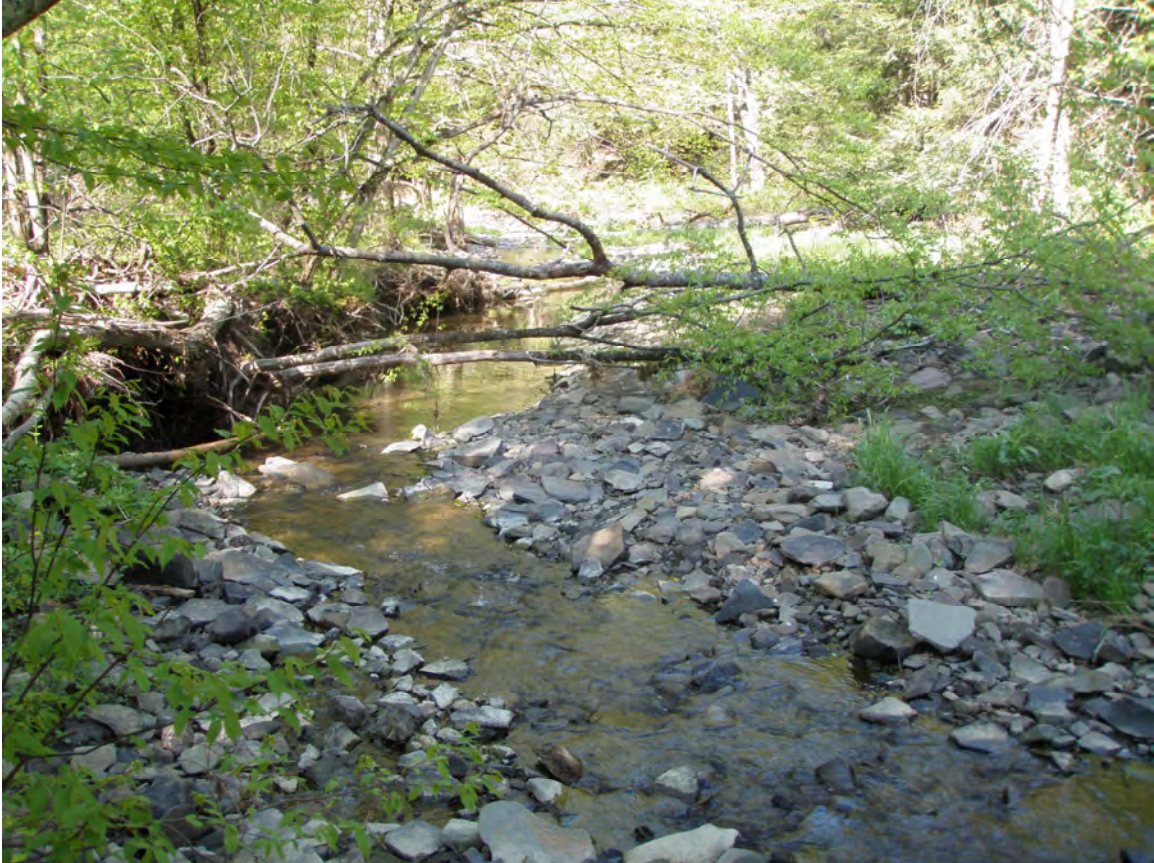
Babcock Run (BABC)

In May 2010, SRBC staff assessed Babcock Run near Cadis, Pa. Overall physical habitat was rated as excellent with the stream supporting a well-developed channel with ample instream cover, riffle frequency, and a minimal amount of embeddedness and sediment deposition. The macroinvertebrate community was rated as slightly impaired as overall taxonomic richness remained low, although 51 percent of the subsample was represented by the pollution sensitive mayfly family Ephemeroptera. All water quality parameters tested within acceptable limits.

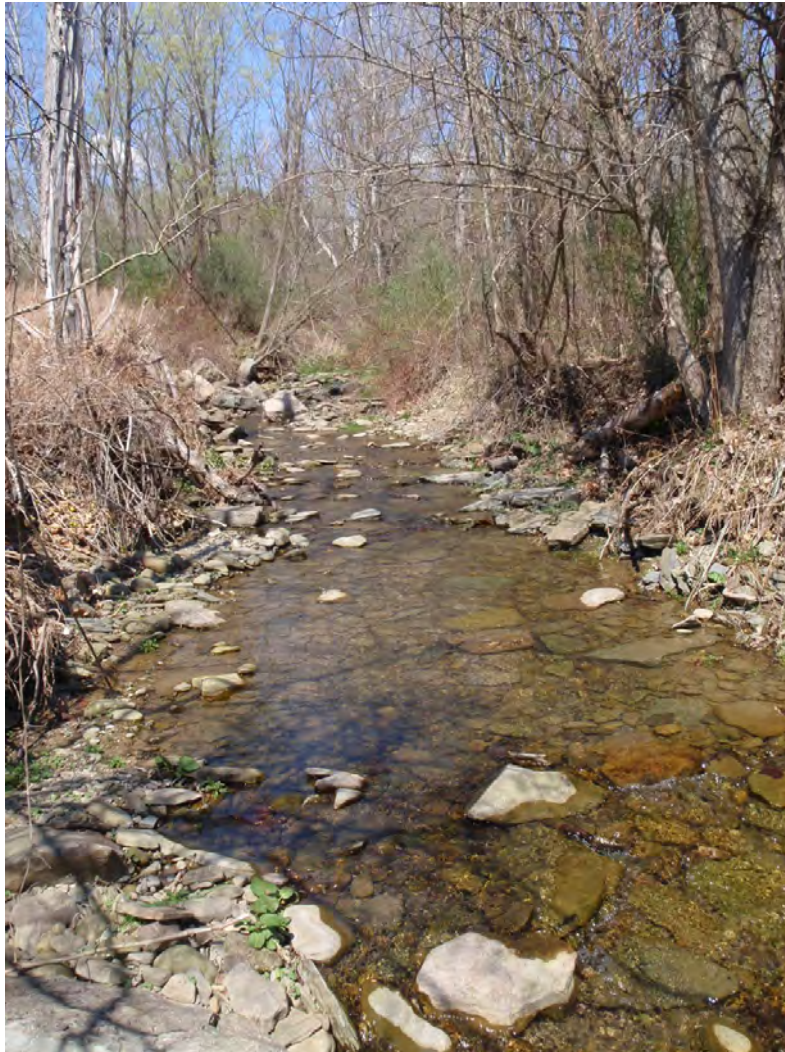
Bill Hess Creek (BILL)

Bill Hess Creek near Route 49 in Nelson, Pa., received a classification of slightly impaired in 2010. The macroinvertebrate community showed good diversity with 27 total taxa, of which 21 were in the pollution sensitive EPT orders. Physical habitat was classified as supporting with abundant instream cover but poor bank conditions. Water quality parameters all tested within acceptable limits.

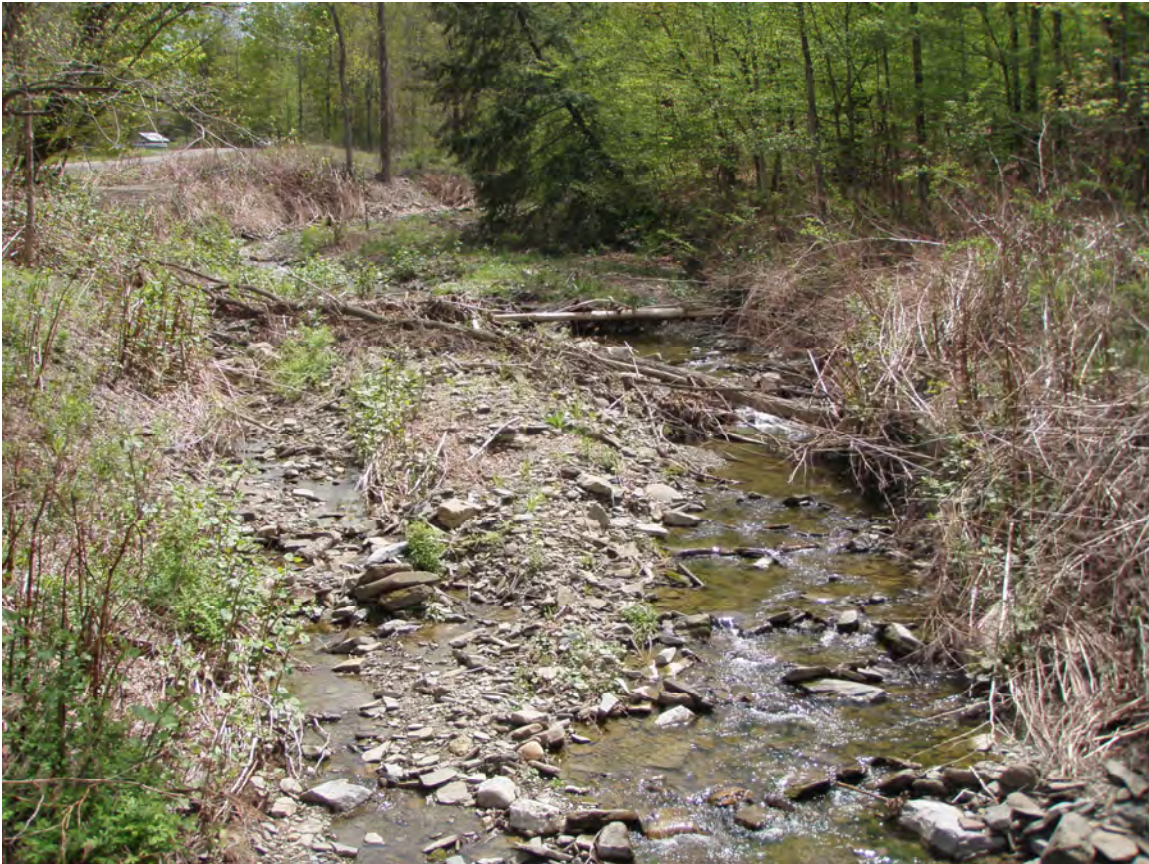
Bird Creek (BIRD)

For the second consecutive year, the biological condition of Bird Creek, near Webb Mills, N.Y., was rated as nonimpaired. The stream scored highly in the Shannon Diversity index and the EPT index and had a substantial proportion (57.5 percent) of the subsample represented by members of the order Ephemeroptera. The assessed physical habitat was classified as supporting with ample riffles and minimal sediment deposition. Channel flow status and instream cover were the lowest scoring habitat parameters. Staff noted strongly undercut banks exposing the channel's cobble and boulder substrate. All measured water quality parameters tested within acceptable limits.

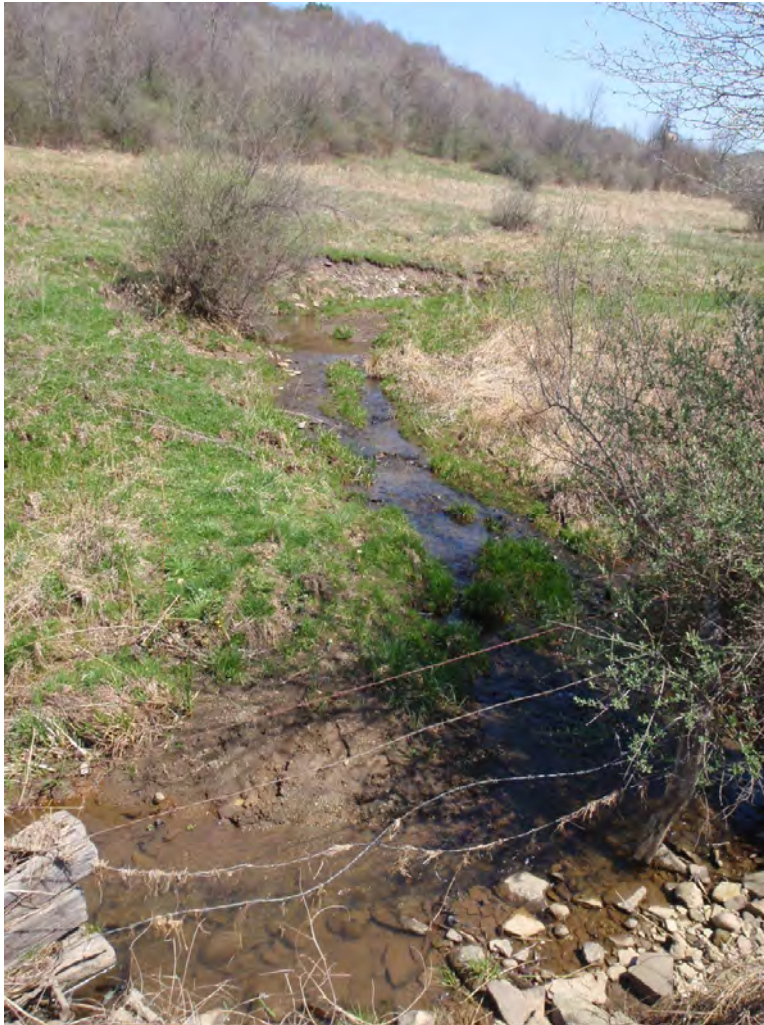
Biscuit Hollow (BISC)

Biscuit Hollow was rated as slightly impaired in 2010, showing a significant improvement from 2009. Physical habitat was deemed excellent despite the agricultural use in the surrounding area. Riparian zone width is problematic as well as the lack of instream cover. Measured water quality parameters all fell within accepted limits.

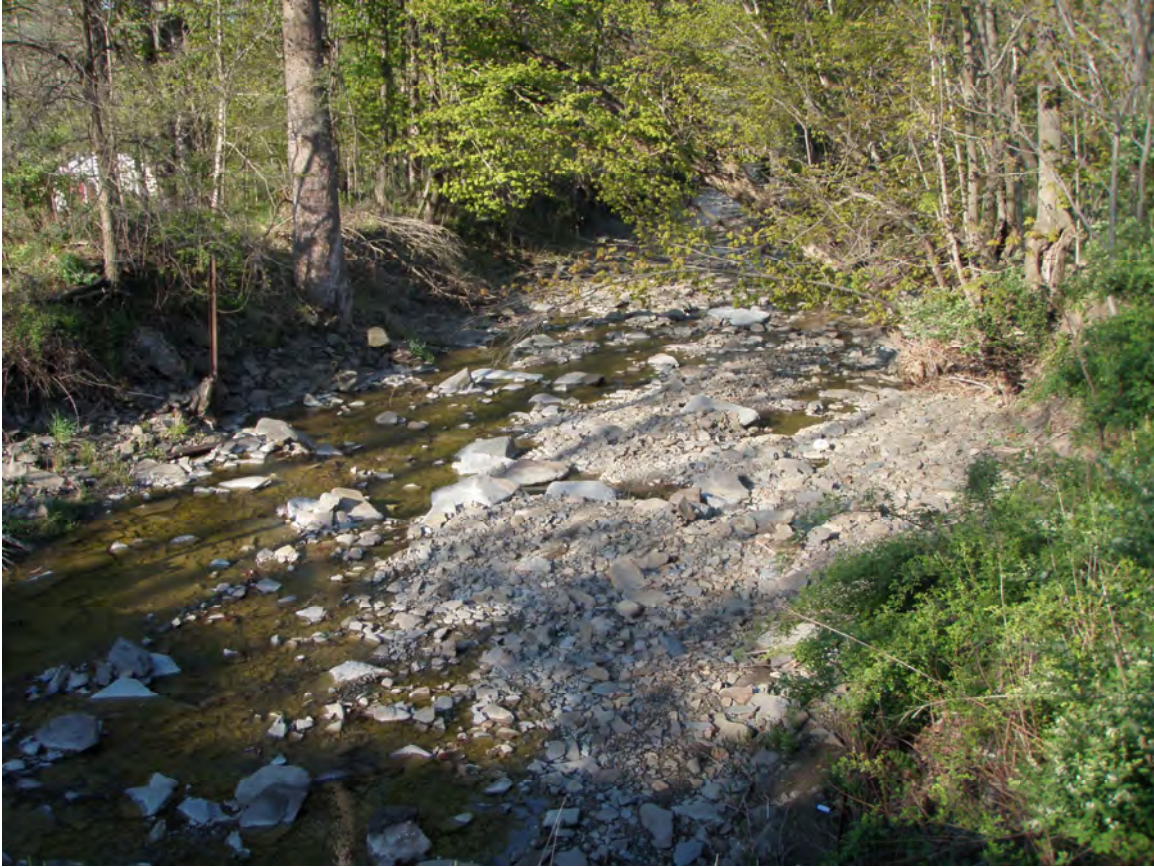
Briggs Hollow Run (BRIG)

Briggs Hollow Run near Nichols, N.Y., received a nonimpaired rating of its biological community in 2010. The macroinvertebrate sample contained a high percentage of pollution sensitive Ephemeroptera taxa and a low percentage of pollution tolerant Chironomidae taxa. Measured water quality parameters were all within acceptable limits. Physical habitat was rated as partially supporting. Briggs Hollow Run scored poorly due to highly eroded banks and limited instream cover. Channel flow status was also problematic with a significant portion of the available channel being exposed substrate.

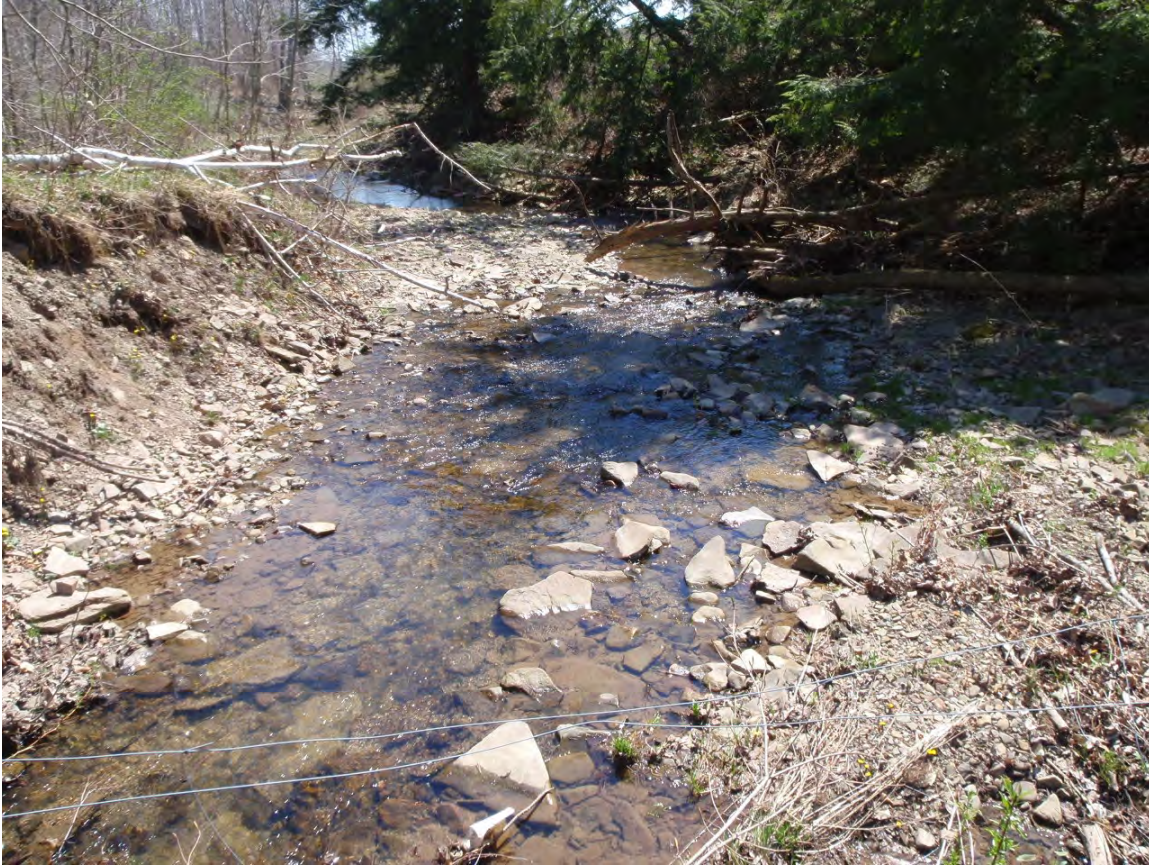
Bulkley Brook (BULK)

Bulkley Brook, located near Knoxville, Pa., had a nonimpaired biological community when sampled in May 2010. Factors contributing to the nonimpaired rating were a high contribution of Ephemeroptera taxa and high EPT and Shannon-Wiener indices scores. Considerable physical habitat issues were noted at the time of assessment leading to a rating of partially supporting. Staff noted rapidly erosion of strongly undercut banks. Within the last year, significant erosion of the left bank has resulted in the loss of protective vegetation. All field chemistry parameters were within acceptable limits at the time of measurement.

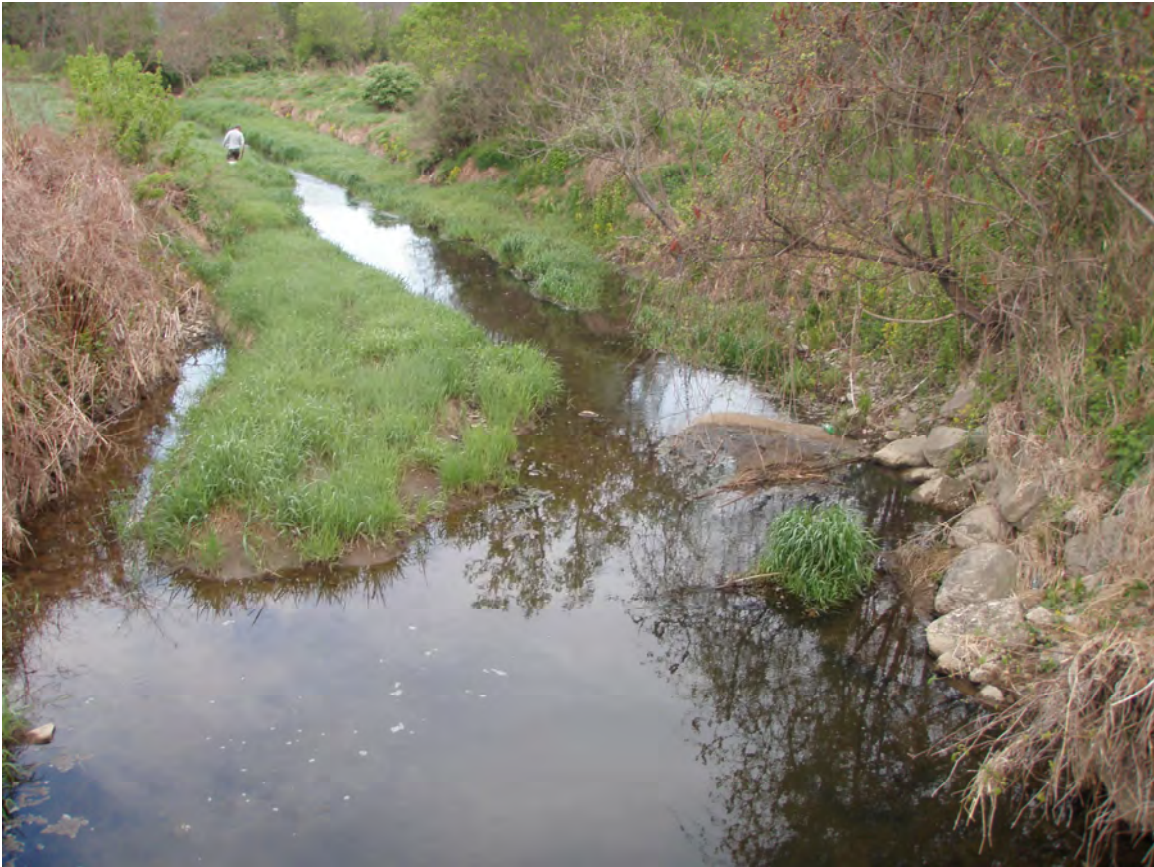
Camp Brook (CAMP)

Camp Brook, in the vicinity of Osceola, Pa., received a moderately impaired rating of its biological community in 2010. Camp Brook was one of two Group 3 streams to receive this rating in 2010. The macroinvertebrate sample was dominated by pollution tolerant Chironomidae taxa and scored poorly in the Hilsenhoff and EPT indices. Physical habitat was assessed as supporting with good velocity/depth regimes and a well-developed channel. SRBC staff noted abundant alga growth. All field chemistry parameters were within acceptable limits though dissolved oxygen was measured at 7.23 mg/L, approaching the state lower threshold of 6.0 mg/L.

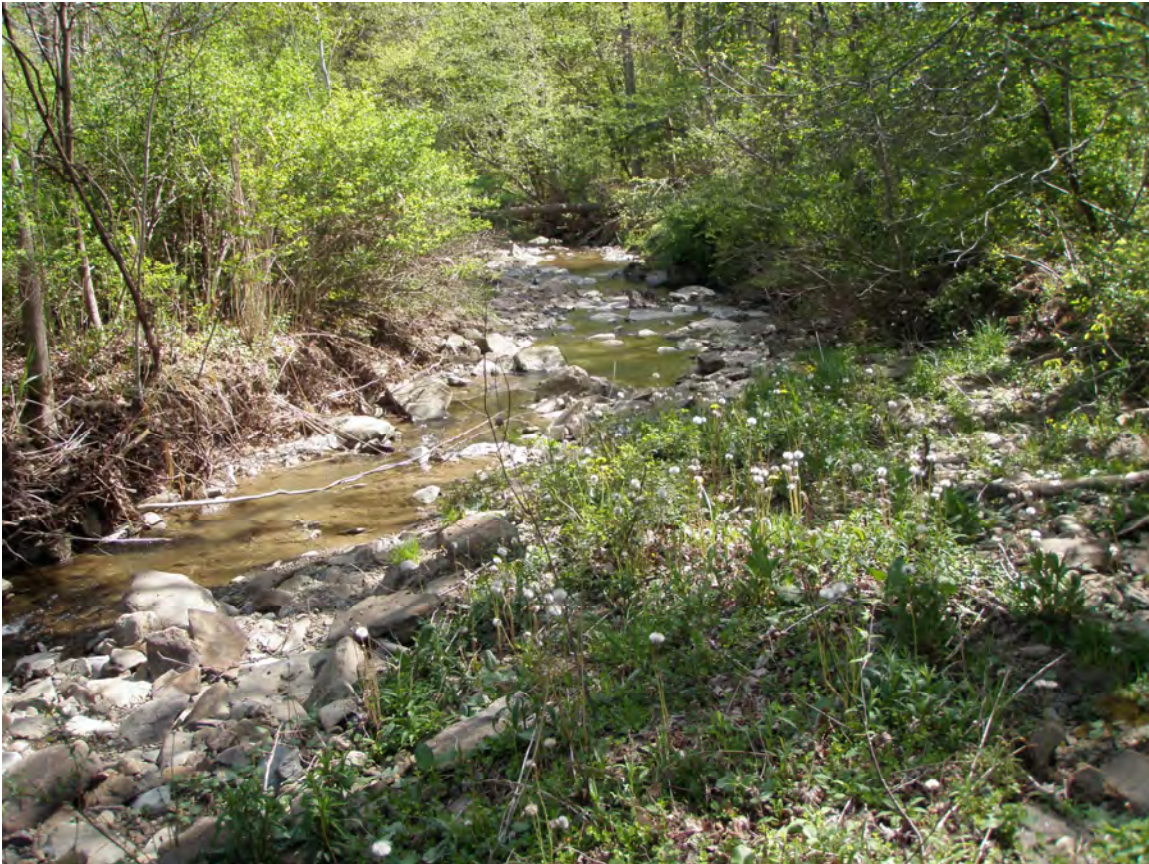
Cook Hollow (COOK)

Camp Hollow Brook, near Austinburg, Pa., had a slightly impaired biological community when sampled in May 2010. Overall taxa richness scored very well with 29 groups being represented, of which 21 were EPT taxa. Camp Hollow Brook had one of the highest EPT indices of all Group 3 streams assessed. Conversely, it also had one of the poorest scoring Hilsenhoff indices, suggesting excessive organic pollution within the watershed. Physical habitat was rated as excellent with ample instream cover and well-developed riffle areas. All field chemistry parameters measured within acceptable limits.

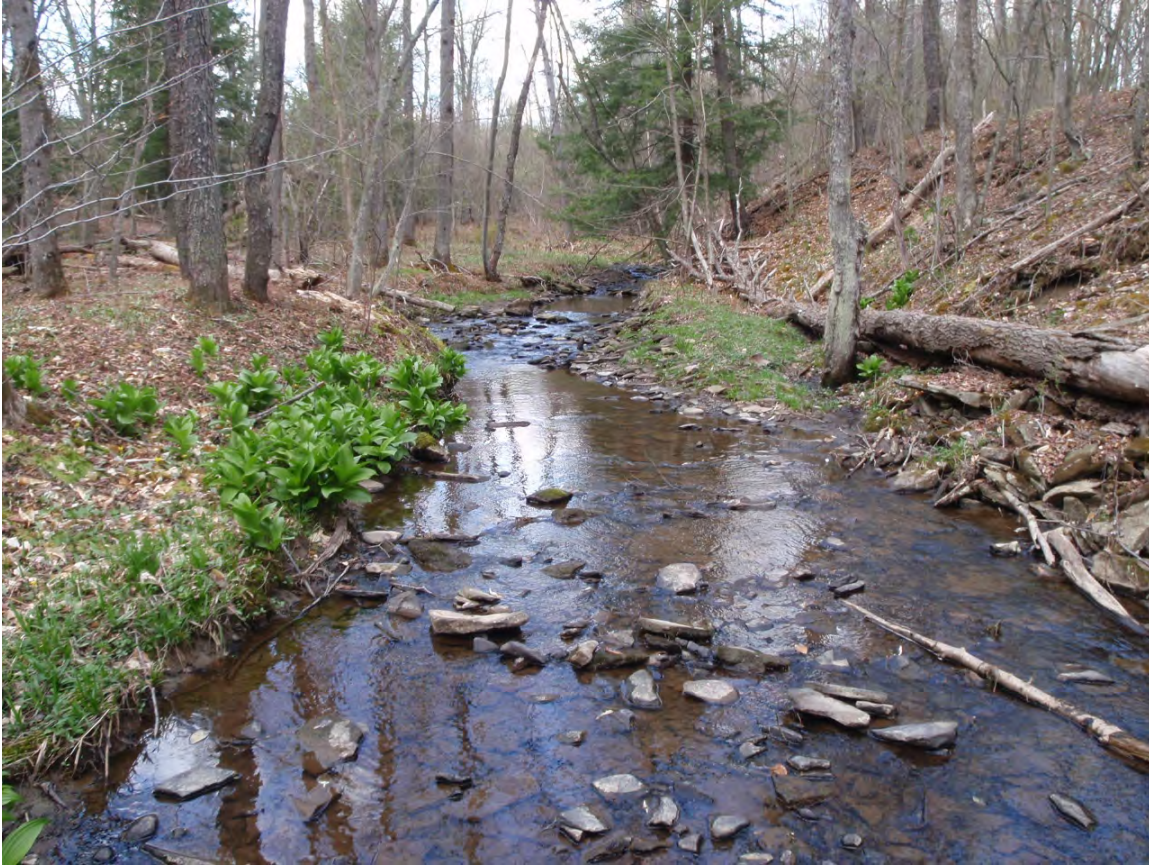
Deep Hollow Brook (DEEP)

Deep Hollow Brook received a nonimpaired biological condition rating for the fourth time in the last five years it has been assessed. The macroinvertebrate community had the greatest taxa richness of all Group 3 streams in 2010 with 35 different groups being identified. Deep Hollow Brook also received a physical habitat rating of excellent due in part to its undisturbed channel and broad riparian vegetative zone widths on both banks. Field chemistry measurements revealed pH and alkalinity to be outside of acceptable limits. Alkalinity was measured to be 8 mg/L and the recorded pH value was 6.0. Pennsylvania's alkalinity threshold requires at least 20 mg/L while New York has an acceptable pH range of 6.5 to 8.5.

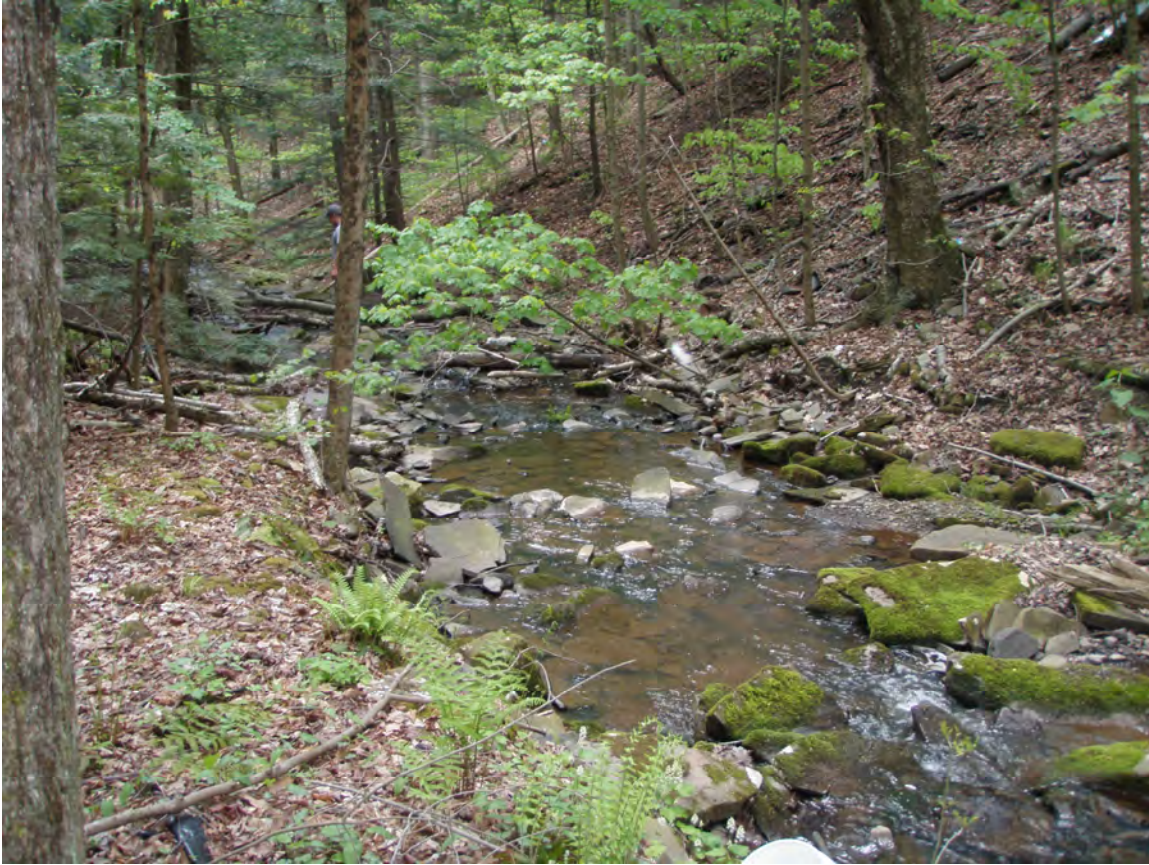
Denton Creek (DENT)

Denton Creek near Hickory Grove, Pa., had a moderately impaired biological community in 2010. Both the Hilsenhoff and EPT indices scored poorly as did percentage contribution of Chironomidae individuals. Physical habitat was deemed as supporting. An upstream impoundment limits the impact of high water events on the instream habitat. Denton Creek had two field chemistry parameters measure outside of acceptable limits. A pH value of 6.05 and an alkalinity reading of 8 mg/L exceeded the New York state pH standard and Pennsylvania alkalinity standard of 6.5-8.5 and <20 mg/L, respectively.

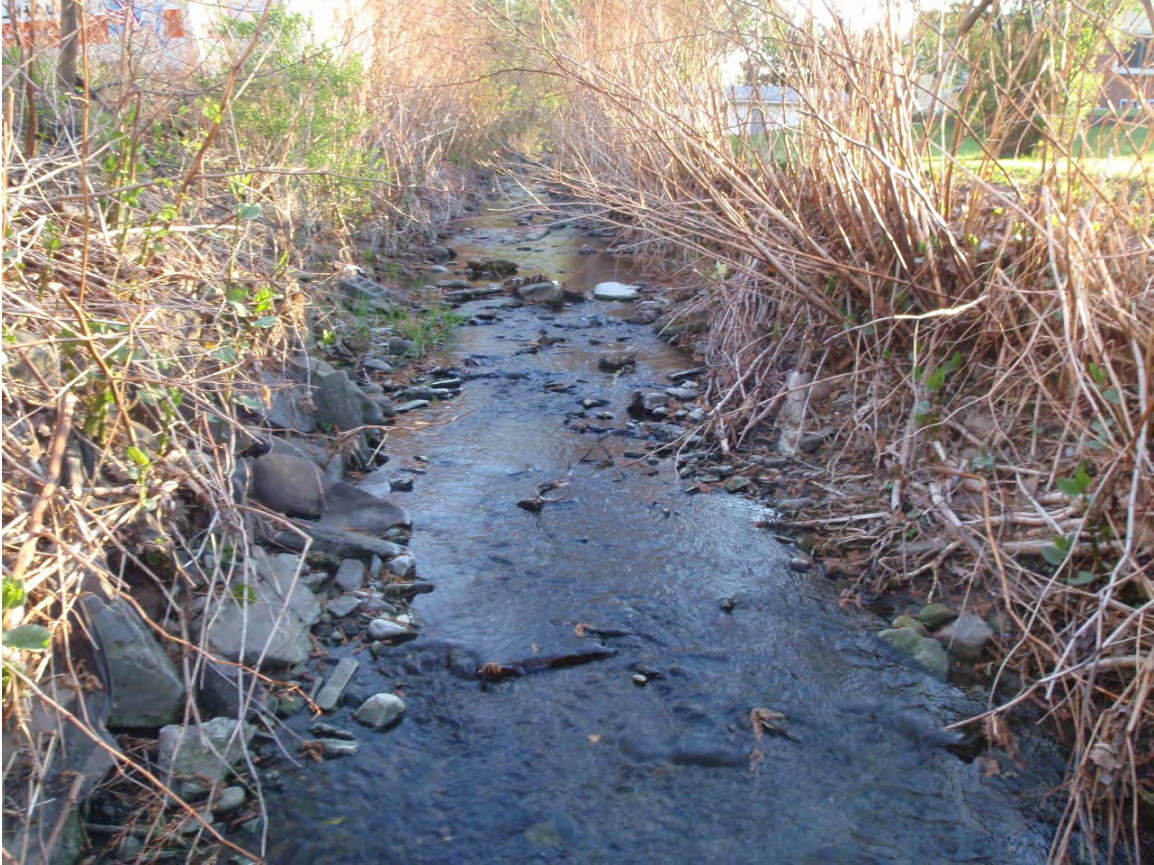
Dry Brook (DRYB)

Dry Brook, sampled in Waverly, Pa., exhibited a slightly impaired biological community in 2010. Heavily influenced by urban development, Dry Brook has consistently scored poorly in both biological and physical habitat conditions. All measured field chemistry parameters were within acceptable limits. Dry Brook was the lone Group 3 interstate stream to receive a physical habitat classification of nonsupporting. A significantly altered channel and an absence of instream cover were two notable habitat limitations. Also negatively contributing to the condition of the stream were narrow riparian vegetative zones consisting mainly of the invasive plant Japanese knotweed.

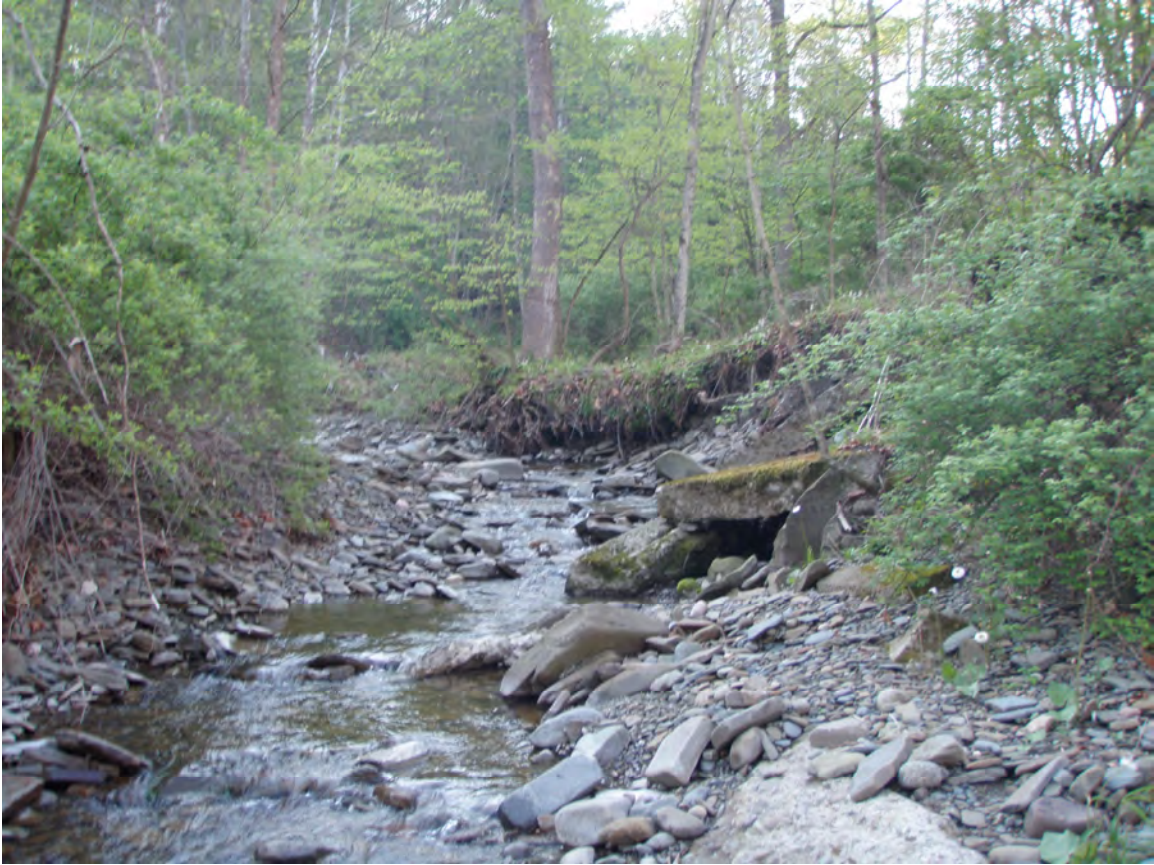
Little Wappasening Creek (LWAP)

Little Wappasening Creek near Nichols, N.Y., received a biological condition rating of nonimpaired for 2010. The stream had an excellent macroinvertebrate community that scored equivalent to the reference stream for this group. The EPT, Hilsenhoff, and Shannon Diversity indices all scored highly for the stream. Physical habitat was again rated as excellent due in part to the abundance of forested area in watershed. At the time of assessment, Little Wappasening Creek had wide riparian vegetative zones and an undisturbed channel with ample riffle habitat. This high gradient stream lacked all velocity/depth regimes and had exposed substrate in the channel. All field chemistry parameters tested within acceptable limits.
