**ASSESSMENT OF INTERSTATE
STREAMS IN THE
SUSQUEHANNA RIVER BASIN**

Monitoring Report No. 24
January 1, 2010 Through December 31, 2010

Publication No. 273

*Monitoring and Protection Program
Susquehanna River Basin Commission*

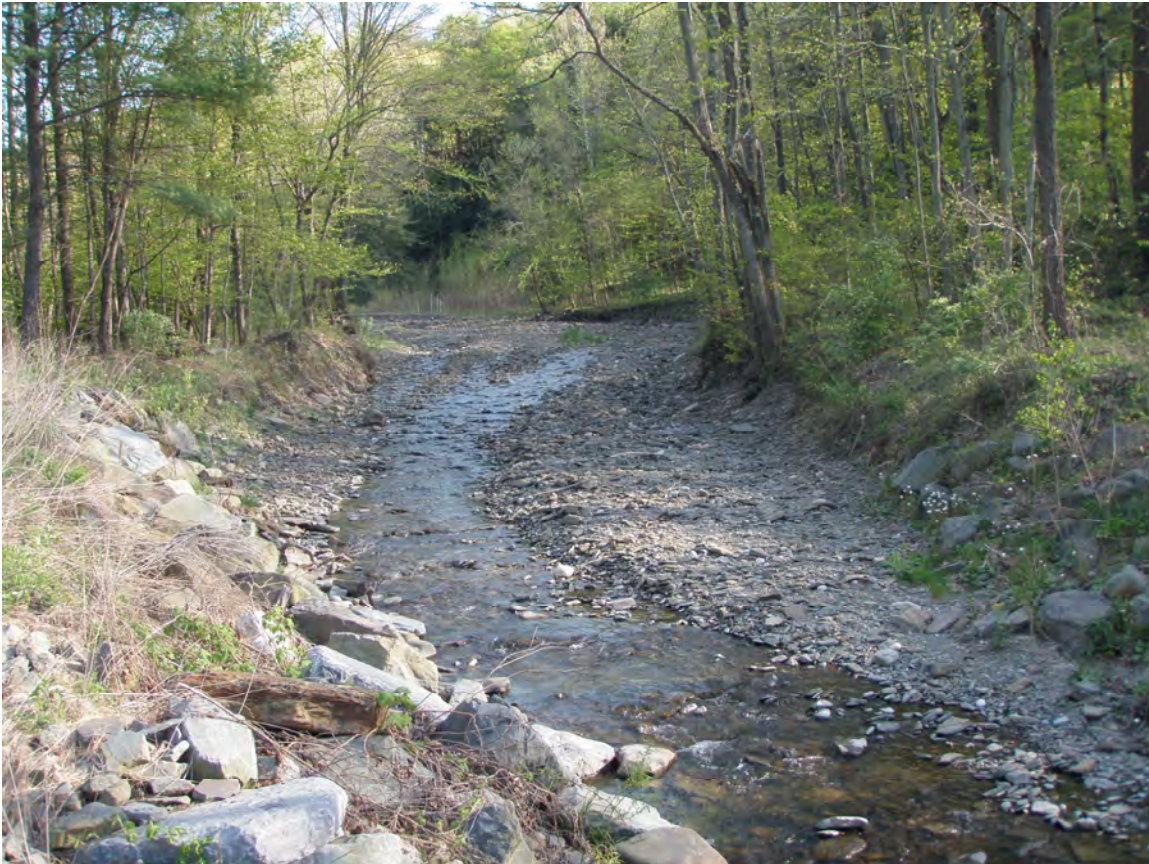
Parks Creek (PARK)

Parks Creek near Litchfield, N.Y., was designated as having a slightly impaired biological community for the sixth consecutive year. Parks Creek's biological community received a good Hilsenhoff index score and had a high percentage of Ephemeroptera taxa present. Physical habitat was rated as supporting with good frequency of riffles and minimal sediment deposition. Evidence of high water impacts are clearly shown in the degraded state of both banks and the significant portion of bare channel exposed. All measured field chemistry parameters were within acceptable limits.

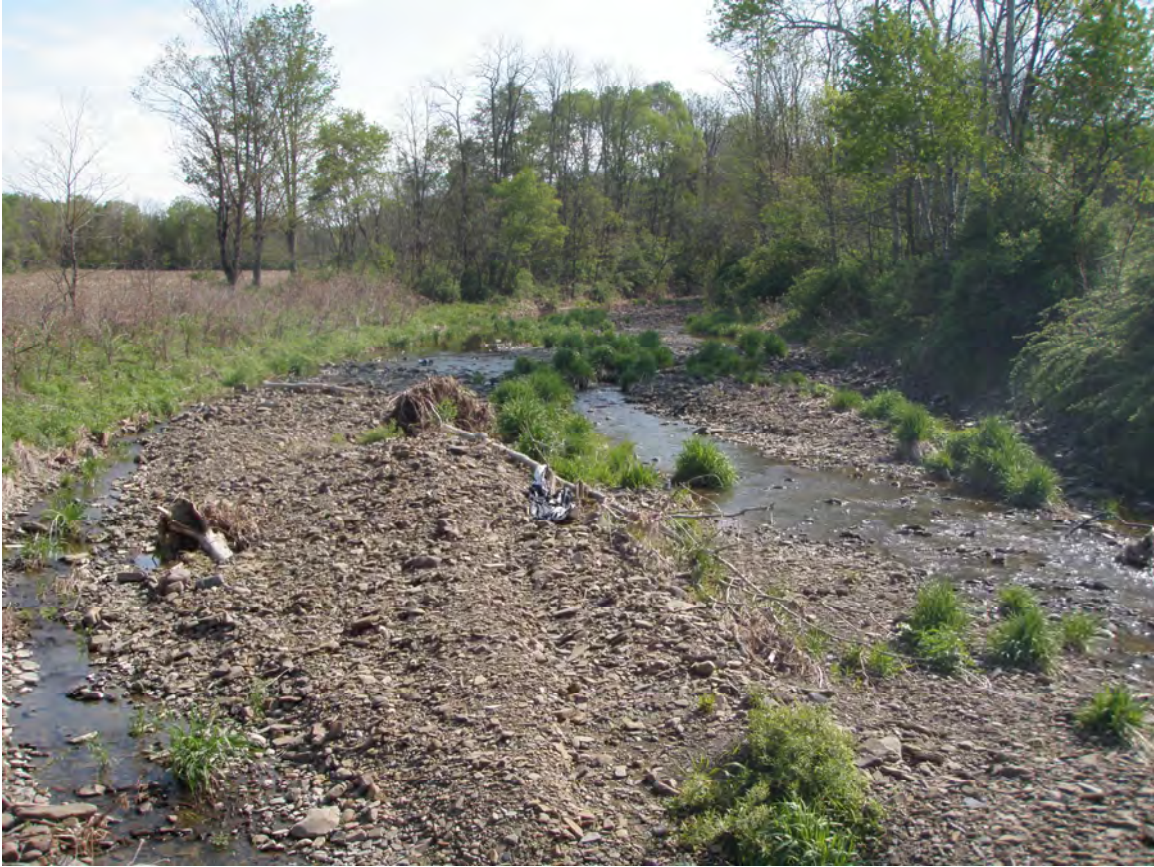
Prince Hollow Run (PRIN)

Prince Hollow Run near Cadis, Pa., received a biological condition rating slightly impaired when sampled in May 2010. The stream scored poorly in the Hilsenhoff index, suggesting organic pollution impacting the macroinvertebrate community. SRBC staff noted active farming occurring immediately adjacent to the streambank. Physical habitat was rated as supporting. As evident in the site photo, a significant portion of the channel was exposed leaving large cobble bars to divide the channel. Bank condition was also noted as problematic. The right bank abuts active cropland while the left bank is eroded and unstable. A pH value of 6.4 was recorded on May 5, 2010. New York's aquatic life use criteria for pH ranges from 6.5 to 8.5 units.

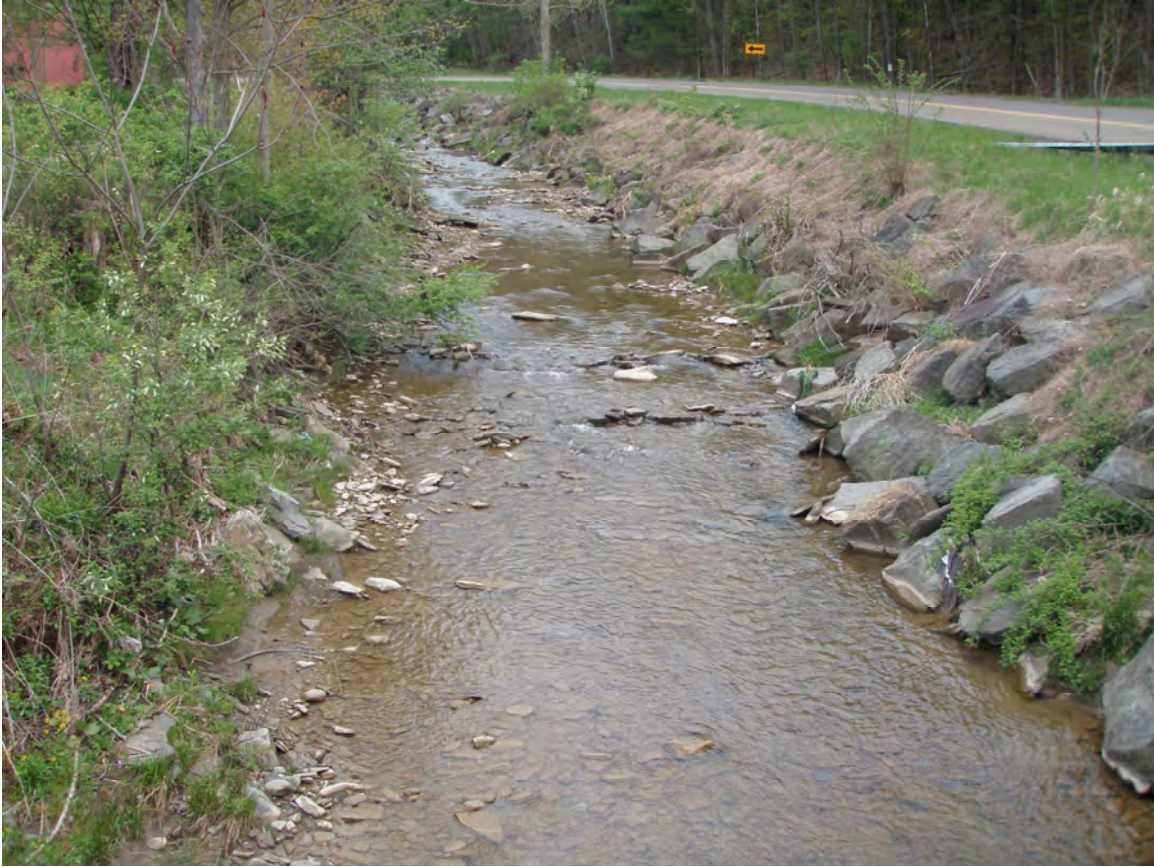
Redhouse Run/Beagle Hollow (REDH)

Redhouse Run (Beagle Hollow) located near Osceola, Pa., received a biological condition rating of nonimpaired in 2010. All metrics scored well except the Hilsenhoff index, which indicated organic pollution impacts. SRBC staff previously noted poor Hilsenhoff index scores and excessive brown alga growth. Physical habitat was classified as supporting with good riffle frequency and adequate epifaunal substrate. Limiting habitat conditions include a left bank supported by rip rap to protect the adjacent roadbed from erosion. All field chemistry parameters were within acceptable limits at the time of measurement.

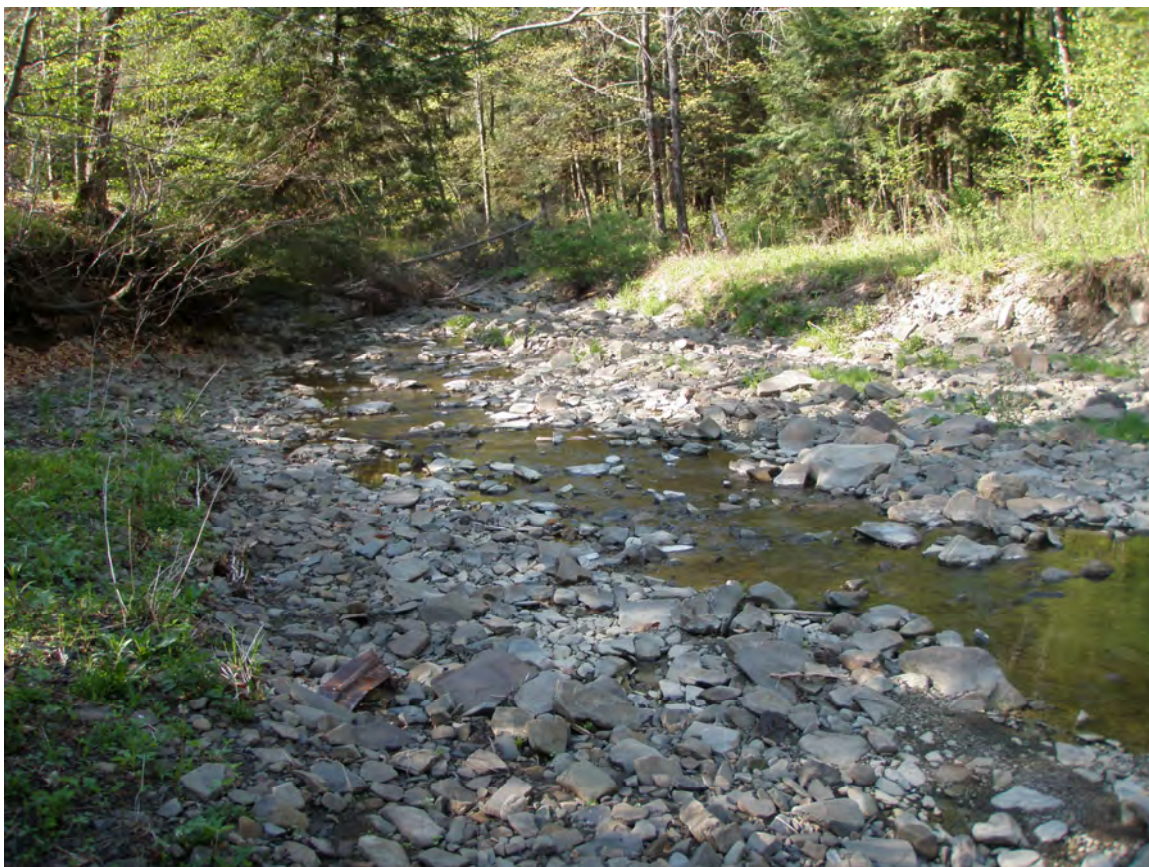
Russell Run (RUSS)

Russell Run near Windham, Pa., had a slightly impaired biological community when sampled in May 2010. The macroinvertebrate community had a strong proportion of Ephemeroptera taxa but a relatively low taxonomic diversity overall. Russell Run also scored poorly in the Hilsenhoff index, a common indicator of organic pollutants. Overall physical habitat was assessed as being supporting. Poor velocity/depth regimes and channel flow status were noted at the time of assessment. Additionally, the right bank showed evidence of destabilization. SRBC staff measured alkalinity at a level of 8 mg/L, under the Pennsylvania aquatic life threshold of 20 mg/L.

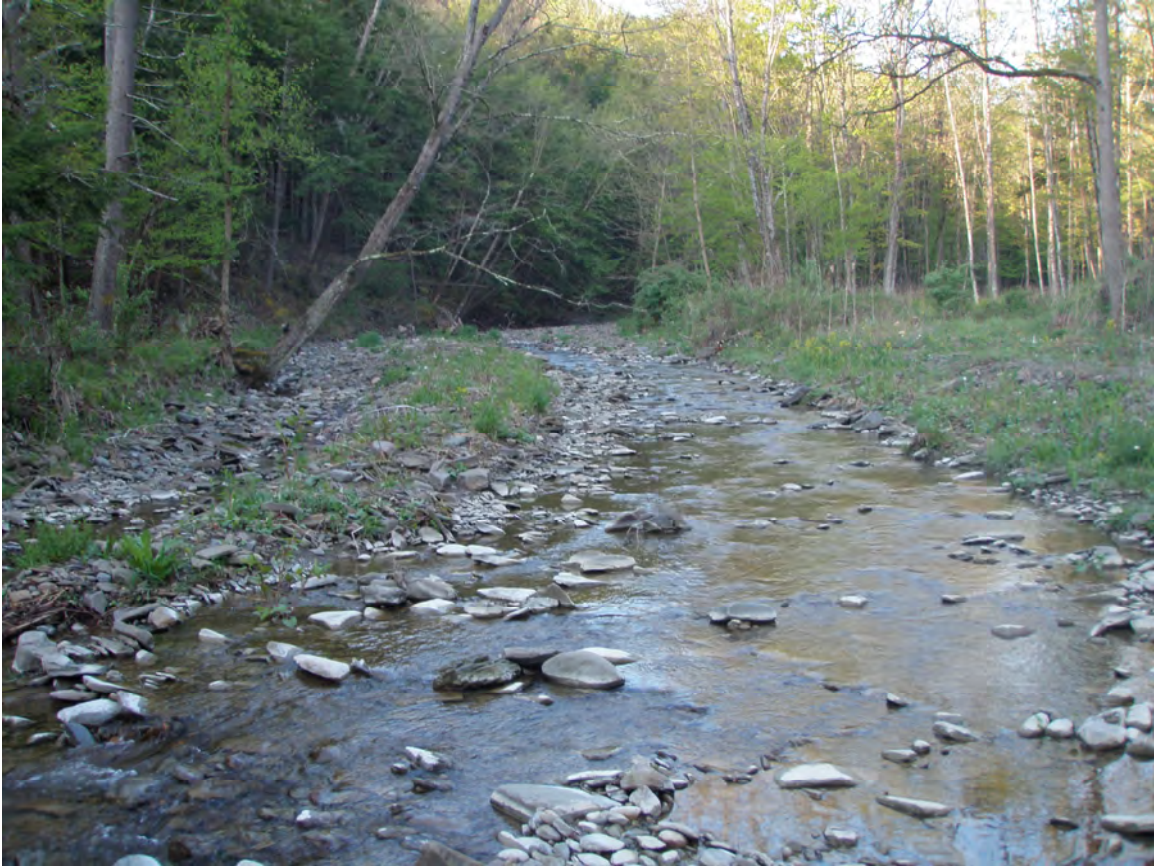
Sackett Creek (SACK)

Sackett Creek near Nichols, N.Y., was designated as having a slightly impaired biological community in 2010. Macroinvertebrate analysis revealed low percentages of pollution tolerant Chironomidae taxa and high proportions of members of the mayfly order, Ephemeroptera. The sample scored poorly in the EPT and Hilsenhoff indices as well as overall taxa richness. Physical habitat was assessed as being supporting. The lowest scoring habitat parameters were instream cover and channel flow status. Sediment deposition and wide riparian vegetative zone widths were parameters scoring in the highest classification. All field chemistry parameters were within acceptable limits at the time of measurement.

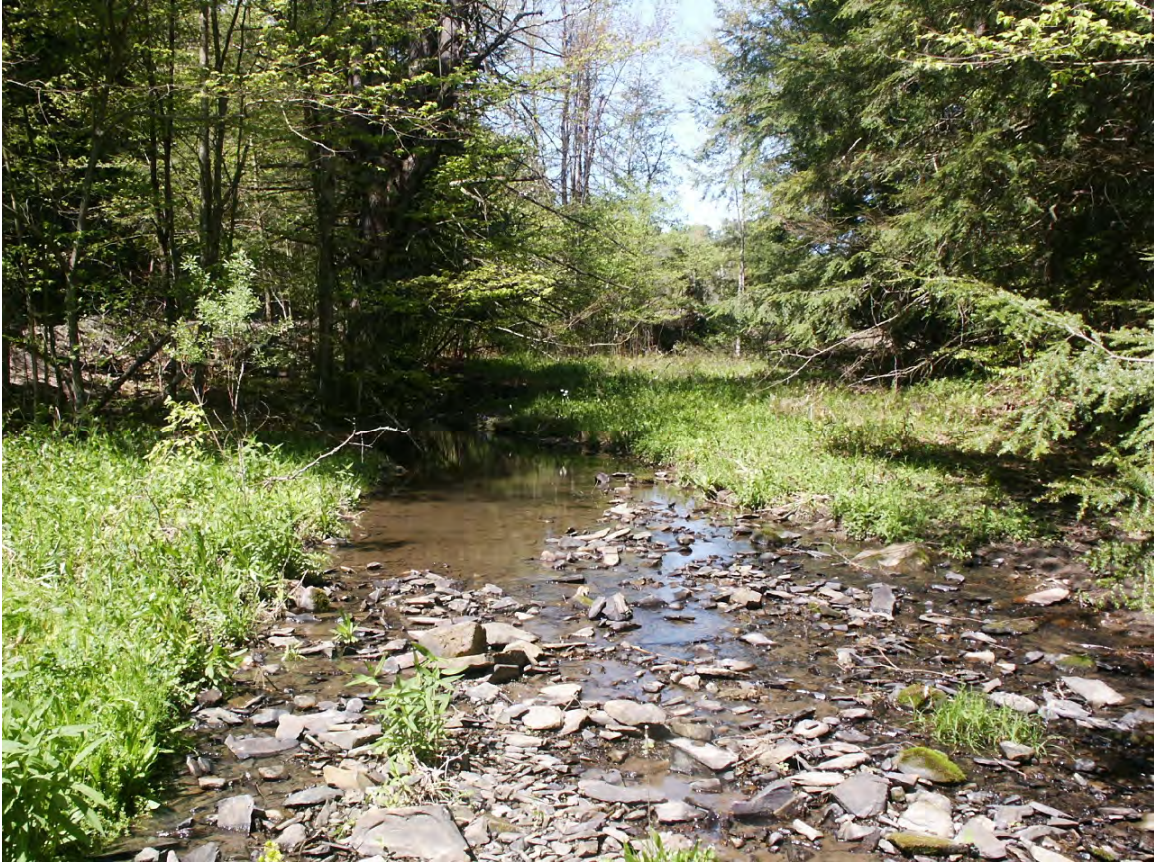
Smith Creek (SMIT)

Smith Creek near East Lawrence, Pa., had an unimpaired biological community when sampled in May 2010. Smith Creek also served as the reference site to which all other Group 3 streams were compared. Smith exhibited the best combination of biological, physical, and water quality conditions. EPT and Shannon Diversity indices were the best scoring of all Group 3 streams assessed in 2010. Overall taxonomic richness placed second among all streams in the group. Physical habitat was rated excellent with stable banks, abundant instream cover, and frequent riffle habitat. No measured field chemistry parameter tested outside of accepted limits.

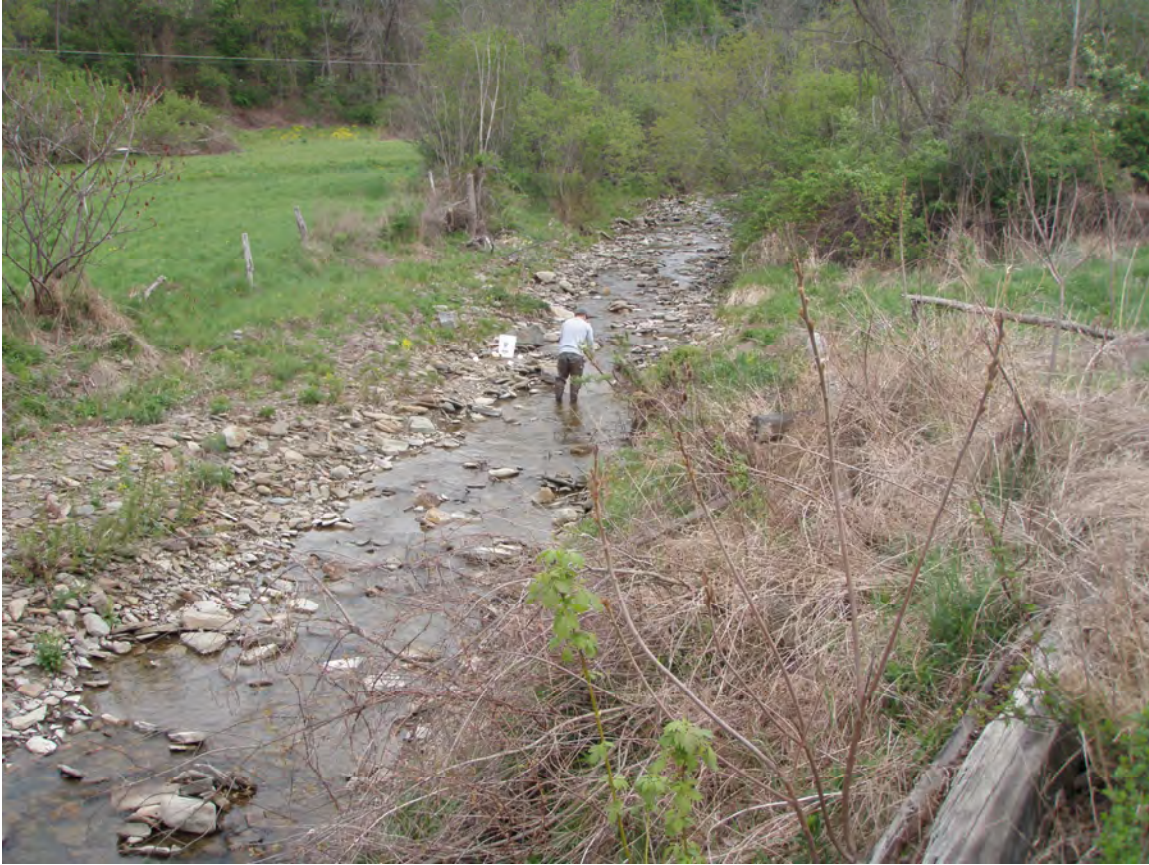
Strait Creek (STRA)

Strait Creek near Nelson, Pa., had a nonimpaired biological community when sampled in May 2010. The macroinvertebrate community scored well with a high percentage of Ephemeroptera taxa and good overall taxa diversity. Physical habitat was rated as partially supporting, mainly due to channel alteration issues. Staff noted a lack of varied velocity/depth regimes and insufficient instream cover. All field chemistry parameters were within acceptable limits at the time of measurement.

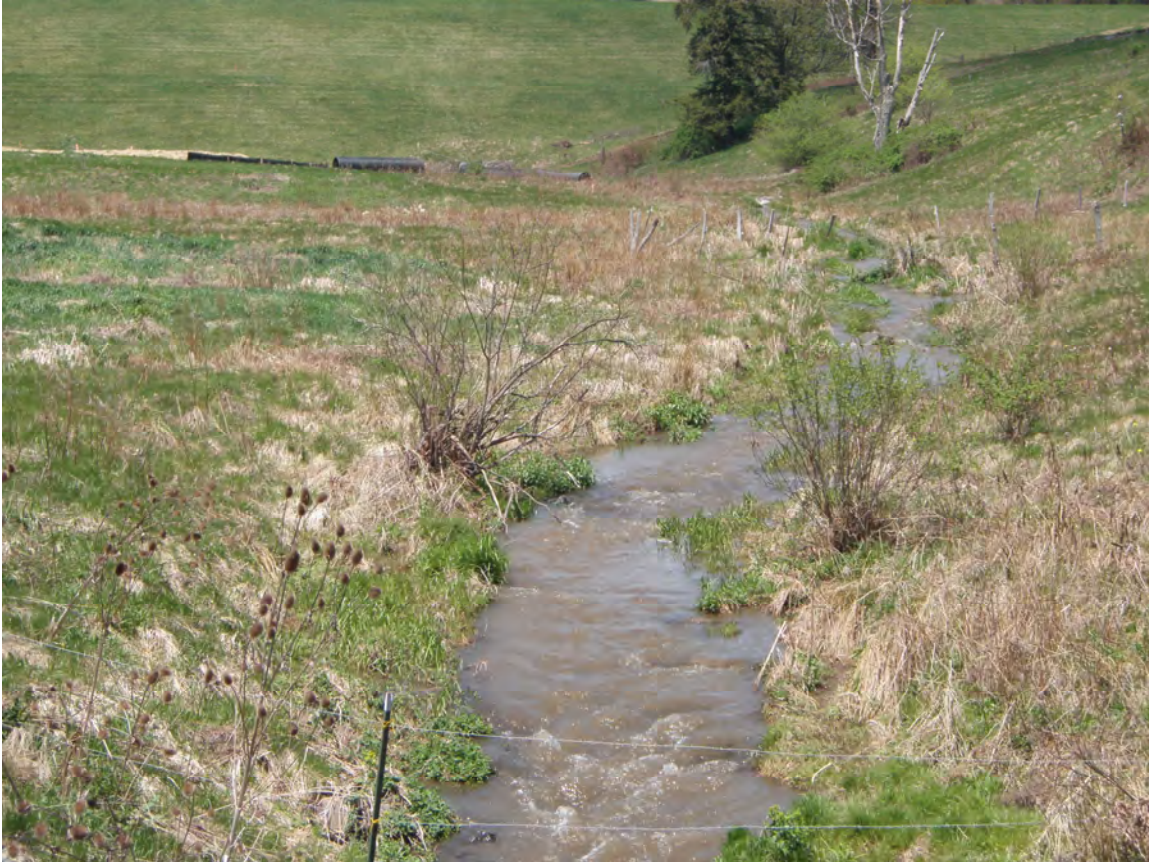
White Branch Cowanesque River (WBCO)

The White Branch Cowanesque River possessed a severely impaired biological community when sampled in May 2010. The sampling location is located immediately downstream of a flood control dam which has been undergoing a rehabilitation project since 2005. The biological community was dominated by Chironomidae taxa (83 percent) and absent of any Ephemeroptera taxa. While physical habitat was rated as excellent, the biological community was believed to be impaired by upstream activities. SRBC staff noted higher than normal flow conditions as the upstream reservoir was being drawn down at the time of sampling. All measured field chemistry parameters were within acceptable limits.

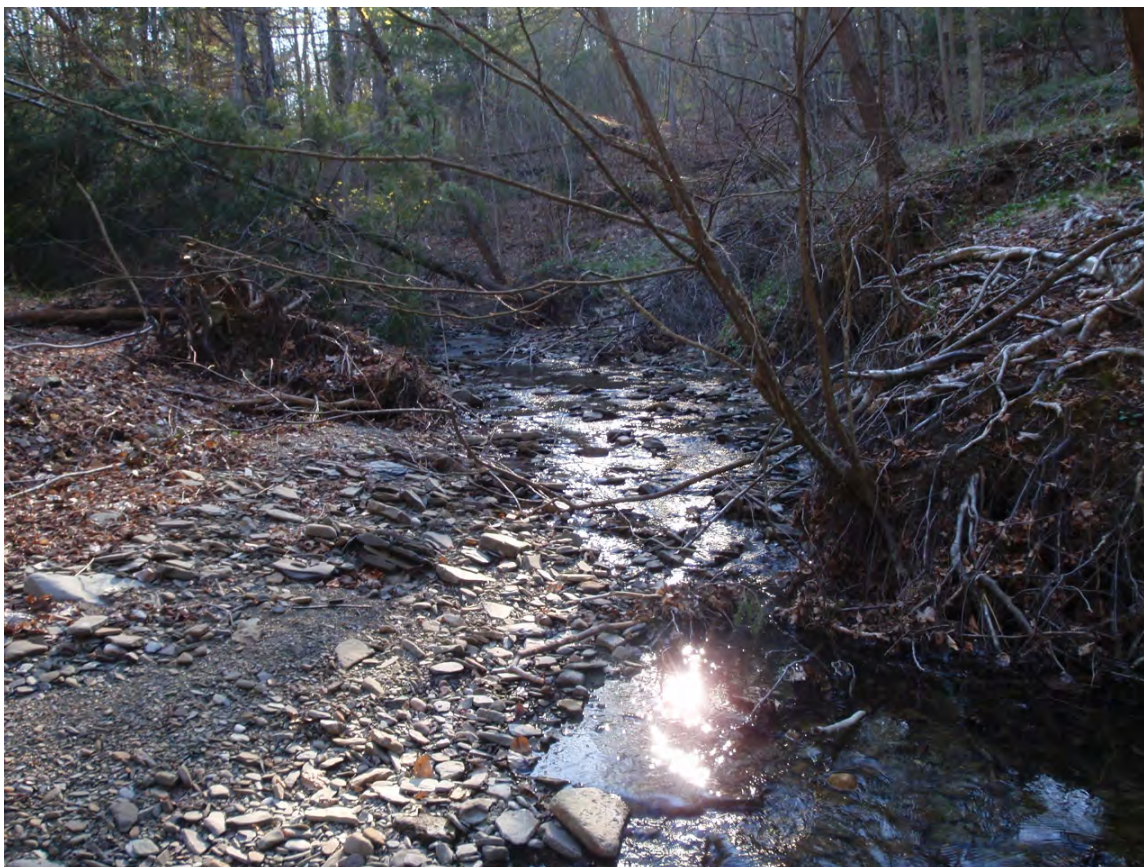
White Hollow (WHIT)

White Hollow near Wellsburg, N.Y., received a biological condition rating of slightly impaired when sampled in May 2010. White Hollow possessed the best Hilsenhoff index score of all Group 3 sites yet scored very low in the EPT index. Overall taxonomic richness scored poorly as well. Physical habitat was rated as excellent, receiving the second highest score of all Group 3 sites assessed in 2010. Measured water quality parameters were all within acceptable limits.
