**ASSESSMENT OF INTERSTATE
STREAMS IN THE
SUSQUEHANNA RIVER BASIN**

Monitoring Report No. 25
January 1, 2011 Through December 31, 2011

Publication No. 281

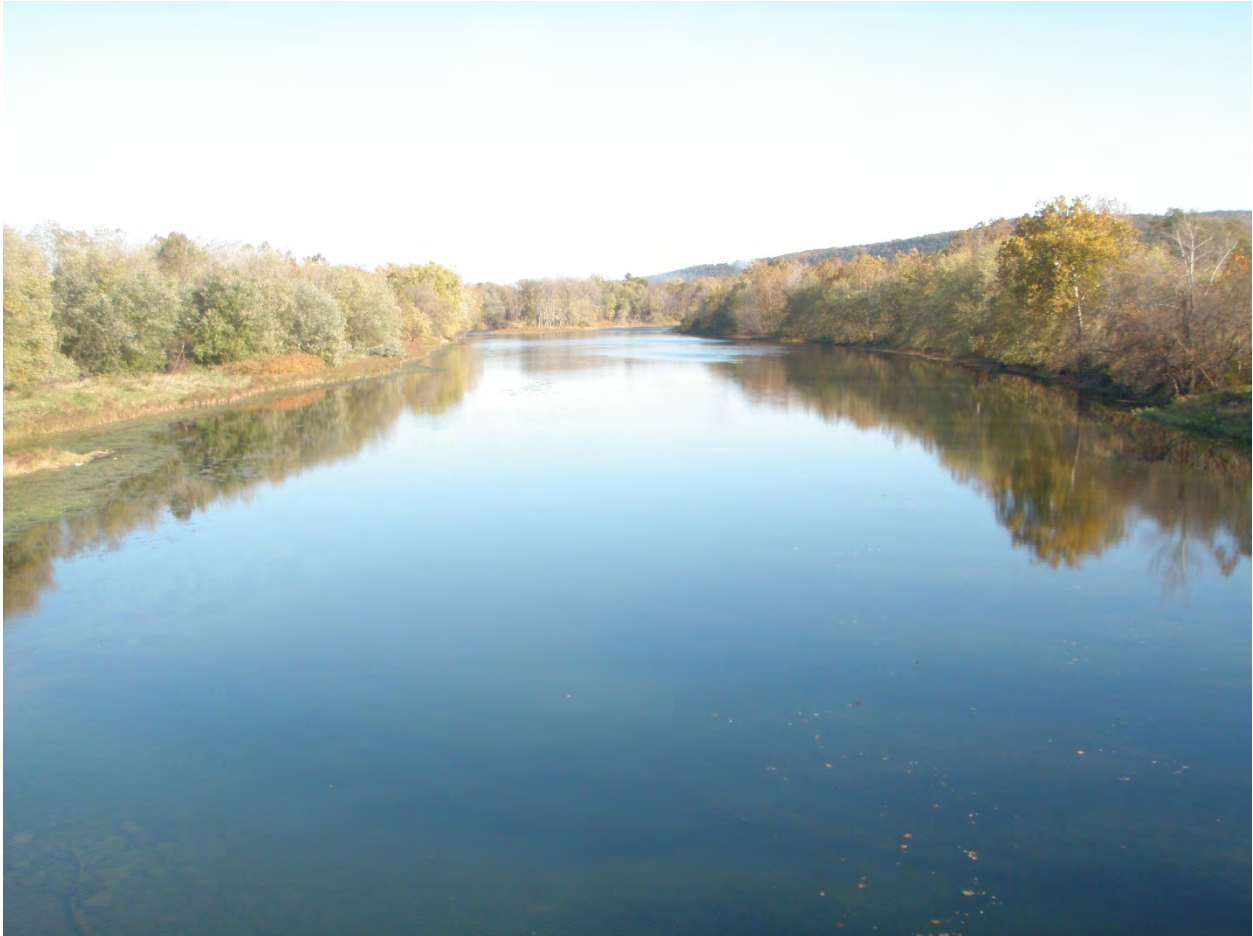
Chemung River at Chemung, NY (CHEM 12.0)

Physical habitat was rated as excellent at CHEM 12.0. The site scored 168 out of a possible 220. Staff noted optimal channel flow status and bank conditions.

Biological Condition: CHEM 12.0 received a biological condition designation of slightly impaired when sampled in 2011.

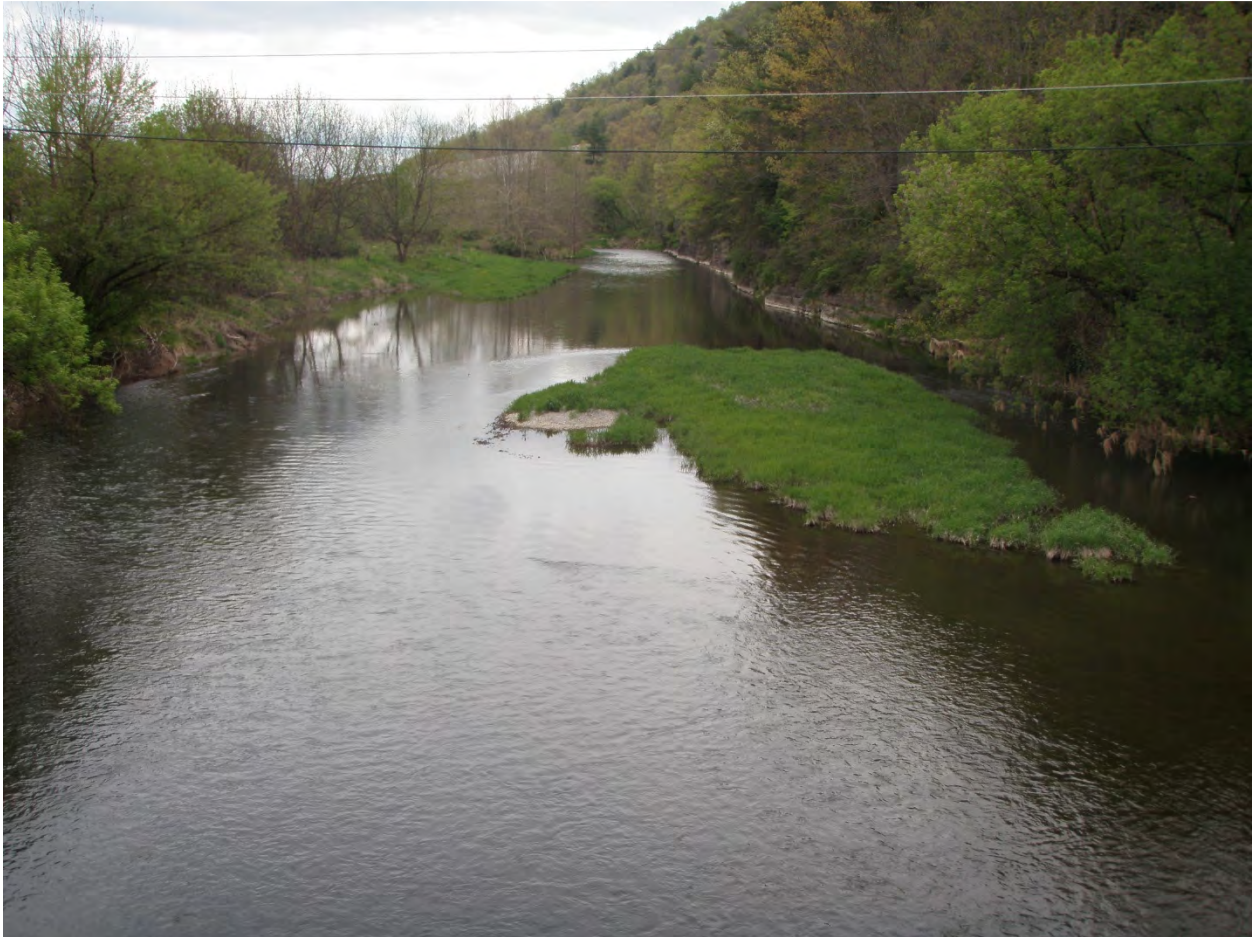
Physical habitat was classified as supporting. The site scored 151 out of a possible 220. Bank conditions were negatively impacted from road development adjacent to the river.

Biological Condition: The biological community was classified as nonimpaired when sampled in 2011.

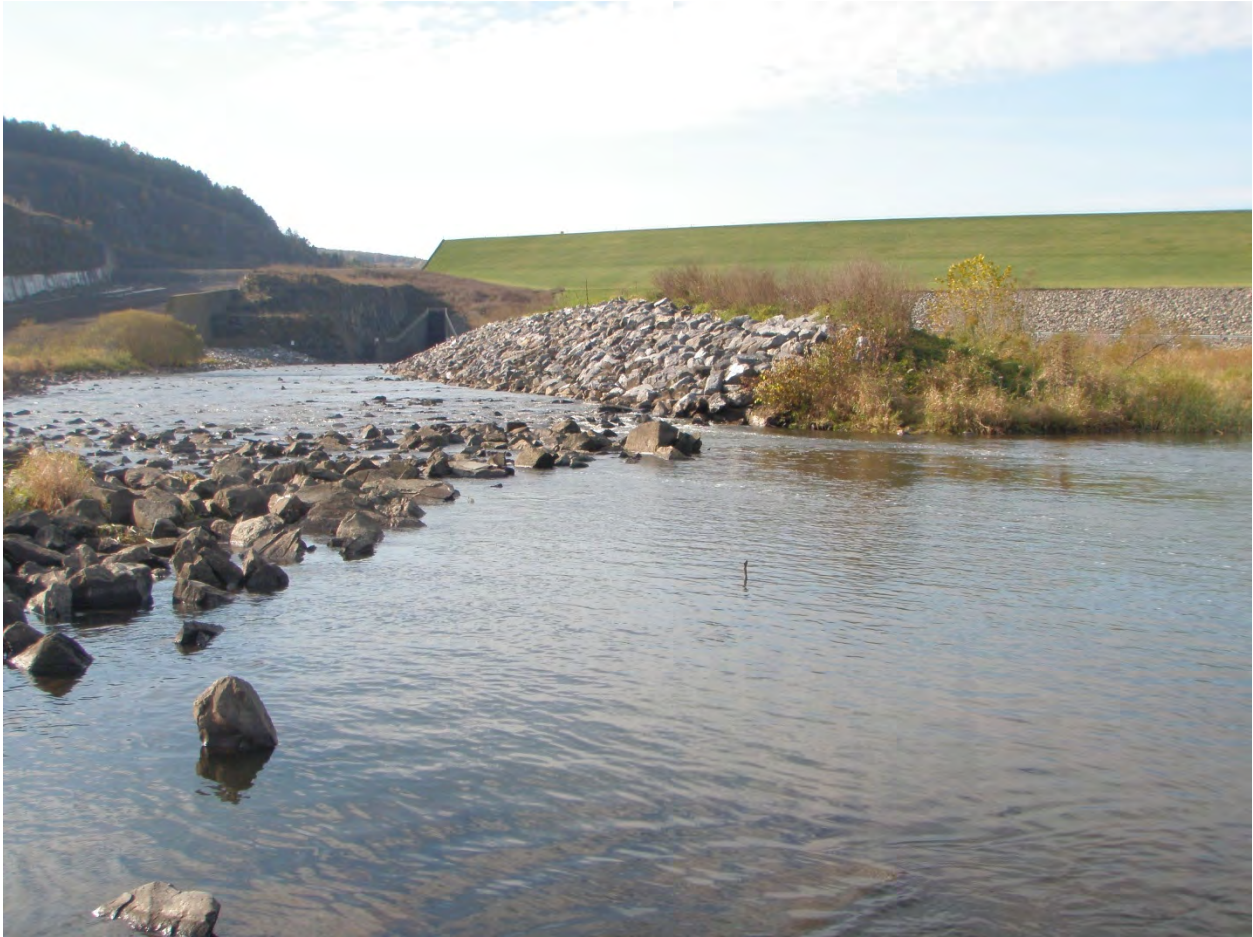
Located directly below a large reservoir, physical habitat was designated as supporting. The site scored 151 out of a possible 220 points. A heavily altered channel and a streambed devoid of cover were factors limiting the available habitat.

Biological Condition: The biological community at COWN 2.2 was classified as severely impaired. The station received the lowest biological condition score of all streams monitored in the project.

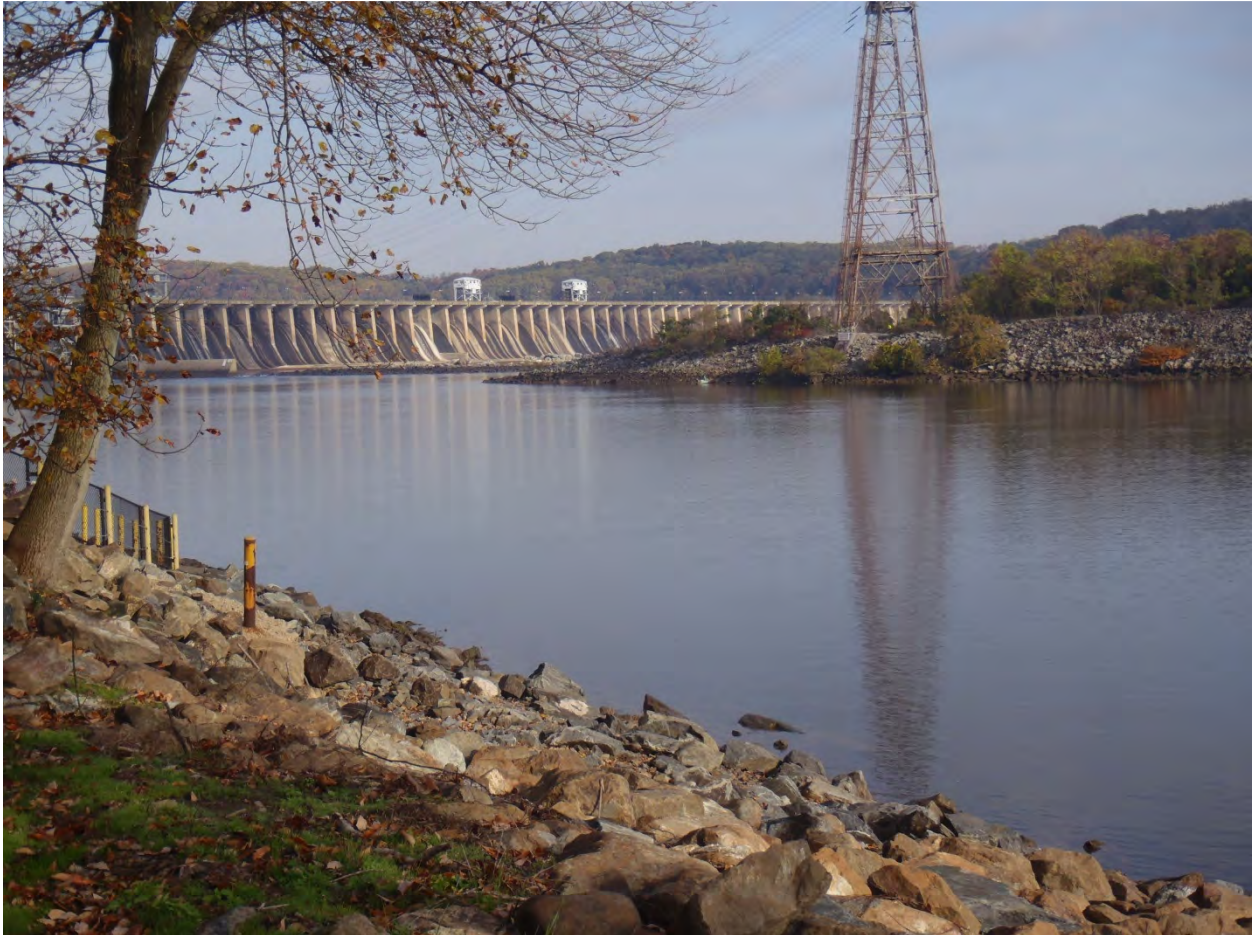
Due to the location of this sampling station, physical habitat is not assessed. The sampling point is directly downstream of the Conowingo Hydroelectric dam and is subject to frequent disturbances in flow due to plant operations.

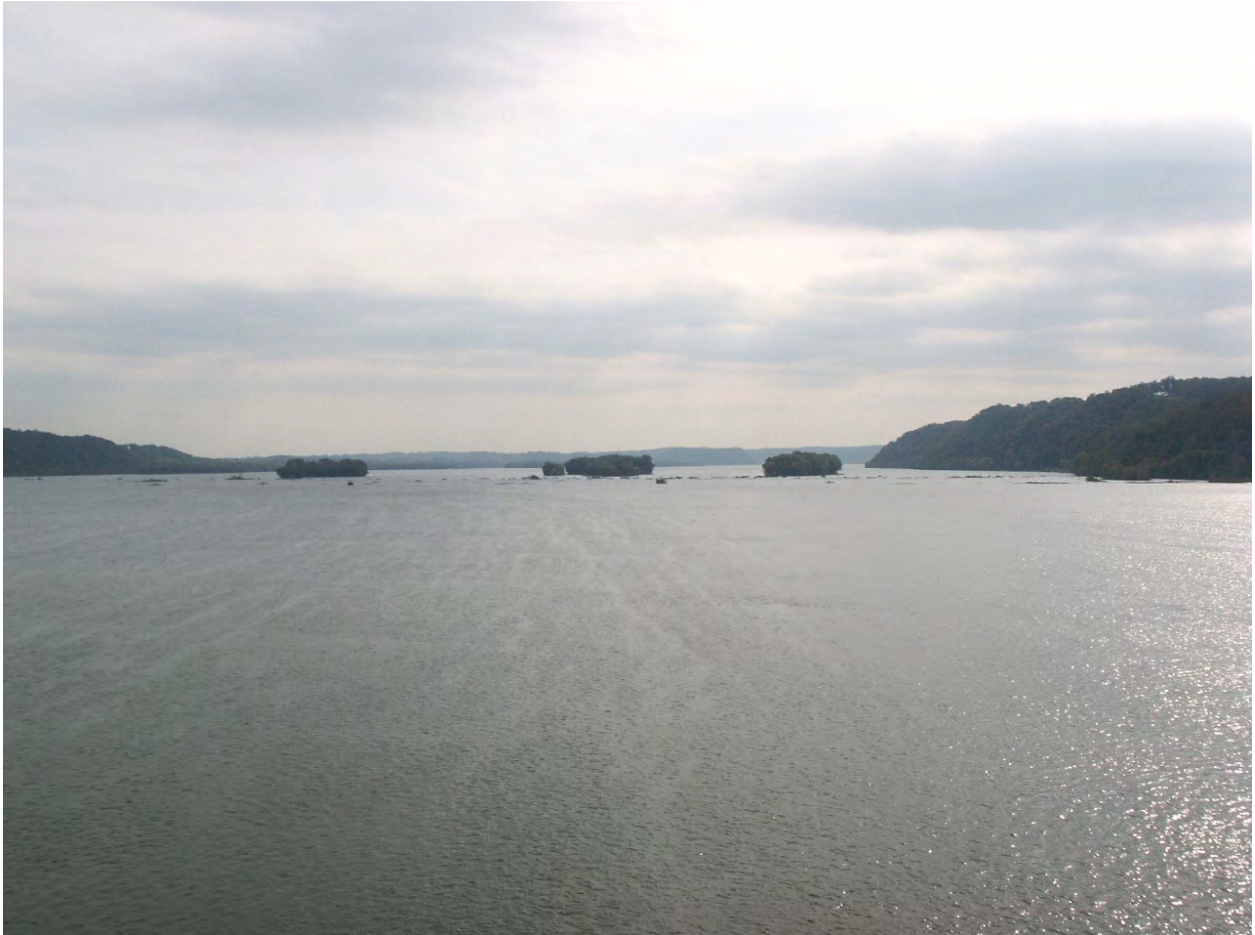
Physical habitat was designated as excellent when assessed in 2011, scoring 154 out of a possible 220. SRBC staff noted a lack of instream cover and pool variability at the site.

Biological Condition: Due to high flows during the summer sampling period, the biological community at SUSQ 44.5 was not assessed in 2011.

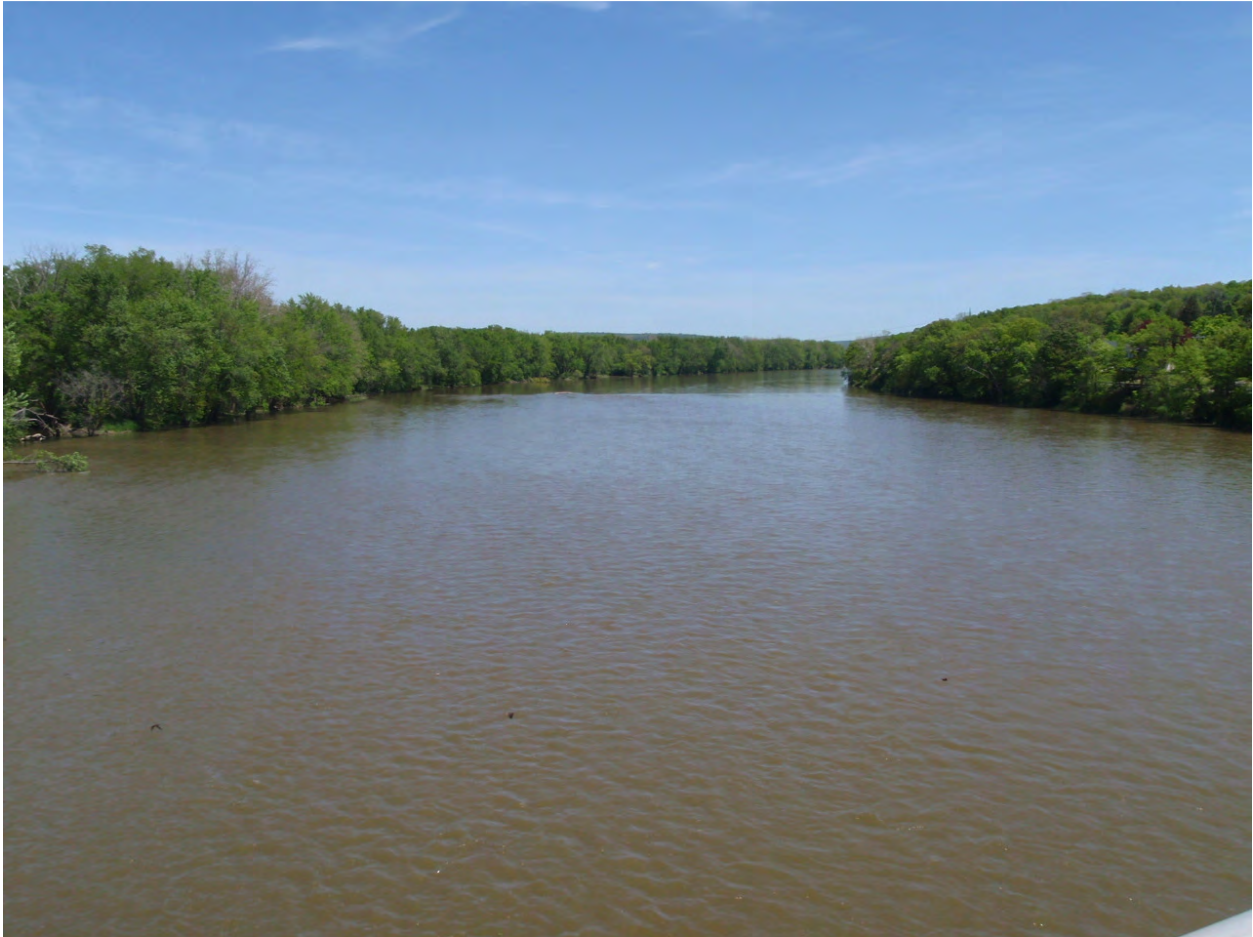
Available physical habitat was classified as excellent in 2011. SUSQ 289.1 scored 171 out of a possible 220 points. SRBC staff noted minimal embeddedness and sediment deposition.

Biological Condition: The biological community at SUSQ 289.1 was classified as nonimpaired in 2011.

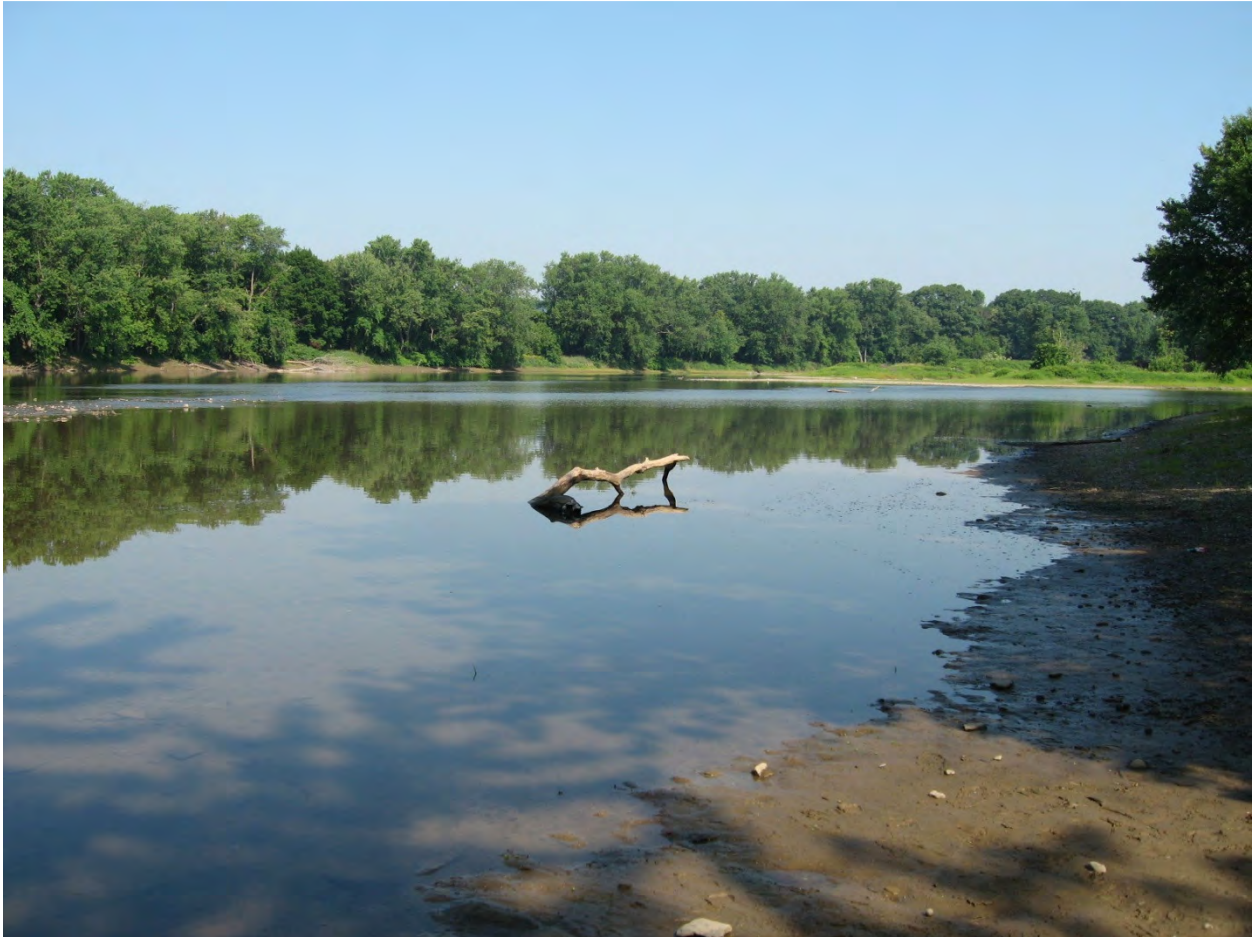
Susquehanna River at Kirkwood, NY (SUSQ 340.0)

Scoring 157 out of a possible 220, physical habitat conditions were considered excellent in 2011.

Biological Condition: The biological community at SUSQ 340.0 was rated as nonimpaired when sampled in 2011. The site served as the reference site to which all other large river sites were compared.

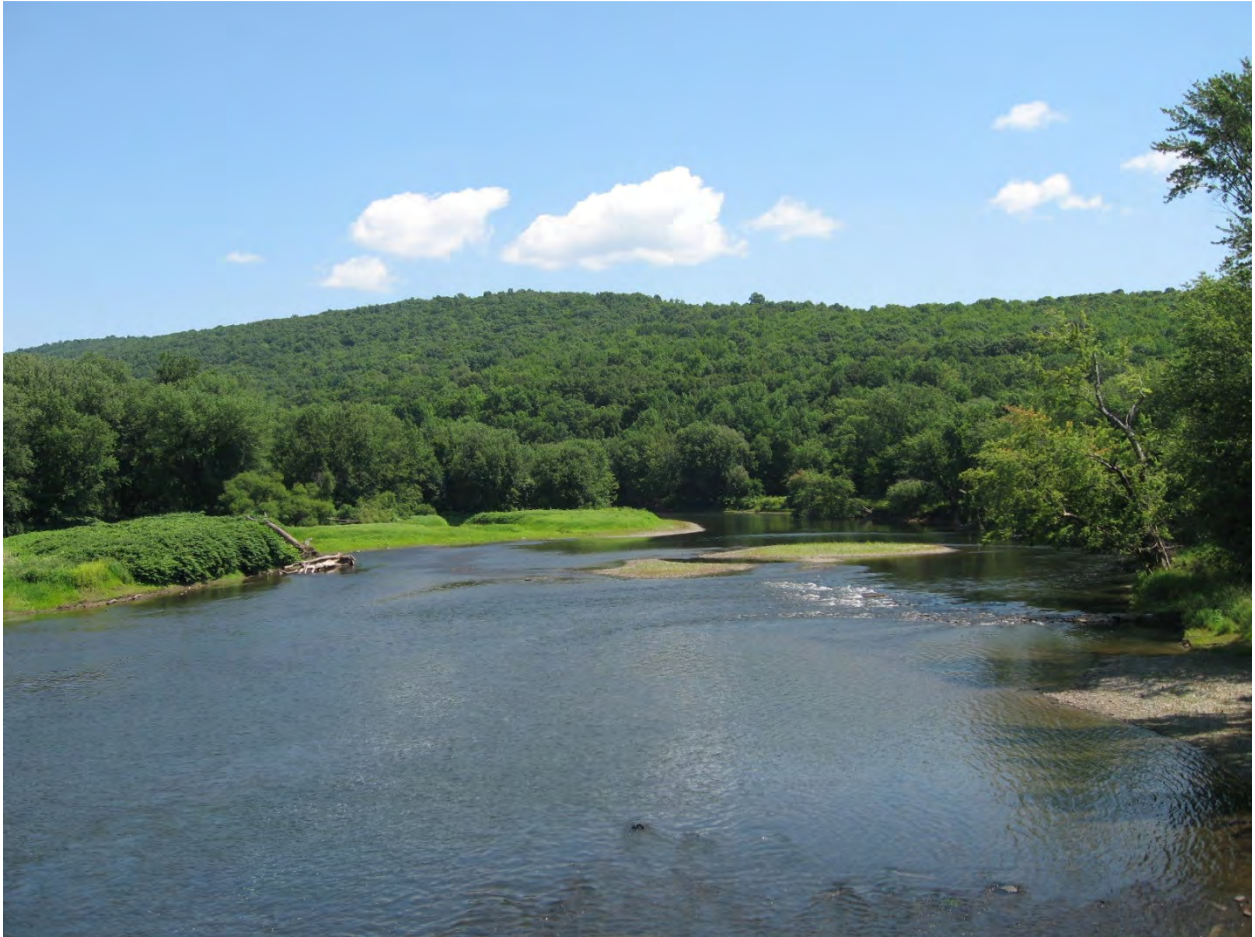
Susquehanna River at Windsor, NY (SUSQ 365.0)

Available physical habitat was classified as excellent in 2011. Scoring 171 out of a possible 220, SUSQ 365.0 possessed the second highest habitat score of all large river sites evaluated in 2011.

Biological Condition: The biological condition of SUSQ 365.0 was designated as nonimpaired when assessed in 2011.

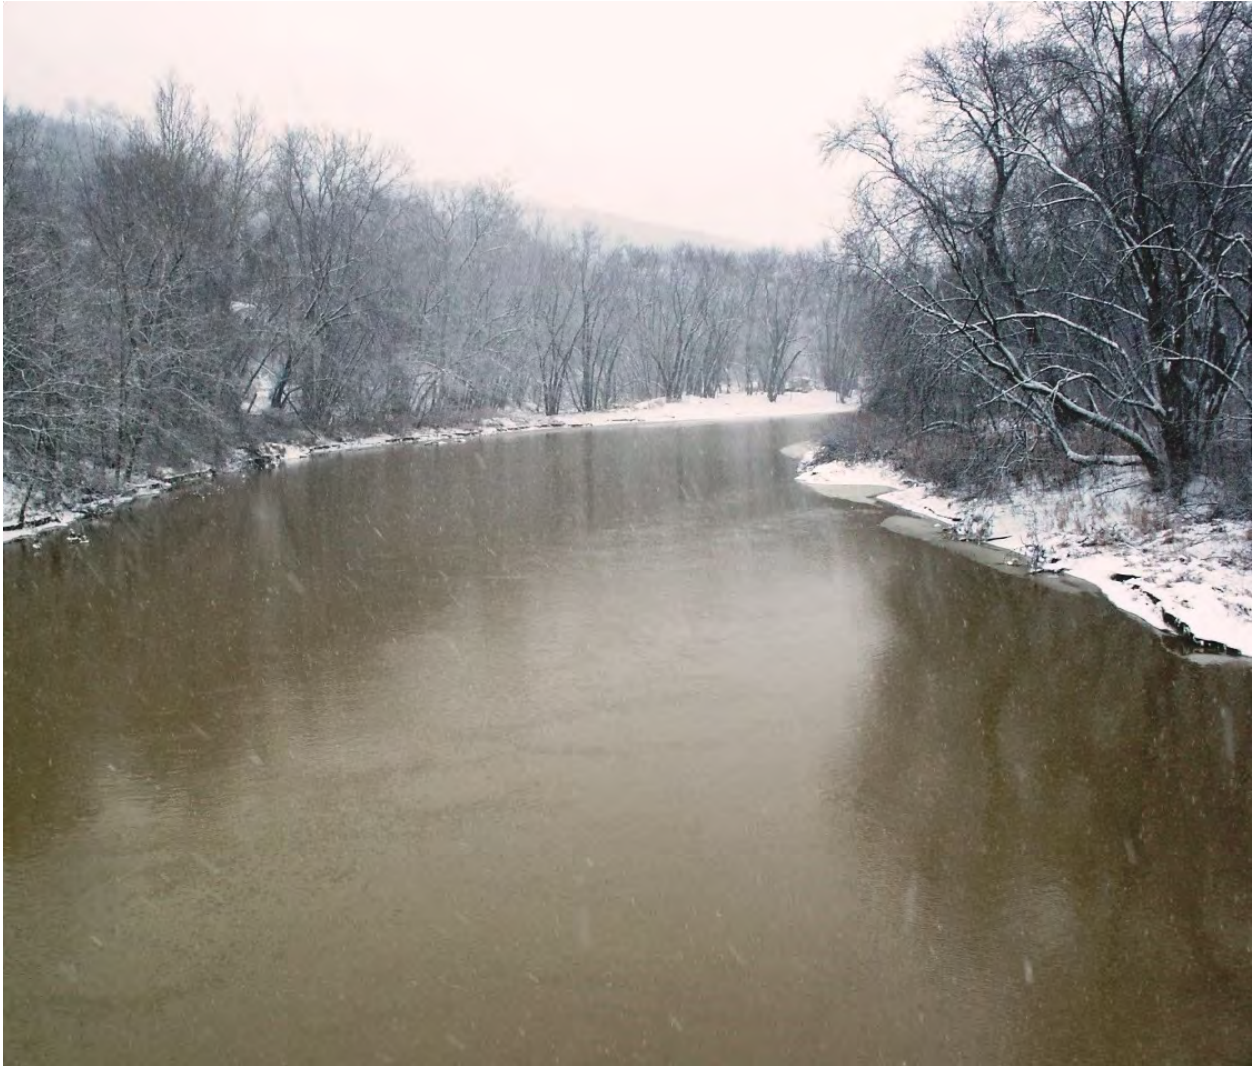
Scoring 178 out of a possible 220, TIOG 10.8 received the highest habitat condition score of all large river sites assessed in 2011.

Biological Condition: The biological condition of TIOG 10.8 was determined to be moderately impaired, marking a significant departure from the nonimpaired status attained in 2010.

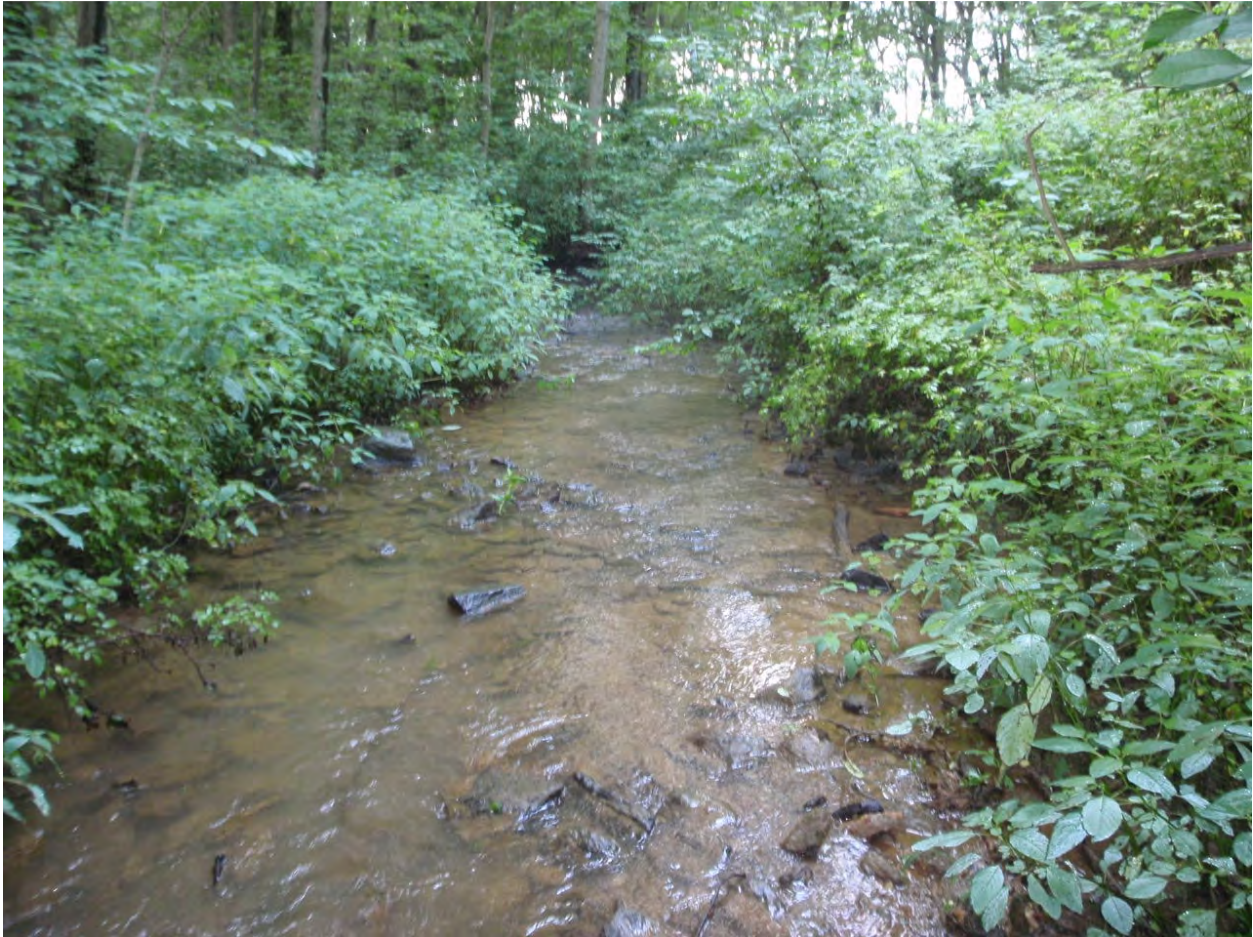
Site Results for Pennsylvania-Maryland Border Sites
Big Branch Deer Creek at Fawn Grove, PA (BBDC 4.1)

Physical habitat was rated as excellent at the station in 2011. Scoring 169 out of a possible 220 points, BBDC 4.1 possessed optimal conditions in nearly all parameters measured. Sediment deposition remained atypically high relative to previous observations.

Biological Condition: The biological community at BBDC 4.1 was rated as slightly impaired in 2011.

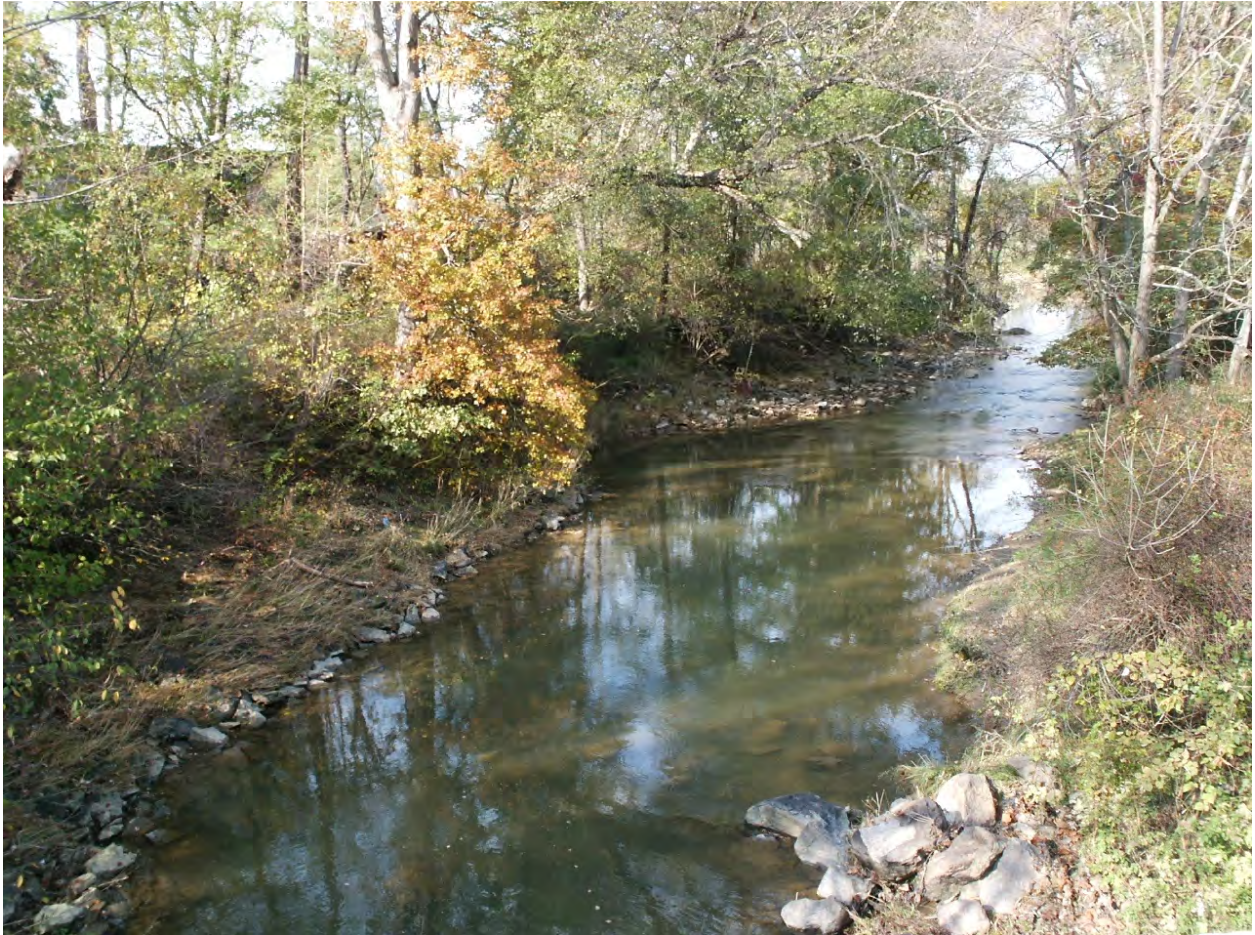
Conowingo Creek at Pleasant Grove, PA (CNWG 4.4)

Scoring 189 out of a possible 220, available physical habitat was classified as excellent in 2011. CNWG 4.4 was one of three sites sharing the highest habitat score in the MD-PA monitoring group.

Biological Condition: The macroinvertebrate community was rated as slightly impaired when sampled in 2011.

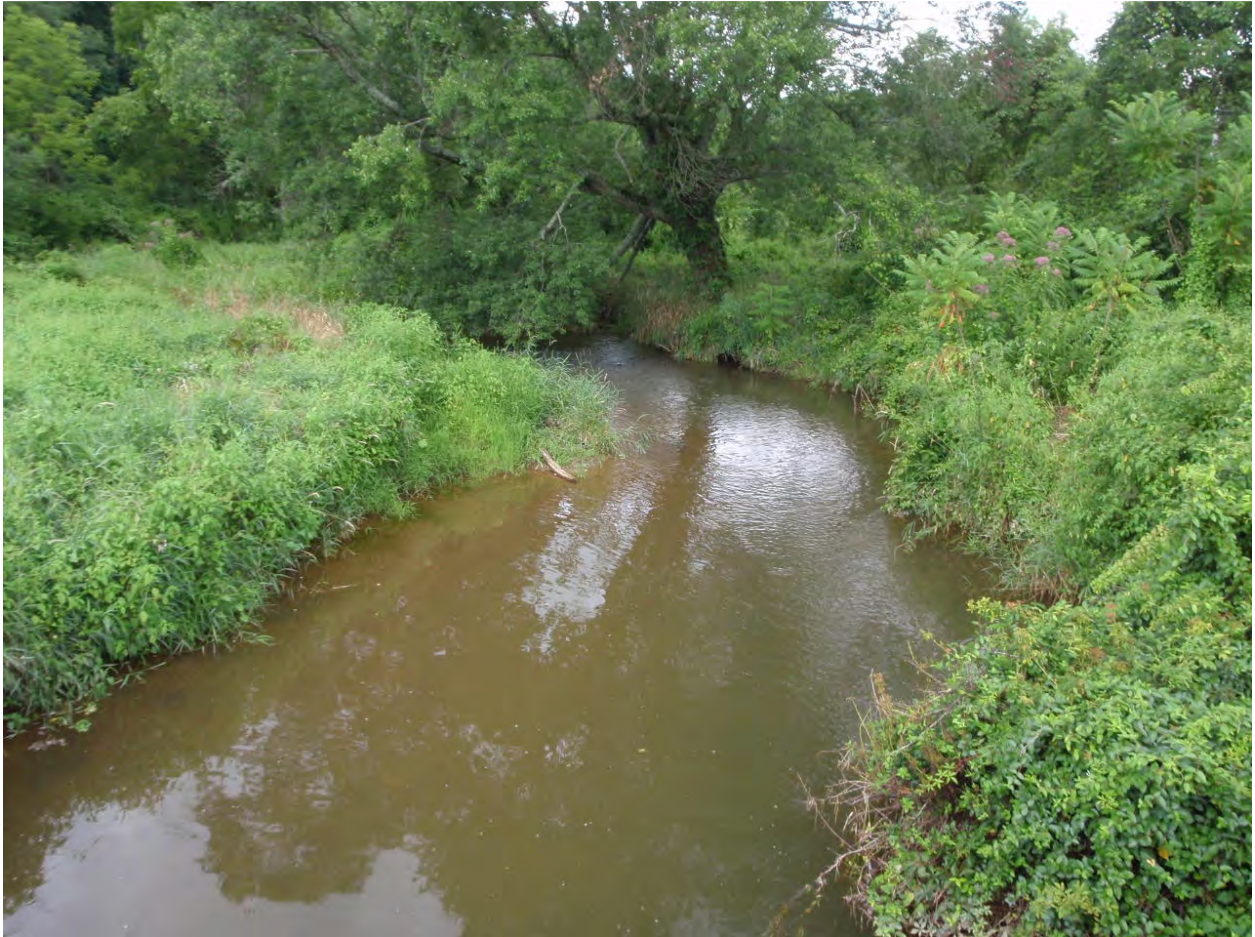
DEER 44.2 possessed excellent habitat conditions as rated by SRBC staff in 2011. Bank erosion and stability were identified as potential areas of concern.

Biological Condition: Deer Creek possessed a slightly impaired biological community in 2011. Although the rating declined from previous years' nonimpaired classification, conditions remained favorable at the station.

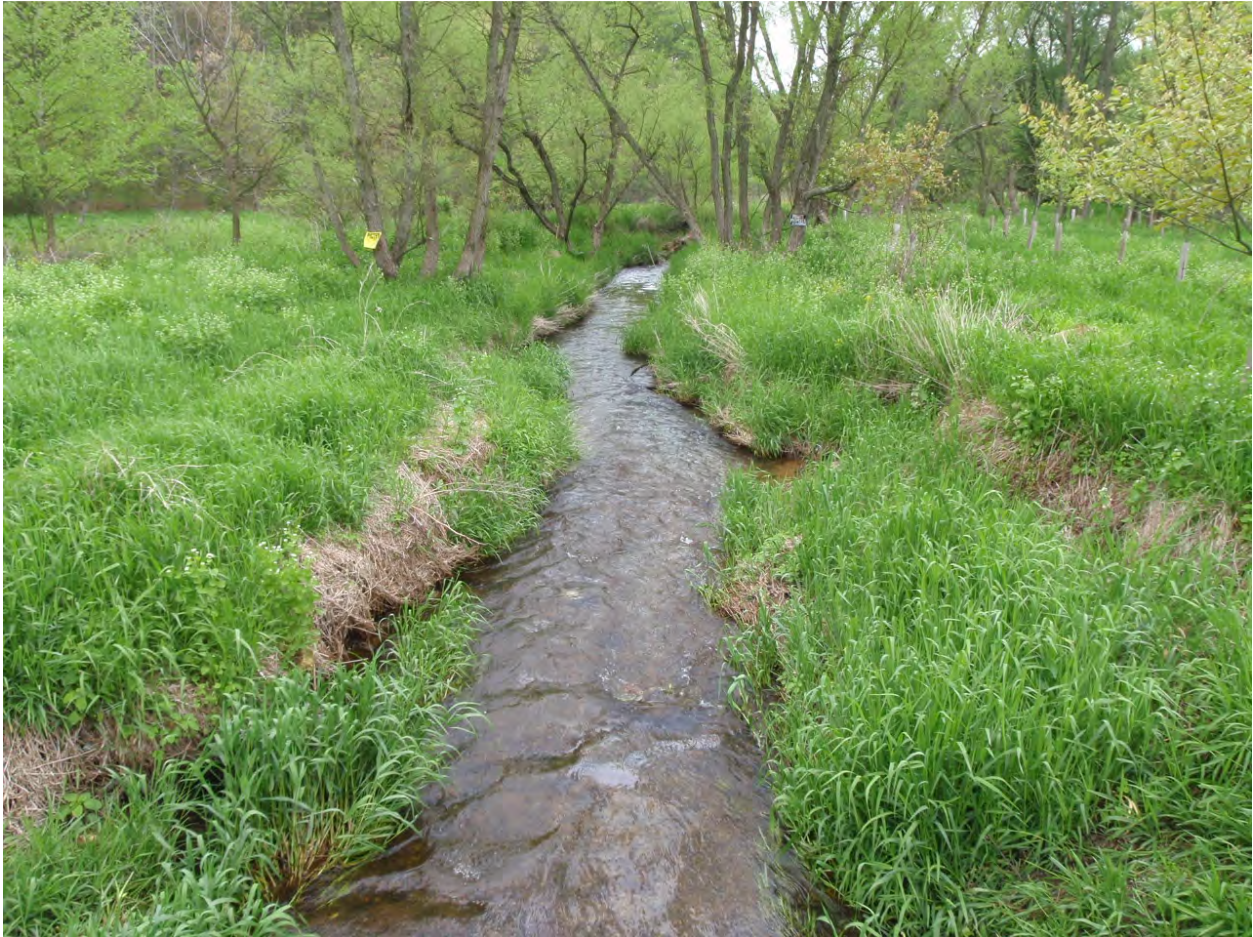
Ebaughs Creek at Stewartstown, PA (EBAU 1.5)

Available physical habitat was rated as excellent in 2011. EBAU 1.5 was one of three sites sharing the highest habitat score in the MD-PA monitoring group.

Biological Condition: The biological condition at EBAU 1.5 was rated as slightly impaired for the third consecutive year.

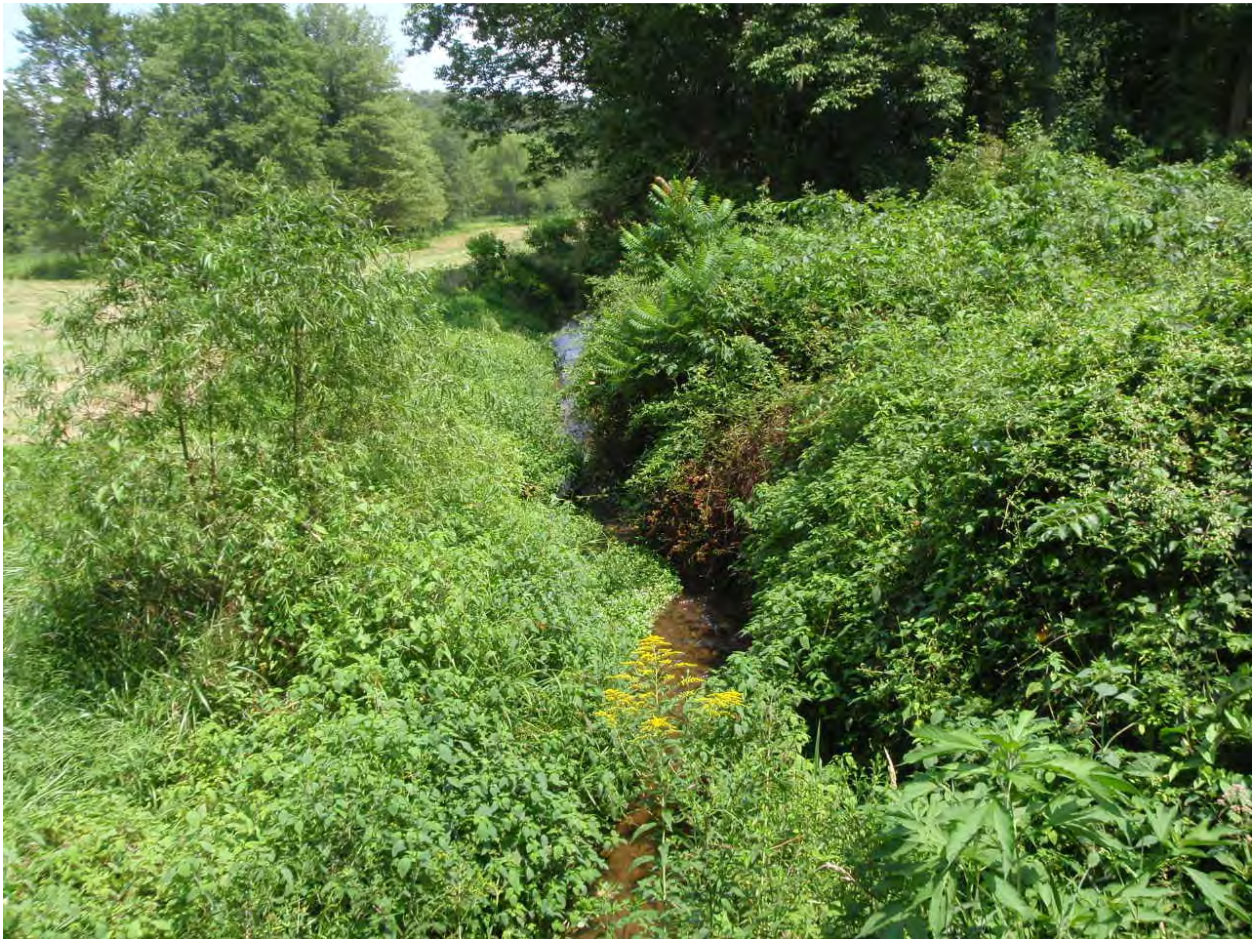
Falling Branch Deer Creek at Fawn Grove, PA (FBDC 4.1)

Scoring 187 out of a possible 220 points, the available physical habitat at FBDC 4.1 was classified as excellent in 2011. Habitat conditions have remained stable and favorable at this site.

Biological Condition: FBDC 4.1 was chosen as the reference site to which all other MD-PA interstate sites were compared in 2011. The biological condition at this site was rated as nonimpaired.

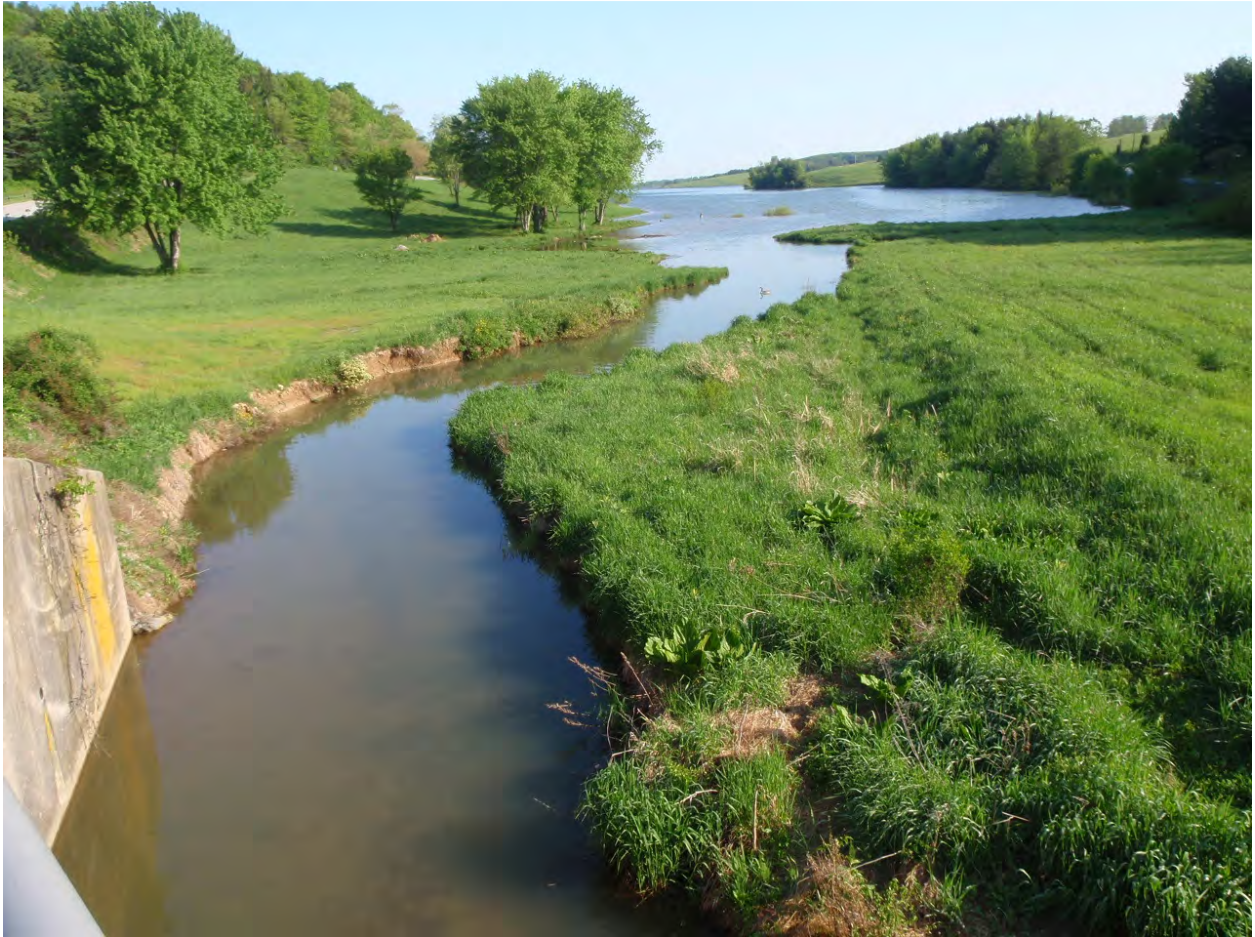
Long Arm Creek at Bandanna, PA (LNGA 2.5)

Receiving a score of 189 out of a possible 220 points, Long Arm Creek's physical habitat was classified as excellent.

Biological Condition: LNGA 2.5 received a biological condition classification of nonimpaired in 2011, marking a significant improvement from previous years' assessments.

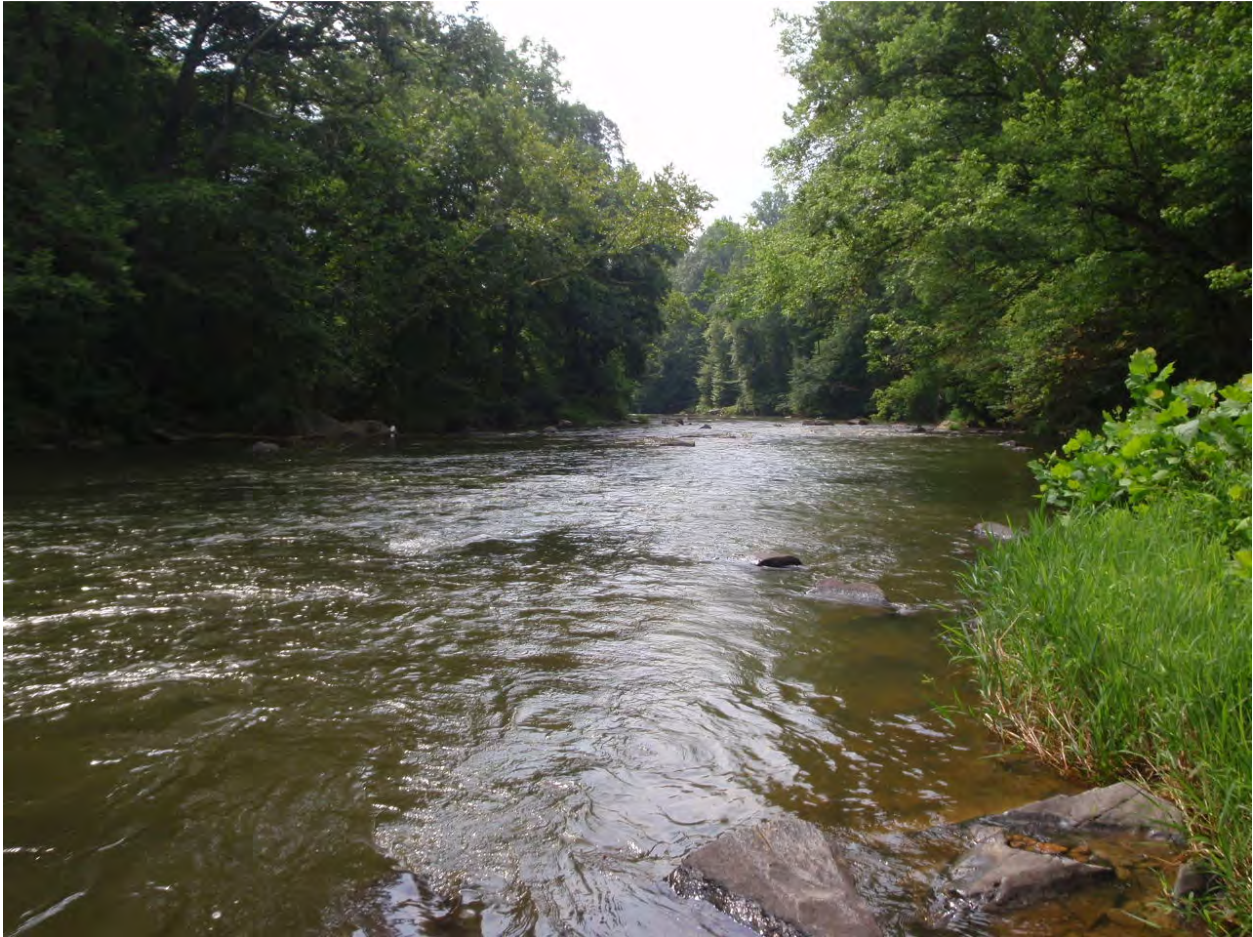
Octoraro Creek at Rising Sun, MD (OCTO 6.6)

Physical habitat was rated as excellent, scoring 177 out of a possible 220. Optimal amounts of instream cover and minimal channel alteration contributed to this classification.

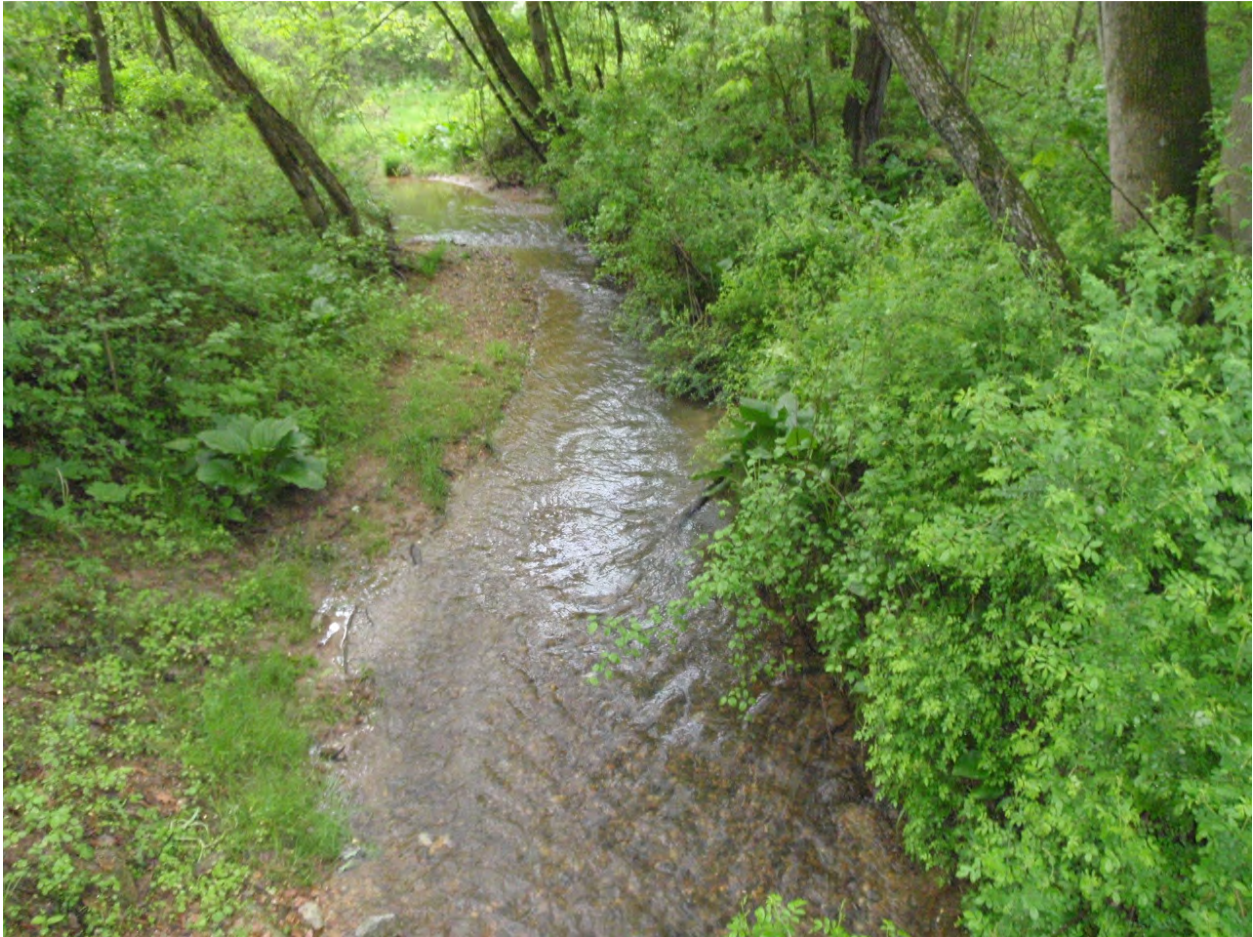
South Branch Conewago Creek at Bandanna, PA (SBCC 20.4)

Located in a primarily forested watershed, the South Branch Conewago Creek site received a habitat classification of excellent in 2011. The site scored 189 out of a possible 220.

SBCC 20.4 received a biological condition rating of nonimpaired in 2011. This represents an improvement over prior years' classifications of slightly impaired.

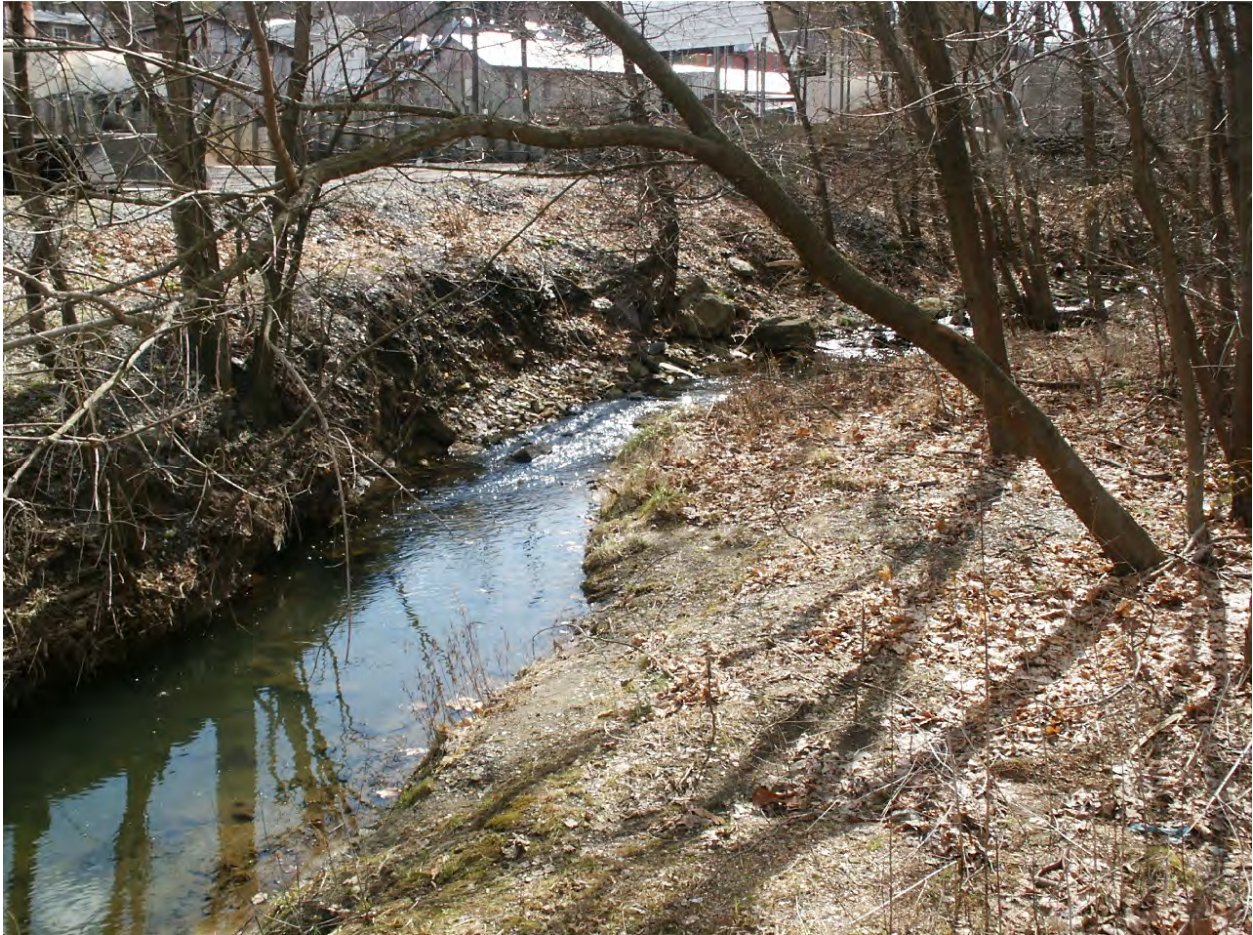
Scott Creek at Delta, PA (SCTT 3.0)

Scoring 114 out of a possible 220 points, available physical habitat was deemed partially supporting in 2011. Highly eroded banks lacking sufficient vegetative protective cover reduced the score at this station.
