**ASSESSMENT OF INTERSTATE
STREAMS IN THE
SUSQUEHANNA RIVER BASIN**

Monitoring Report No. 25
January 1, 2011 Through December 31, 2011

Publication No. 281

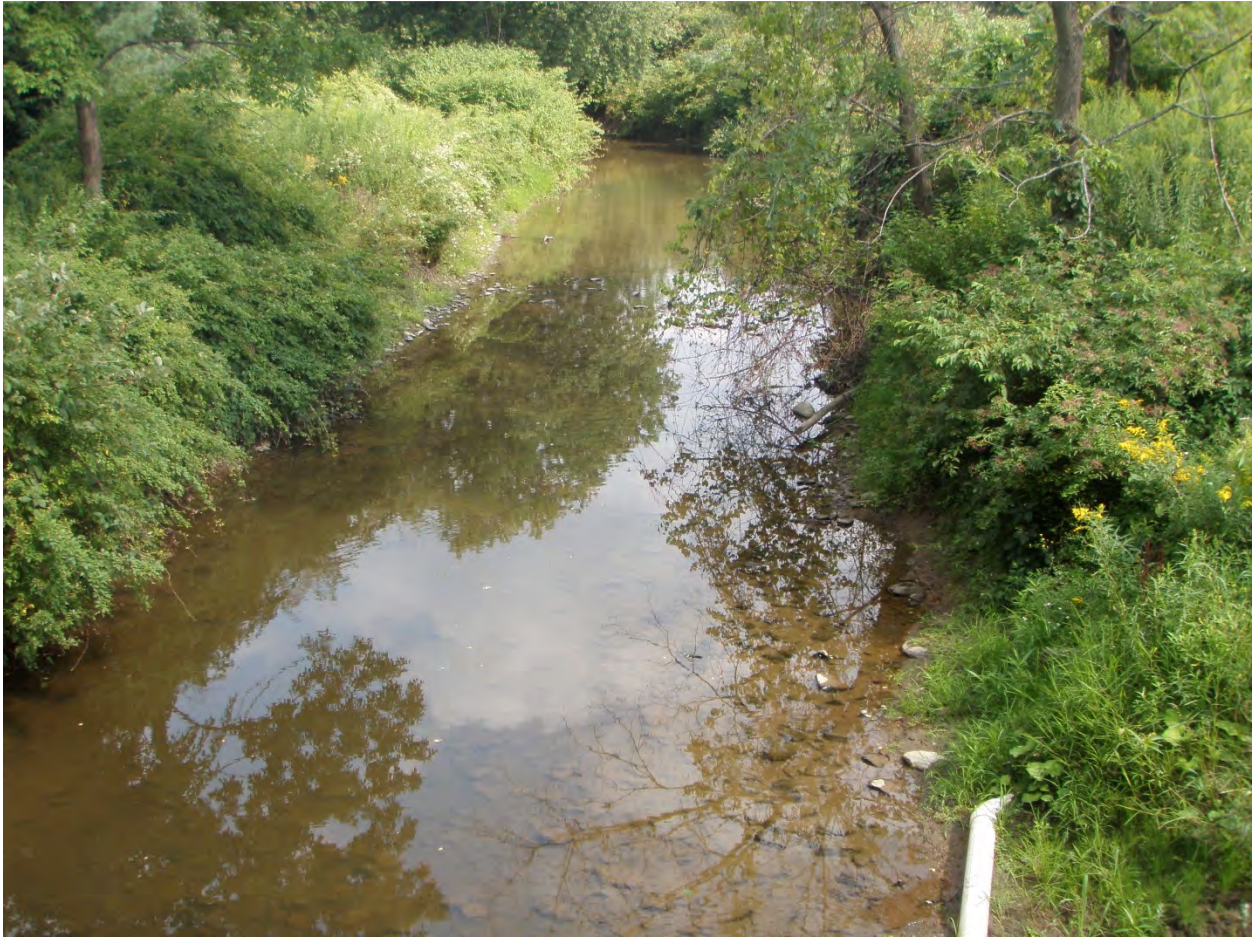
Scoring only 85 points out of a possible 220, physical habitat was classified as nonsupporting at APAL 6.9 in 2011. SRBC staff noted excessive sedimentation and poor velocity/depth regimes contributing to the low rating.

Biological Condition: Macroinvertebrates were not collected at this station in 2011 due to anomalous conditions.

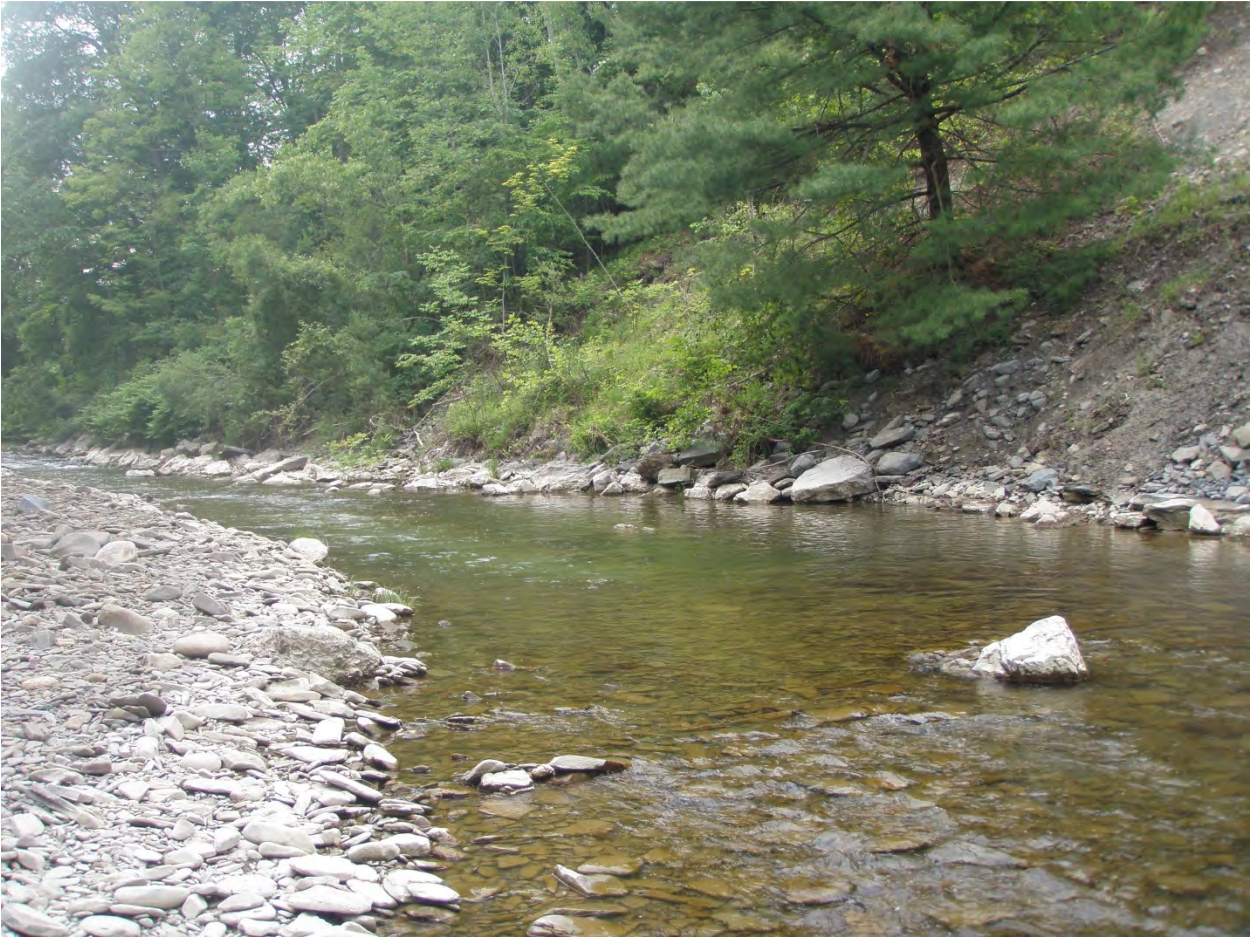
Bentley Creek at Wellsburg, NY (BNTY 0.9)

Scoring 127 out of a possible 220, available physical habitat was rated as partially supporting. Considerable bank erosion and a highly mobile stream channel contributed to the low score.

Biological Condition: The biological community of BNTY 0.9 was rated as slightly impaired in 2011.

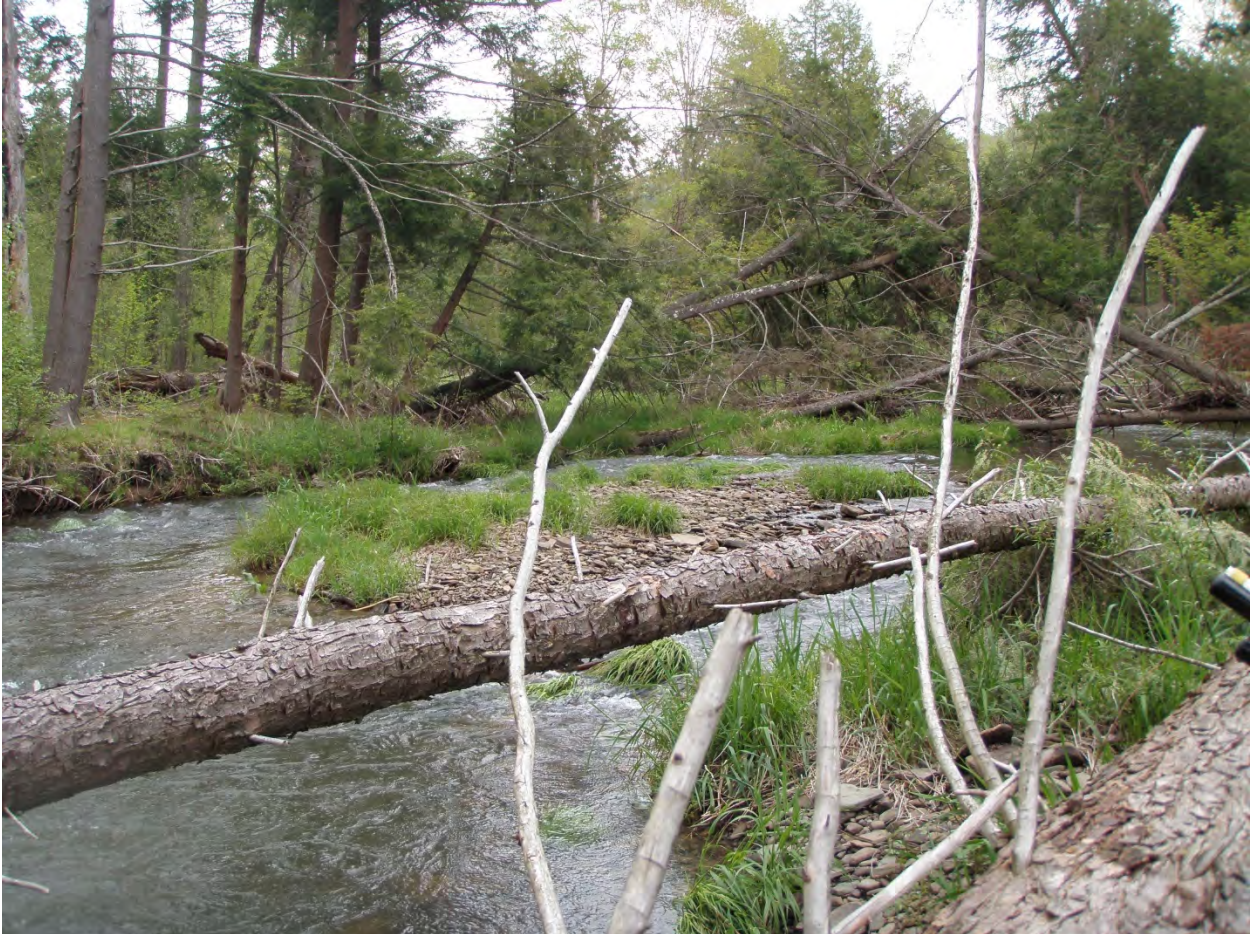
Scoring 203 out of a possible 220, Cascade Creek's physical habitat received a rating of excellent in 2011. The station received the highest habitat condition score of all interstate sites monitored in the project.

Biological Condition: CASC 1.6 received a nonimpaired macroinvertebrate community designation in 2011. The station served as the reference site to which all other NY-PA Group 1 and 2 streams were compared.

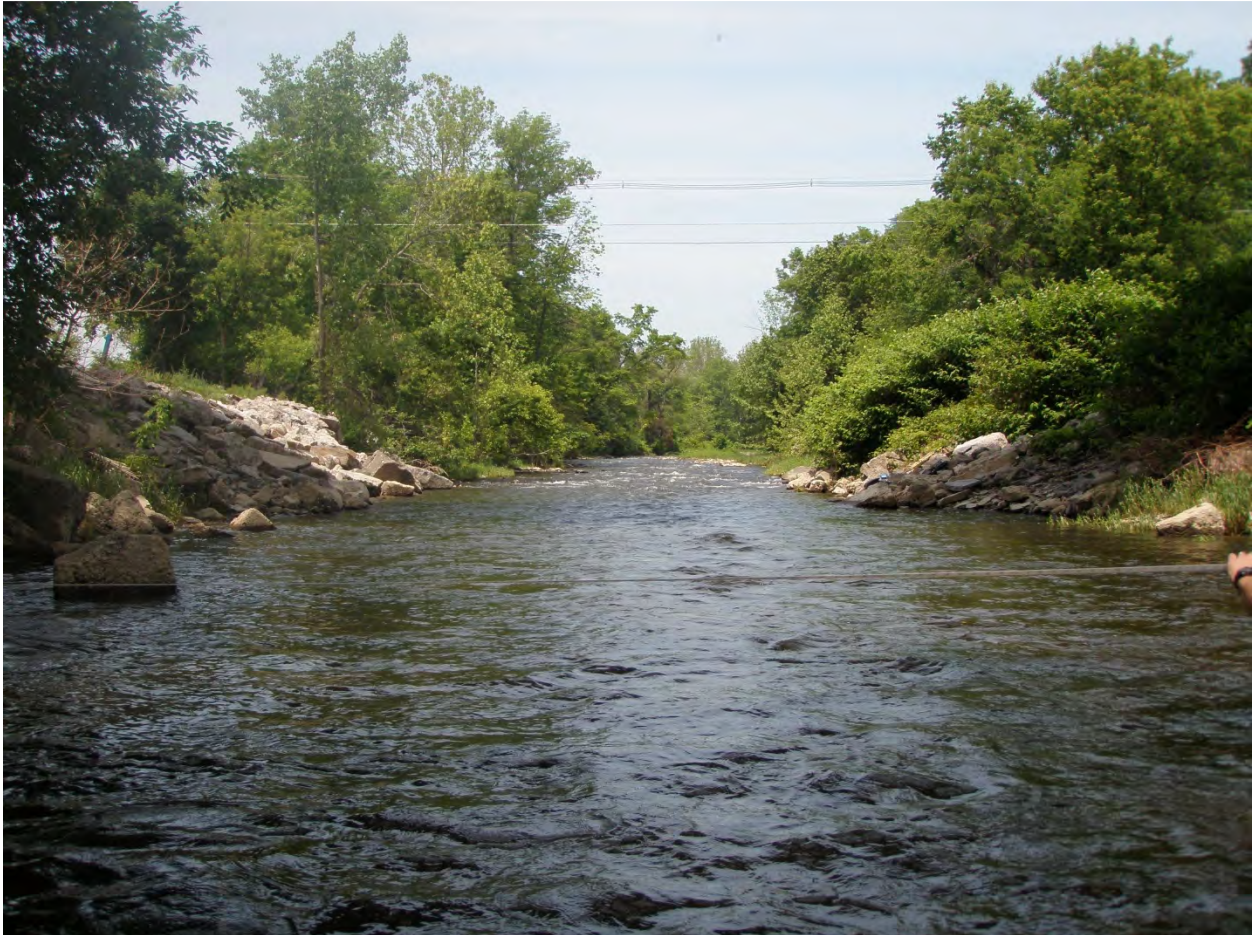
Cayuta Creek at Waverly, NY (CAYT 1.7)

Scoring 149 out of 220, physical habitat was rated as partially supporting. Surrounding industrial land uses contributed negatively to this assessment.

Biological Condition: The biological community was rated as slightly impaired in 2011.

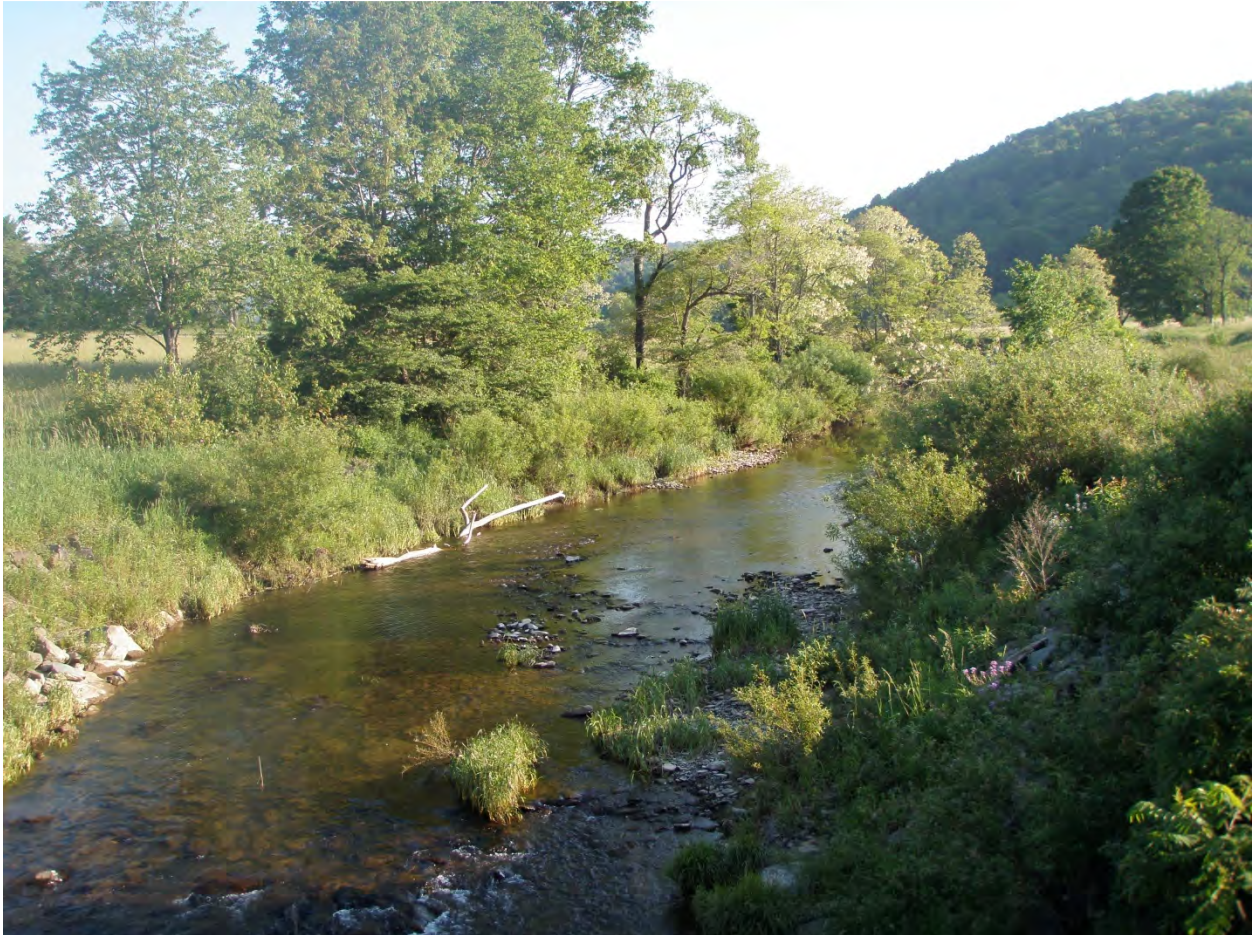
Choconut Creek at Vestal Center, NY (CHOC 9.1)

Physical habitat was rated excellent when assessed in 2011. The site scored 186 out of 220 possible points. SRBC staff noted optimal velocity/depth regimes and minimal sediment deposition.

Biological Condition: CHOC 9.1 received a biological condition rating of slightly impaired for the fifth consecutive year when sampled in 2011.

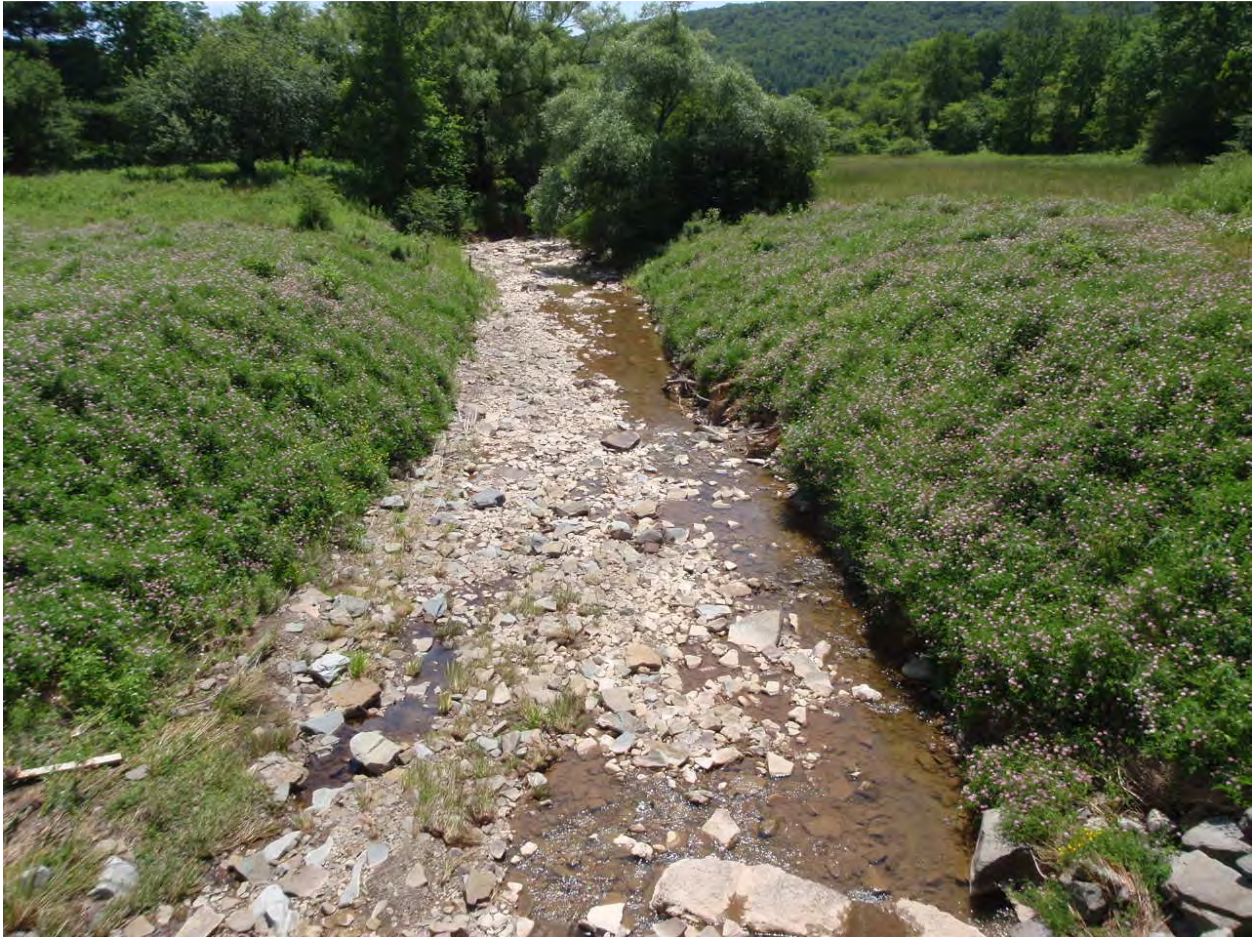
Physical habitat was deemed supporting, receiving a score of 174 out of a possible 220. Low flow conditions were evident at the time of sampling.

Biological Condition: The macroinvertebrate community was assessed as being nonimpaired when sampled in 2011.

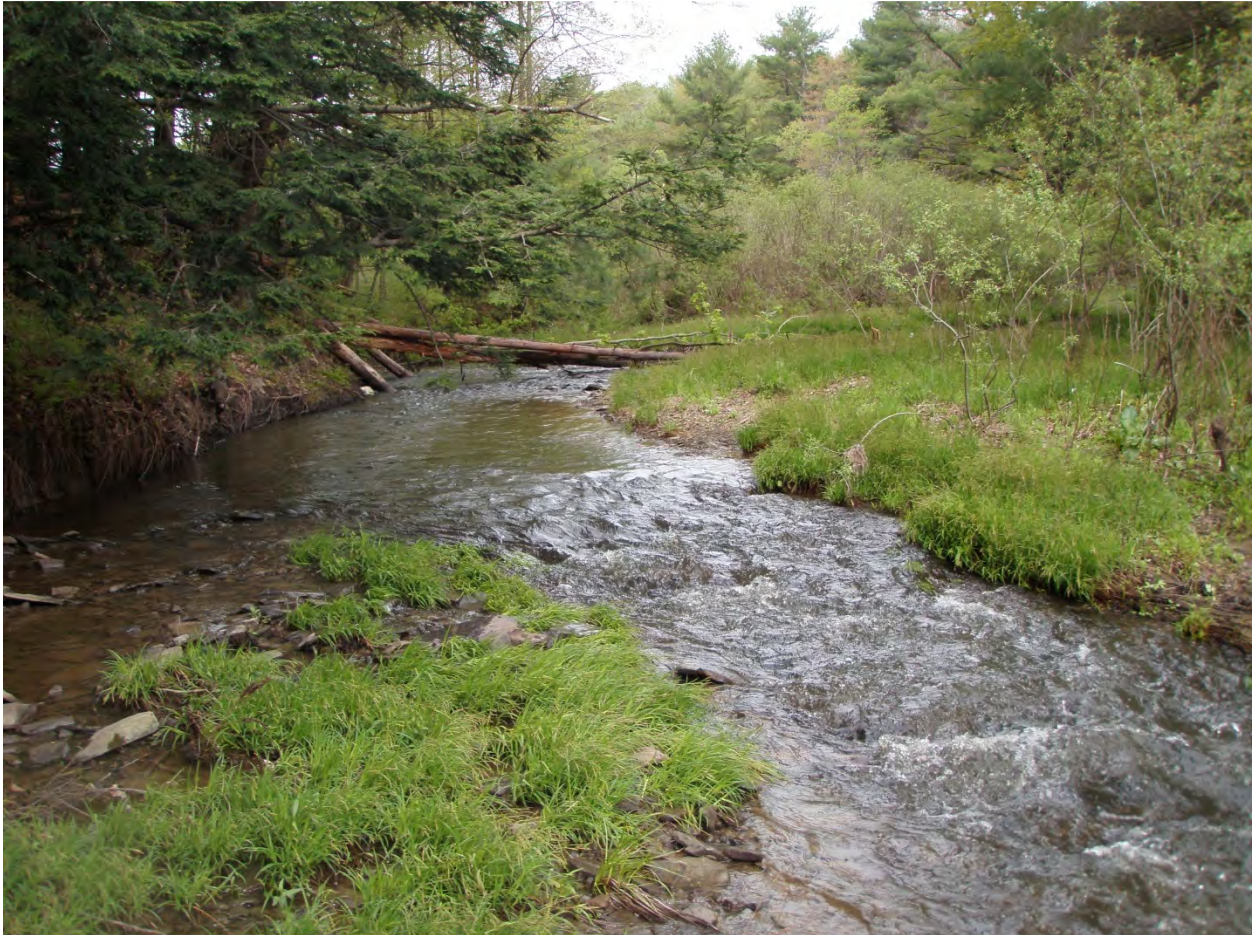
Little Snake Creek at Brackney, PA (LSNK 7.6)

Available physical habitat was rated as excellent in 2011. The station received a habitat score of 201 out of 220, netting the second highest habitat score of all interstate streams sites.

Biological Condition: Little Snake Creek received a biological condition rating of nonimpaired in 2011.

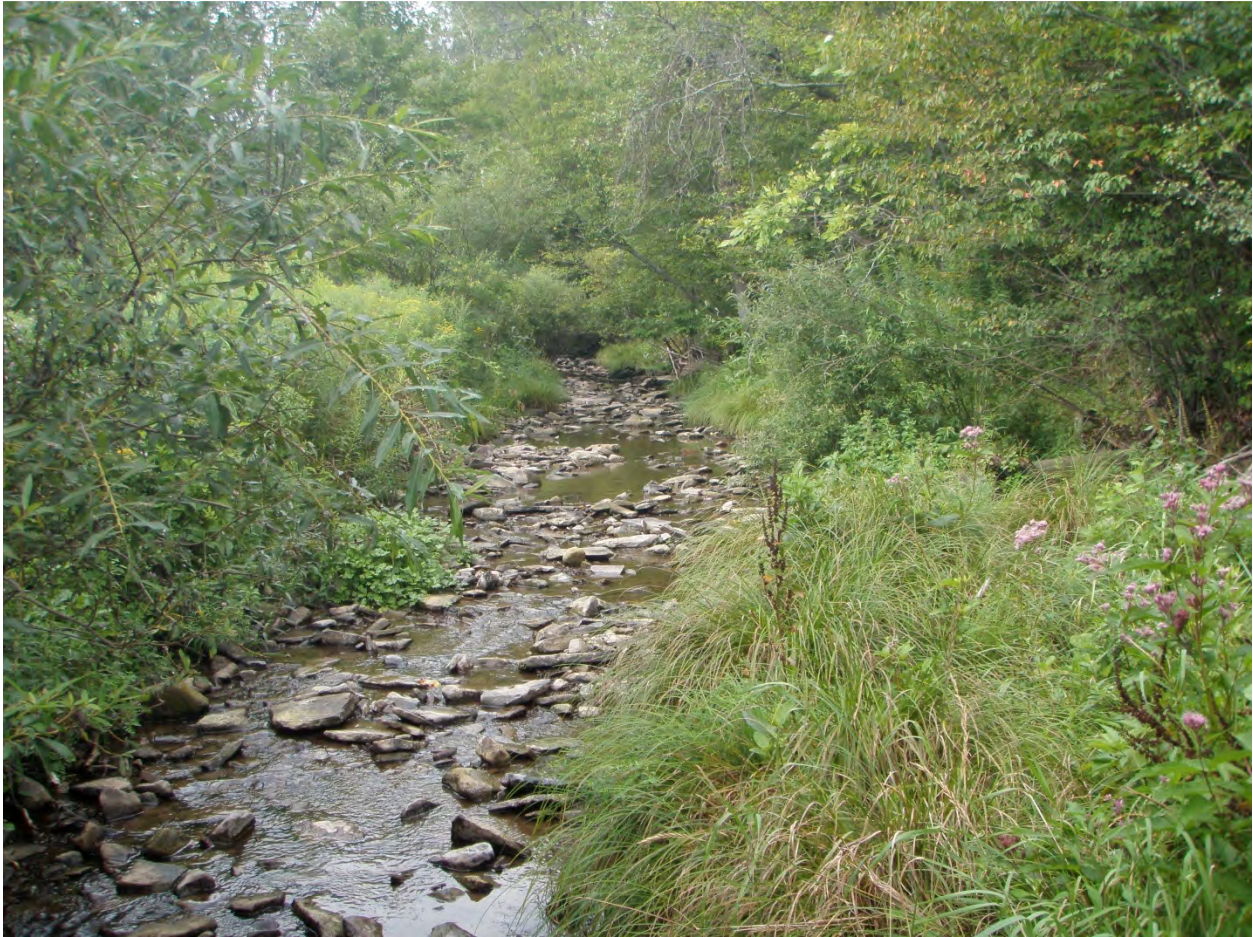
North Fork Cowanesque River at North Fork, PA (NFCR 7.6)

Physical habitat at the site was rated as excellent, receiving a score of 193 out of a possible 220 points. SRBC staff noted wide riparian buffer widths and a mostly undisturbed watershed during the site visit.

Biological Condition: NFCR 7.6's macroinvertebrate community received a nonimpaired classification in 2011.

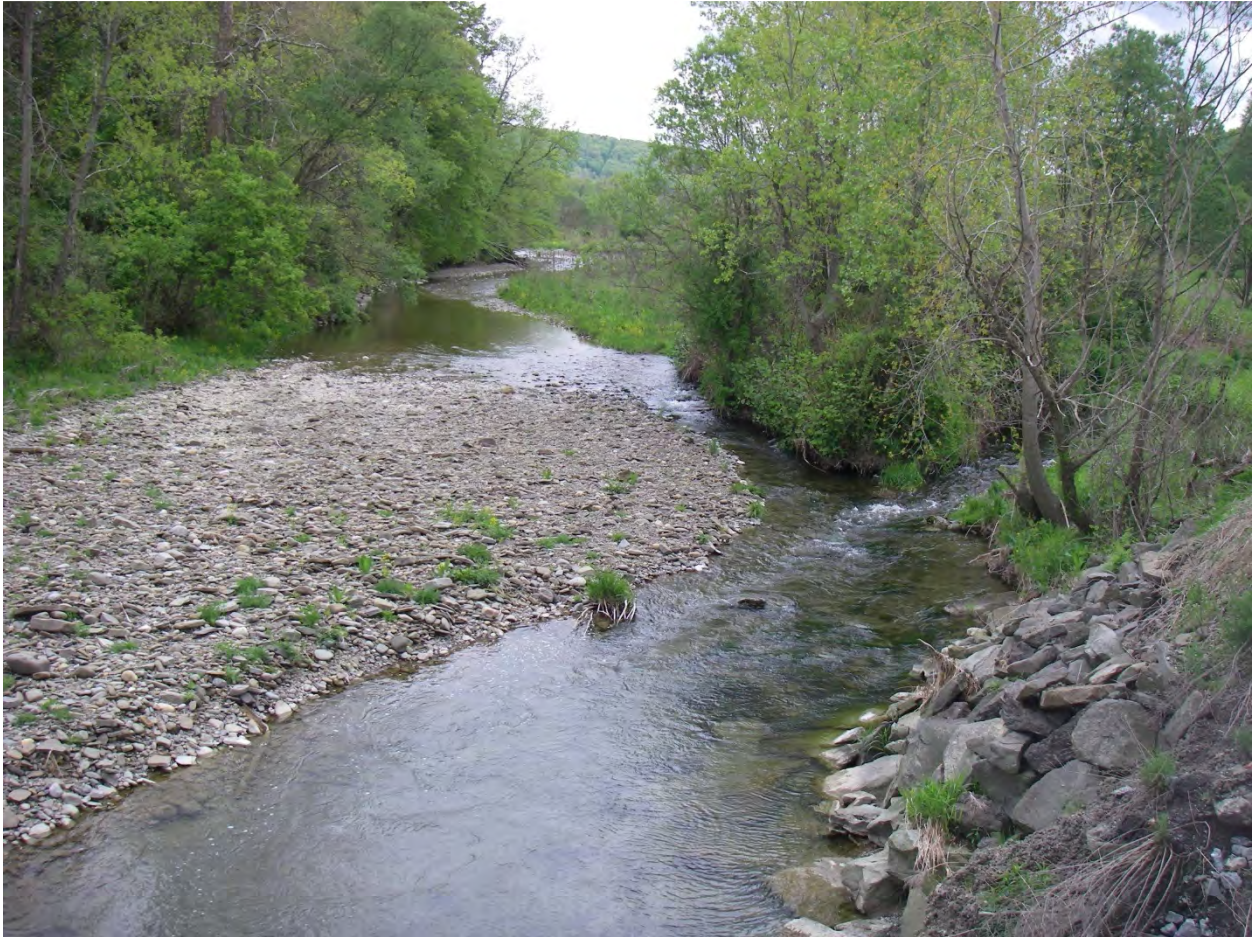
Seely Creek at Seely Creek, NY (SEEL 10.8)

Available physical habitat was classified as supporting in 2011. SRBC staff noted construction activities occurring at the site throughout the duration of the 2011 sampling year. These activities negatively impacted available habitat immediately downstream of the sampling site.

Biological Condition: SEEL 10.8 received a biological condition rating of slightly impaired in 2011.

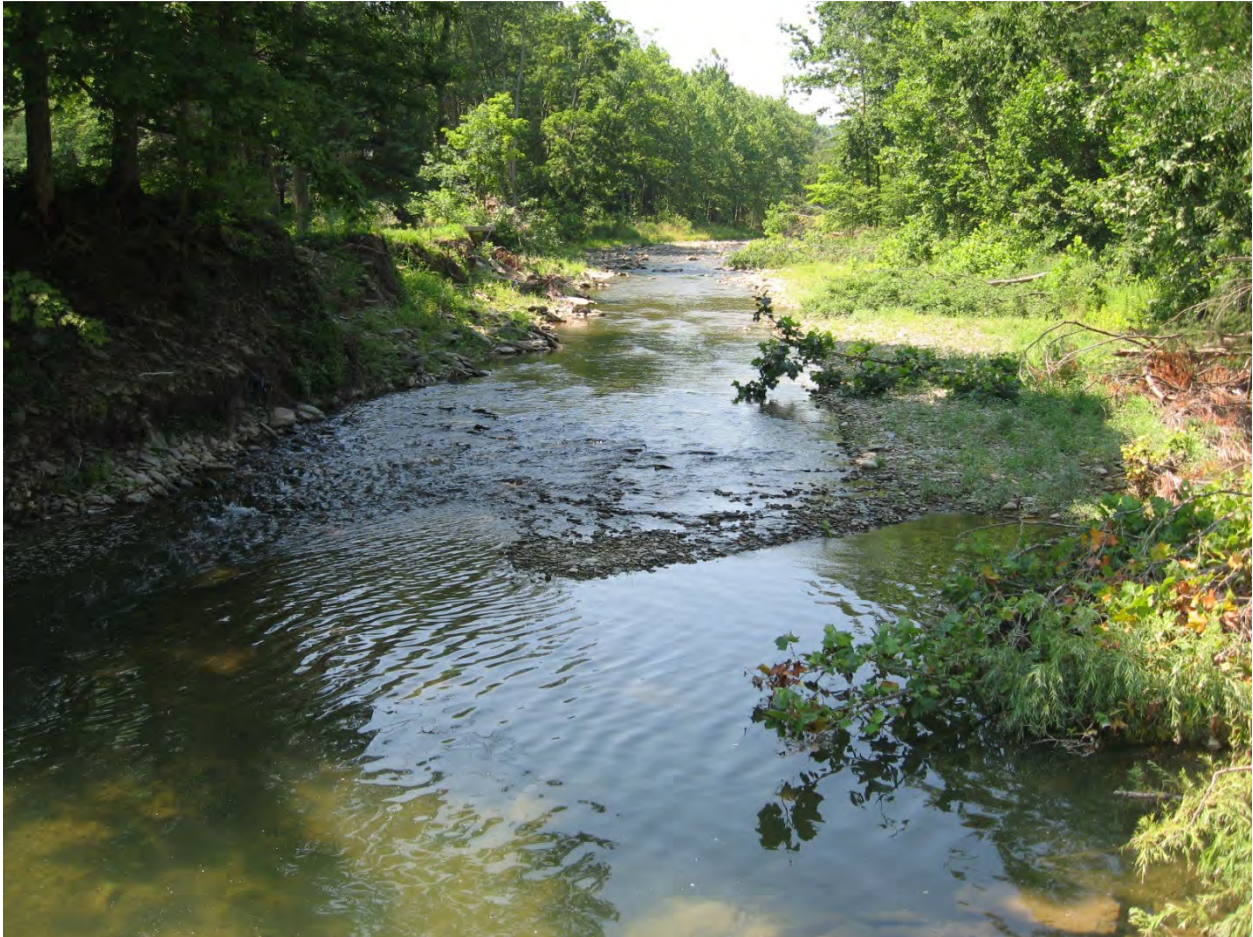
Snake Creek at Brookdale, PA (SNAK 2.3)

Physical habitat at Snake Creek was rated as supporting in 2011. SRBC staff noted bank instability and residual impacts from recent construction activities at the site.

Biological Condition: The macroinvertebrate community of Snake Creek received a classification of nonimpaired when sampled in 2011.

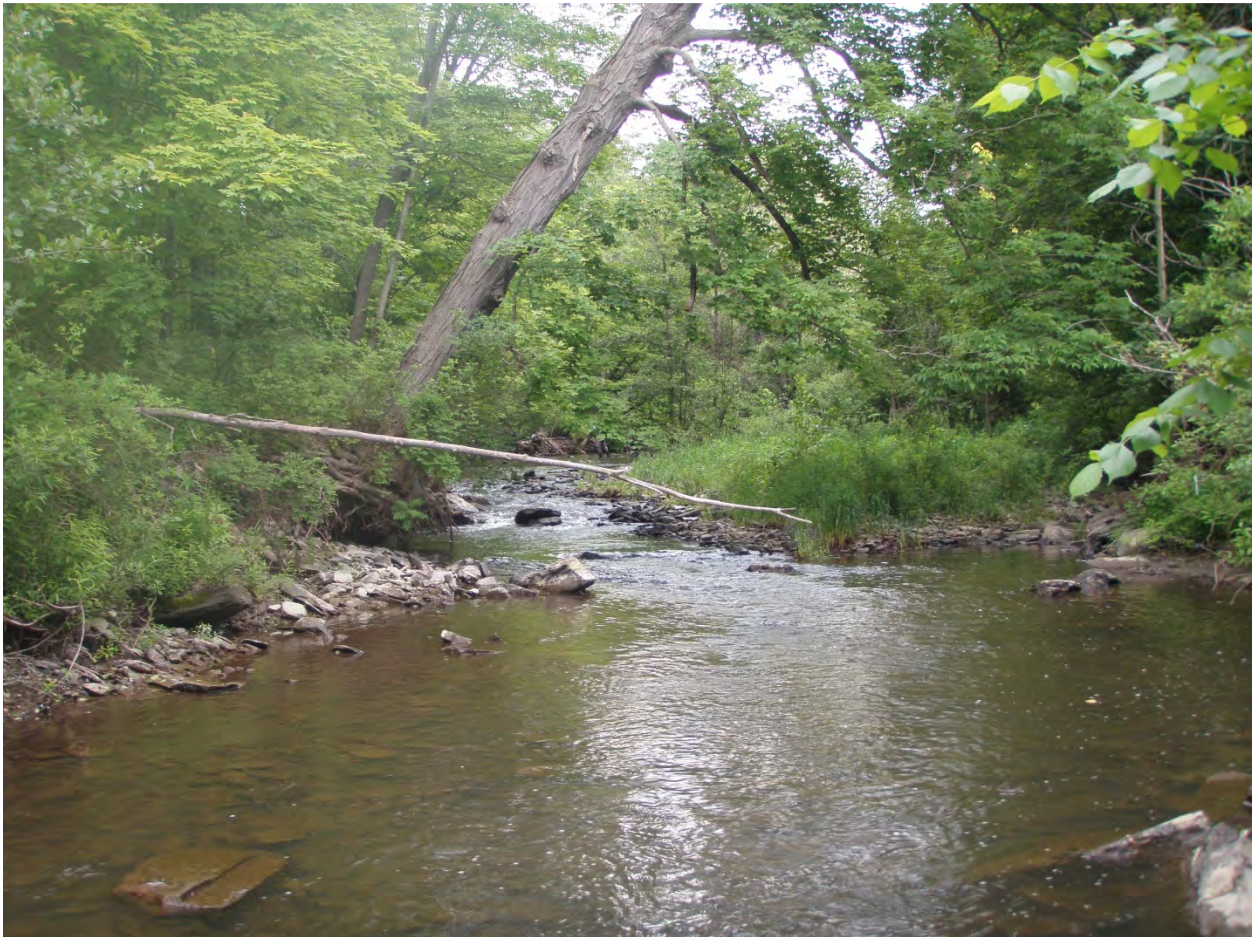
South Creek at Fassett, PA (SOUT 7.6)

Available physical habitat was rated as supporting. The site possessed good epifaunal substrate and instream cover; however, sedimentation was problematic at the monitoring site.

Biological Condition: South Creek possessed a nonimpaired biological community when sampled in 2011.

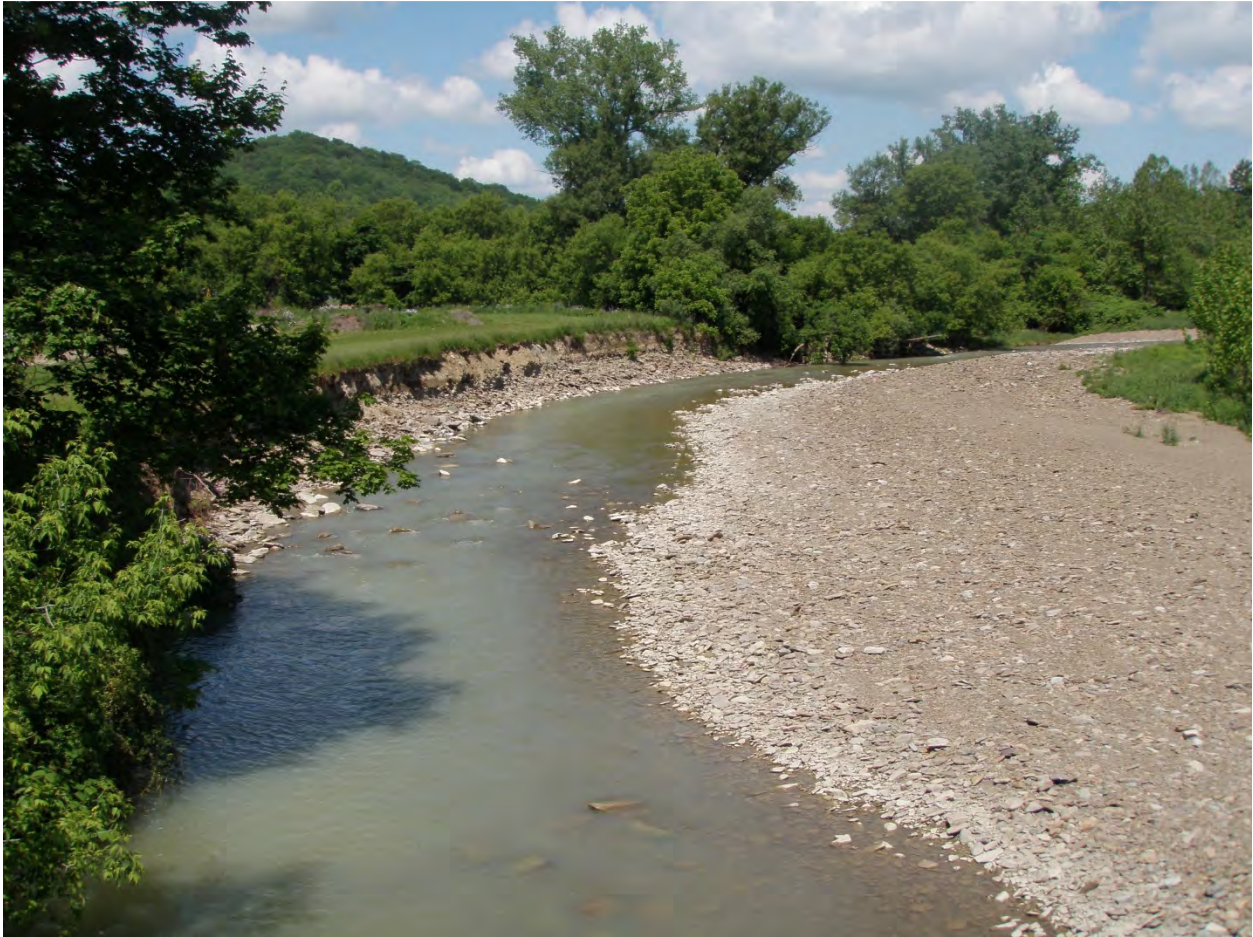
Troups Creek at Austinburg, PA (TRUP 4.5)

SRBC staff classified available physical habitat at Troups Creek as being supporting. Significant bank erosion continued to impact conditions at the site. Pre-construction activities for bridge repairs were occurring in fall 2011, indicating potential future impacts.

Biological Condition: The macroinvertebrate community was rated as slightly impaired when sampled in 2011.

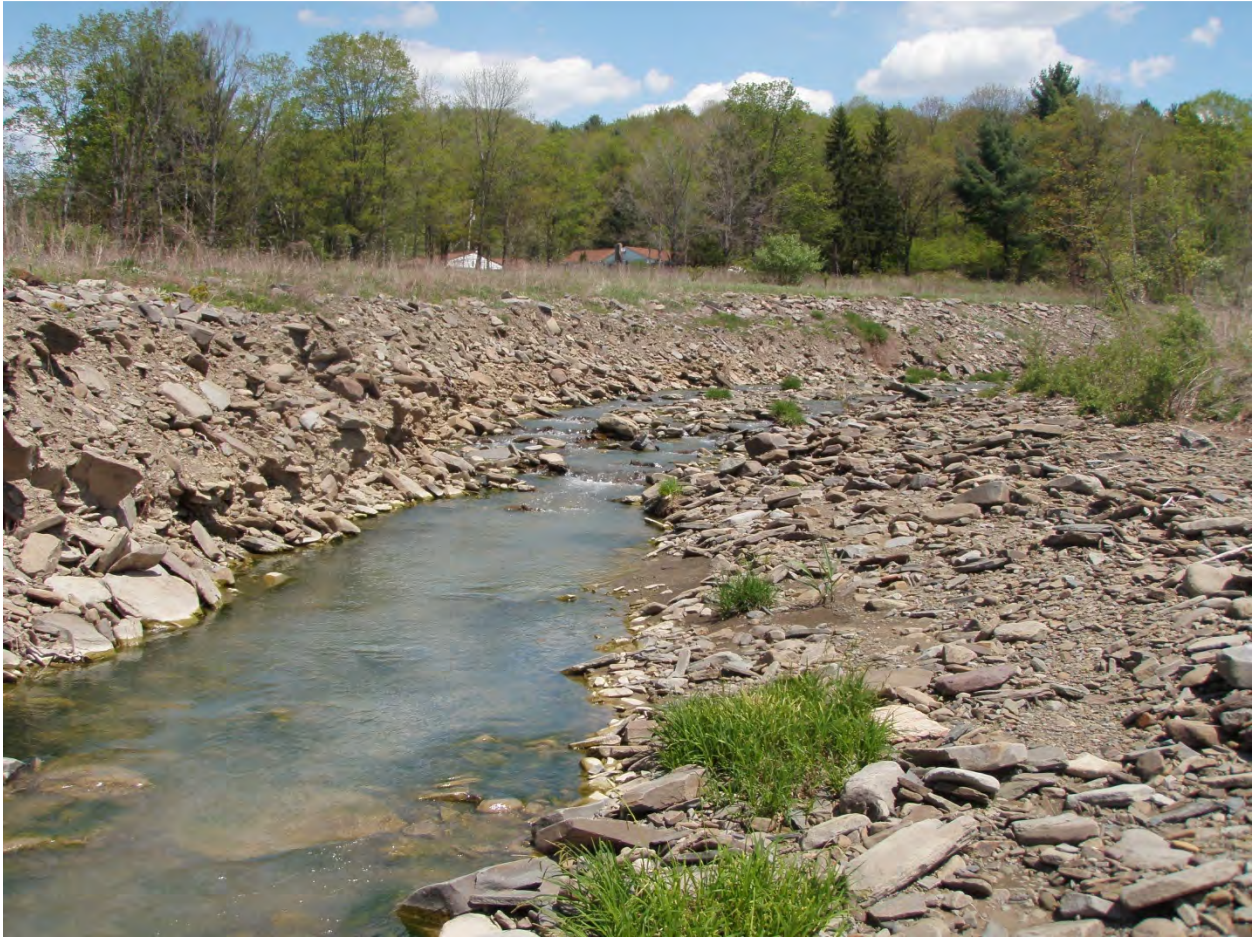
Trowbridge Creek at Great Bend, PA (TROW 1.8)

Physical habitat was rated as supporting when assessed in 2011. The site scored 154 out of a possible 220, losing significant points for poor bank conditions.

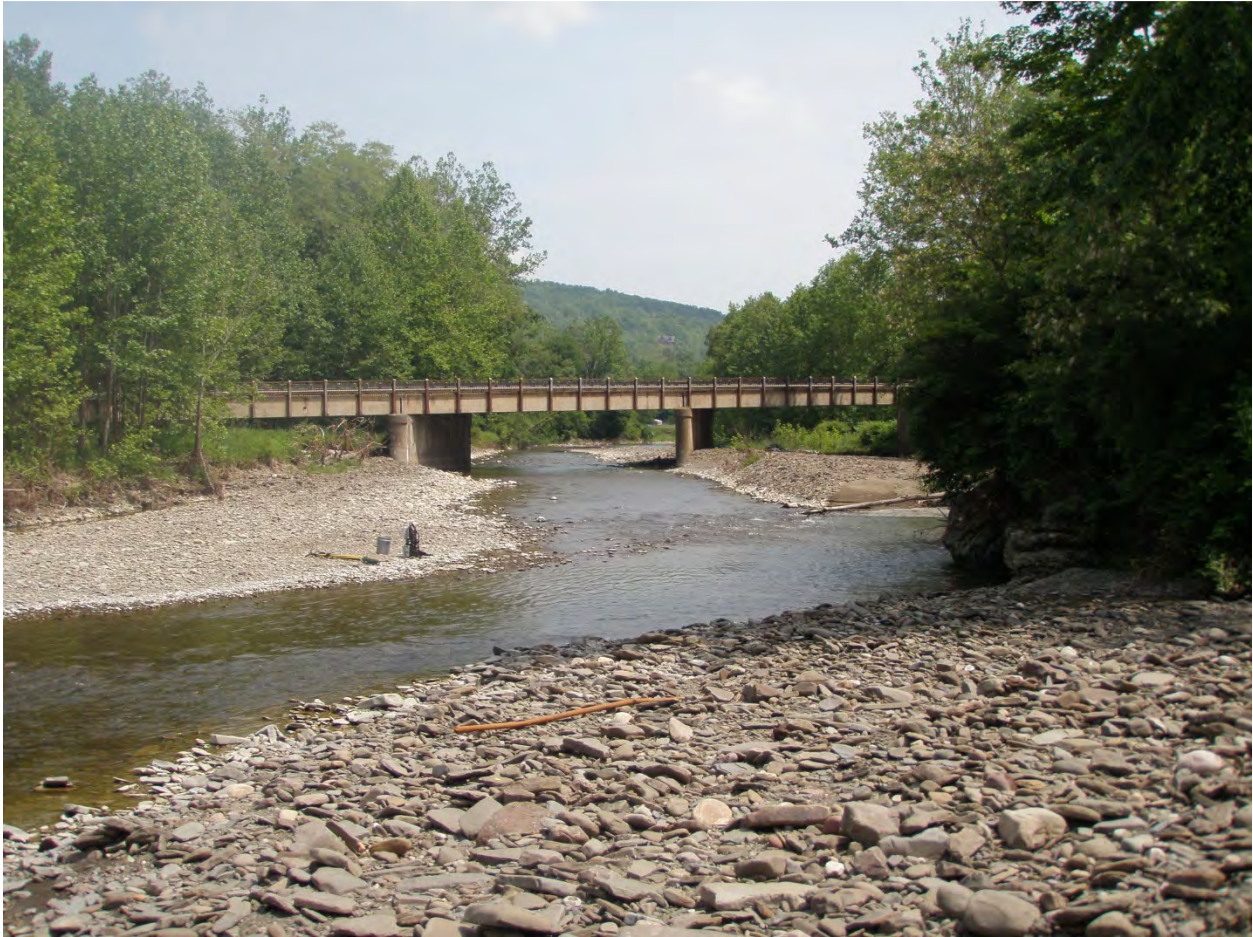
Wappasening Creek at Nichols, NY (WAPP 2.6)

Available physical habitat at WAPP 2.6 was classified as supporting in 2011. SRBC staff noted a lack of instream cover and variability in velocity/depth regimes.

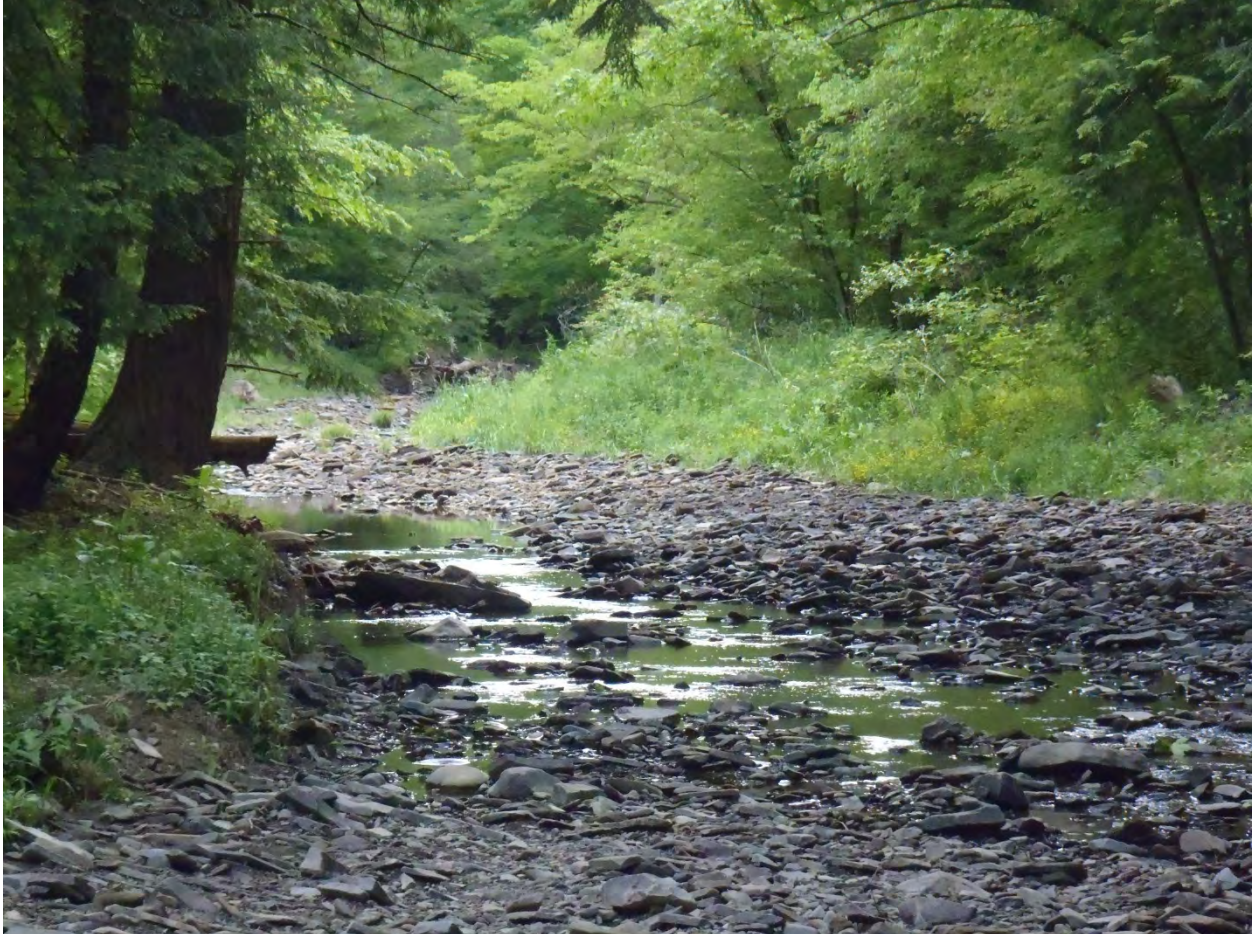
Babcock Run (BABC)

In May 2011, SRBC staff assessed Babcock Run near Cadis, Pa. Overall physical habitat was rated as supporting within minimal channel alteration with frequent, well-developed riffles. The station suffered biologically from poor taxonomic richness and possessed relatively few EPT taxa. All water quality parameters tested within acceptable limits.

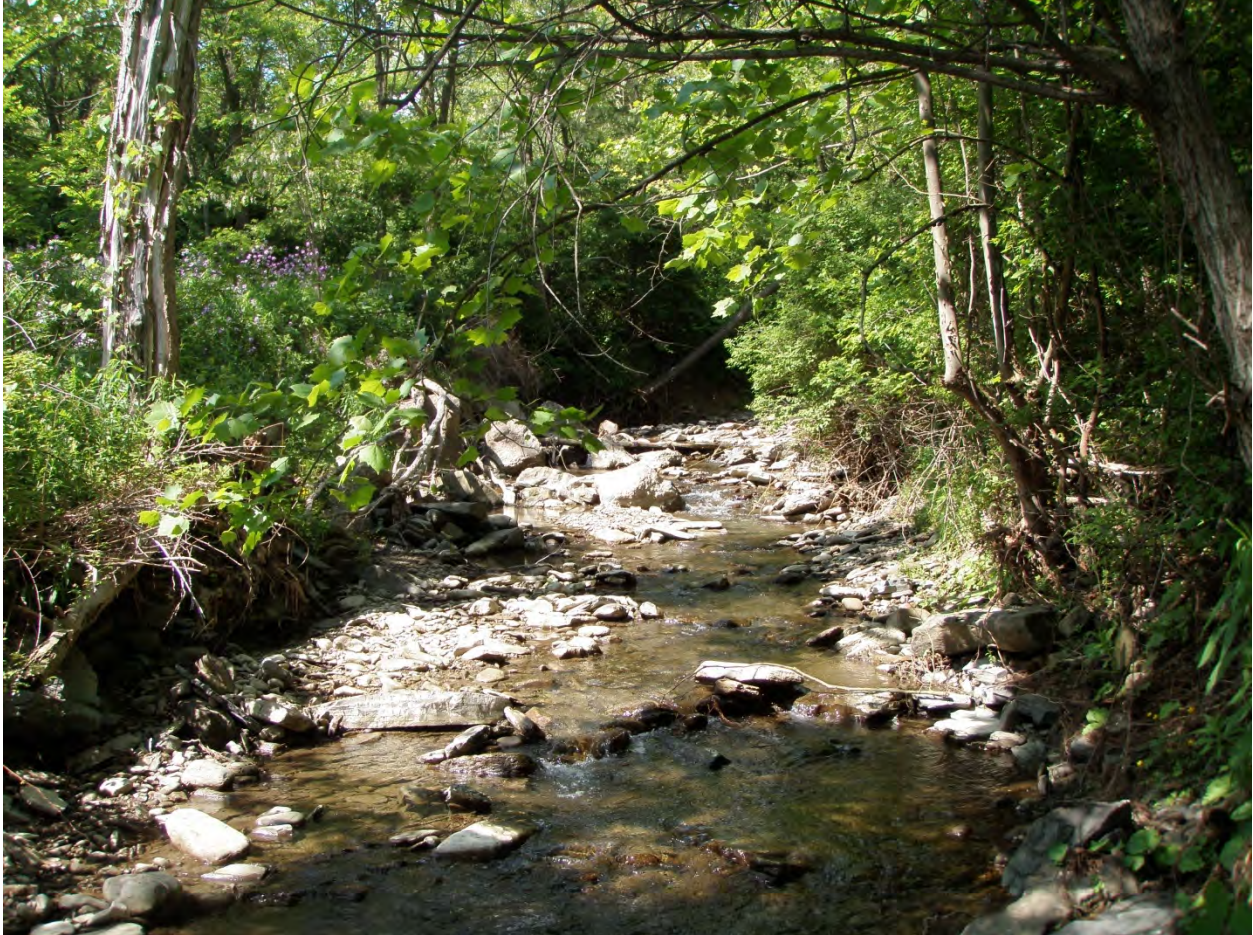
Bill Hess Creek (BILL)

Bill Hess Creek, located near Route 49 in Nelson, Pa., received a biological condition rating of slightly impaired when sampled in 2011. This represents the third consecutive year the stream has attained this classification. The macroinvertebrate sample scored well on the Shannon Diversity Index but lacked significant numbers of EPT taxa. Overall physical habitat was rated as supporting. All water quality parameters tested within acceptable limits.

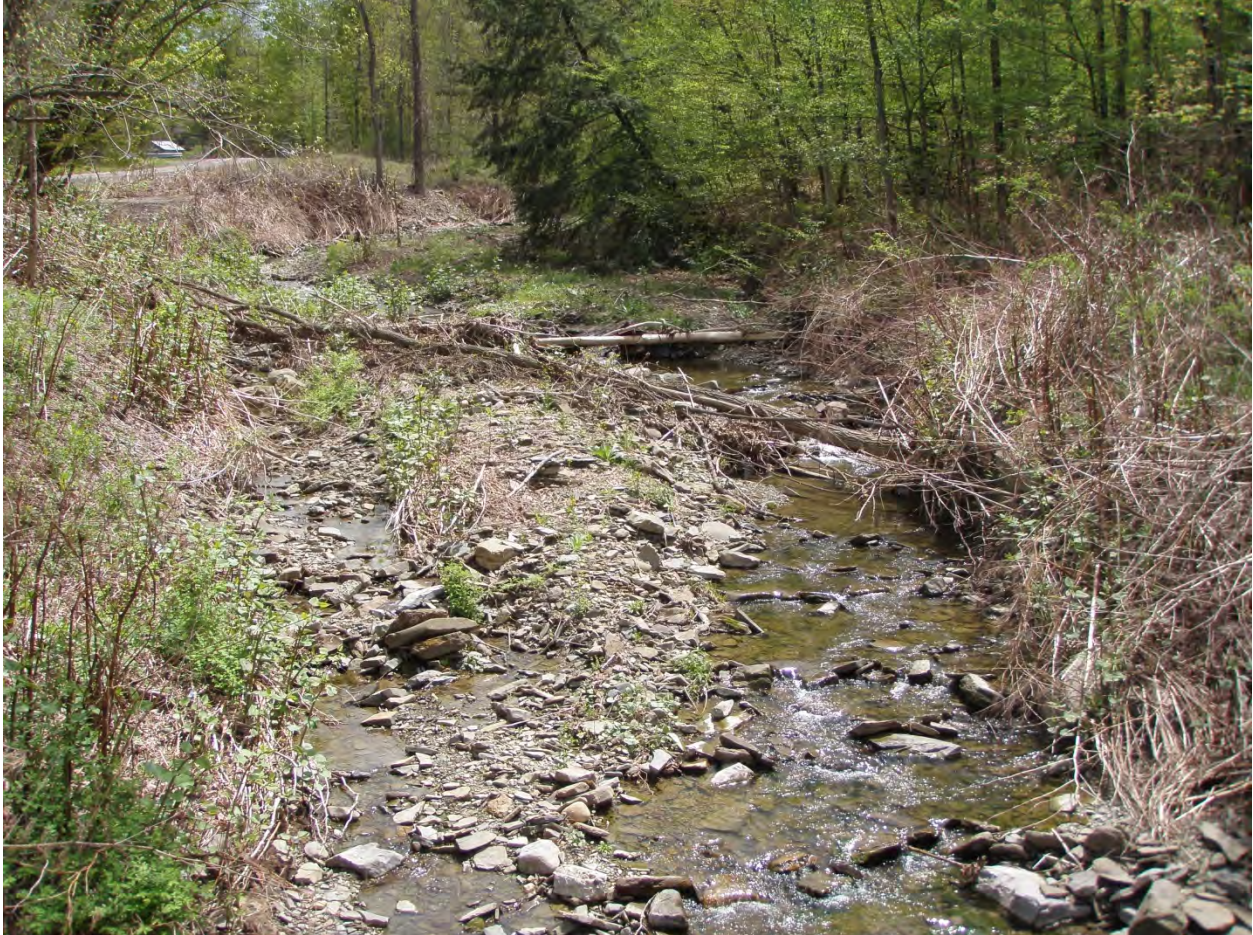
Bird Creek (BIRD)

SRBC staff assessed Bird Creek located near Webb Mills, N.Y., in May 2011. Water chemistry parameters measured in the field were all within accepted criteria. Overall available physical habitat was rated as supporting. Streambank erosion issues identified in prior surveys remained evident in the 2011 habitat assessment. The biological condition rating of Bird Creek declined to slightly impaired after two years of attaining a nonimpaired status. The macroinvertebrate sample possessed a large proportion of Ephemeroptera taxa but did score poorly on the modified Hilsenhoff Index.

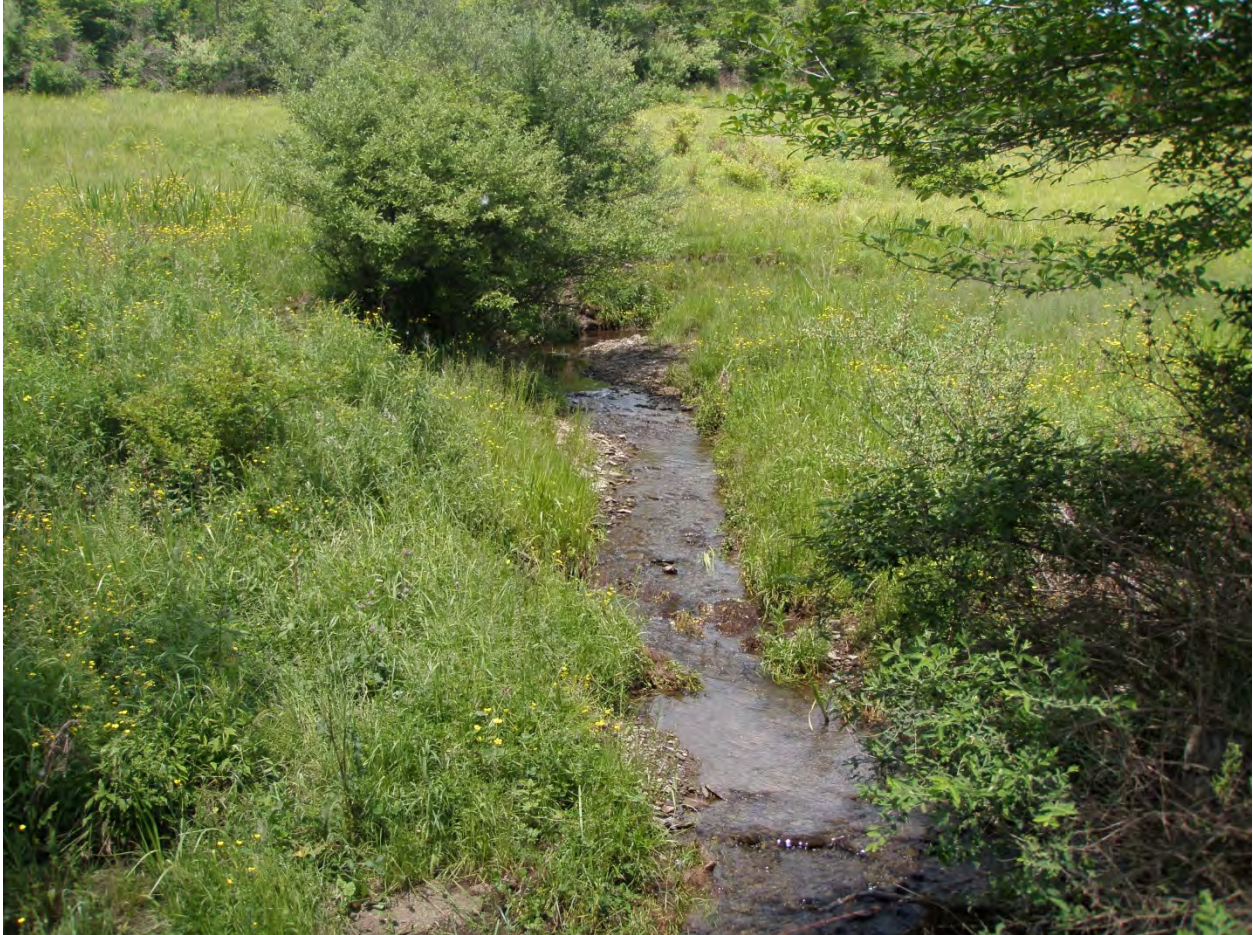
Biscuit Hollow (BISC)

Biscuit Hollow, near Austinburg, Pa., received a biological condition rating of slightly impaired when SRBC staff evaluated the stream in May 2011. BISC possessed the highest taxonomic richness of all Group 3 streams surveyed in 2011, netting 29 distinct taxa. Available physical habitat was rated as excellent and conditions continued to improve as surrounding pasture lands revert back to forest. All measured water quality parameters fell within accepted limits.
