**ASSESSMENT OF INTERSTATE
STREAMS IN THE
SUSQUEHANNA RIVER BASIN**

Monitoring Report No. 25
January 1, 2011 Through December 31, 2011

Publication No. 281

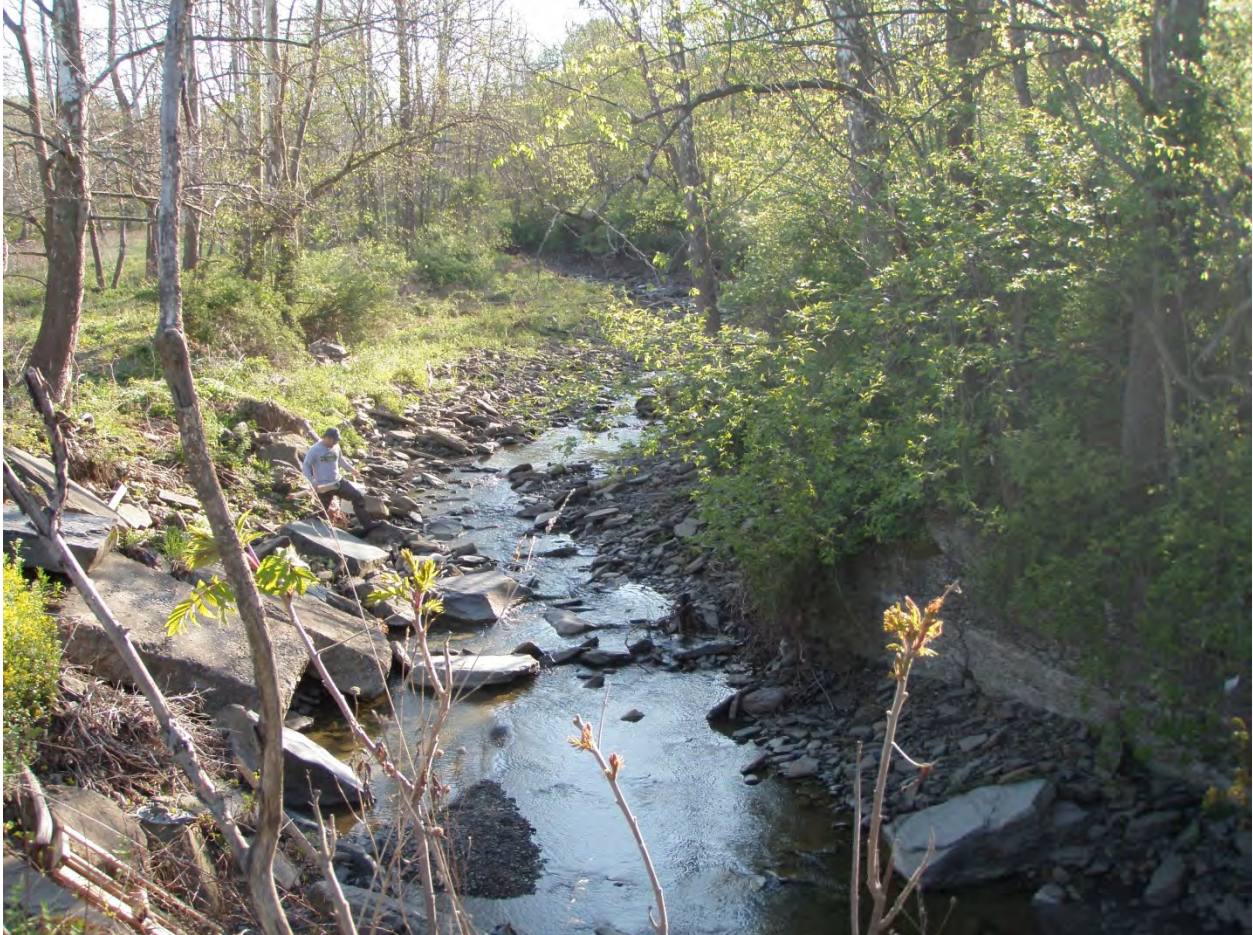
Briggs Hollow Run (BRIG)

Briggs Hollow Run near Nichols, N.Y., received a slightly impaired rating of its biological community in 2011. The macroinvertebrate sample contained good taxonomic evenness and a favorable Shannon Diversity Index score. Available physical habitat was rated as supporting with minimal embeddedness and good riffle frequency. Bank conditions were problematic with poor vegetative protective cover on the left descending bank. All measured water quality parameters tested within acceptable limits.

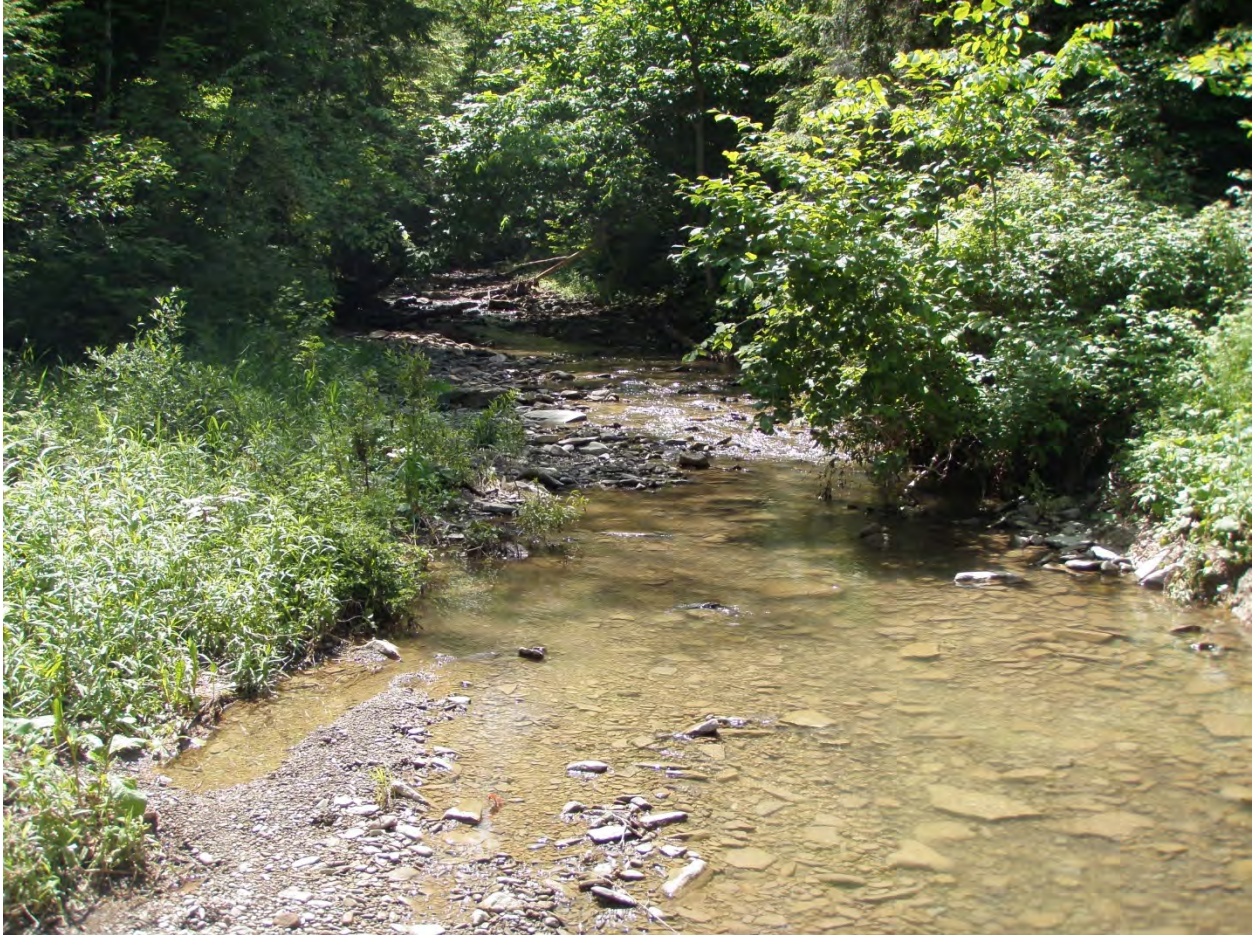
Bulkley Brook (BULK)

SRBC staff evaluated Bulkley Brook, near Knoxville, Pa., in May 2011. BULK received a biological condition rating of slightly impaired and a habitat assessment rating of supporting. The site possessed generally favorable habitat conditions despite lower flow conditions at the time of the survey. All measured water quality parameters tested within acceptable limits.

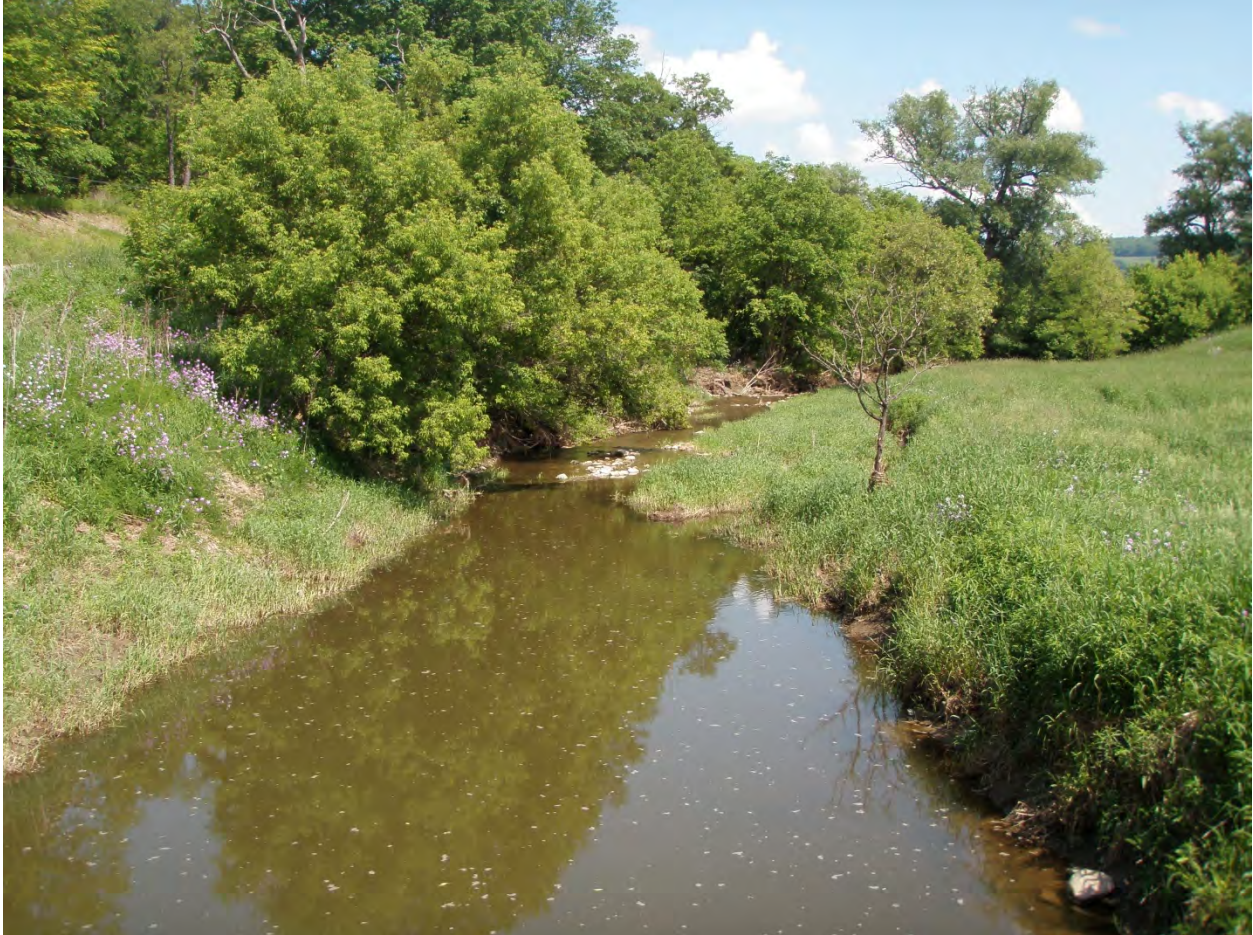
Camp Brook (CAMP)

Camp Brook, located outside of Osceola, Pa., received a nonimpaired biological condition assessment in 2011. The macroinvertebrate sample taken from this stream possessed the best overall rating since the 2006 monitoring year. Despite receiving mostly sub-optimal physical habitat parameter ratings, the overall assessment classified the stream as supporting. Key areas for improvement included velocity/depth regimes and sediment deposition. All measured water quality parameters tested within acceptable limits.

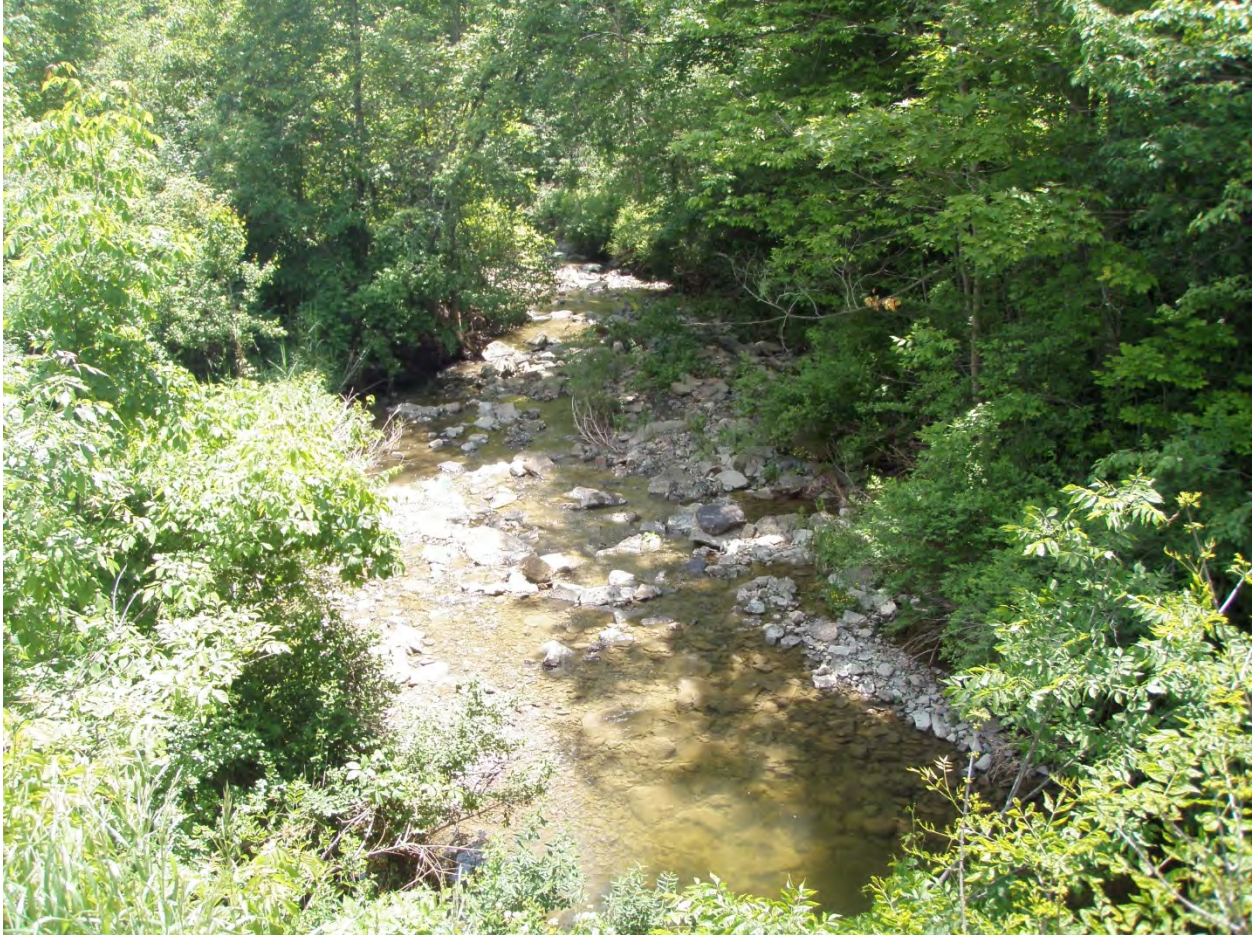
Cook Hollow (COOK)

Cook Hollow Brook, near Austinburg, Pa., attained a biological condition rating of slightly impaired for the sixth consecutive year. The available physical habitat was rated as excellent featuring a minimally altered channel and frequent riffles. Bank conditions and vegetative protective widths received the highest scores of all Group 3 streams monitored in 2011. All measured water quality parameters tested within acceptable limits.

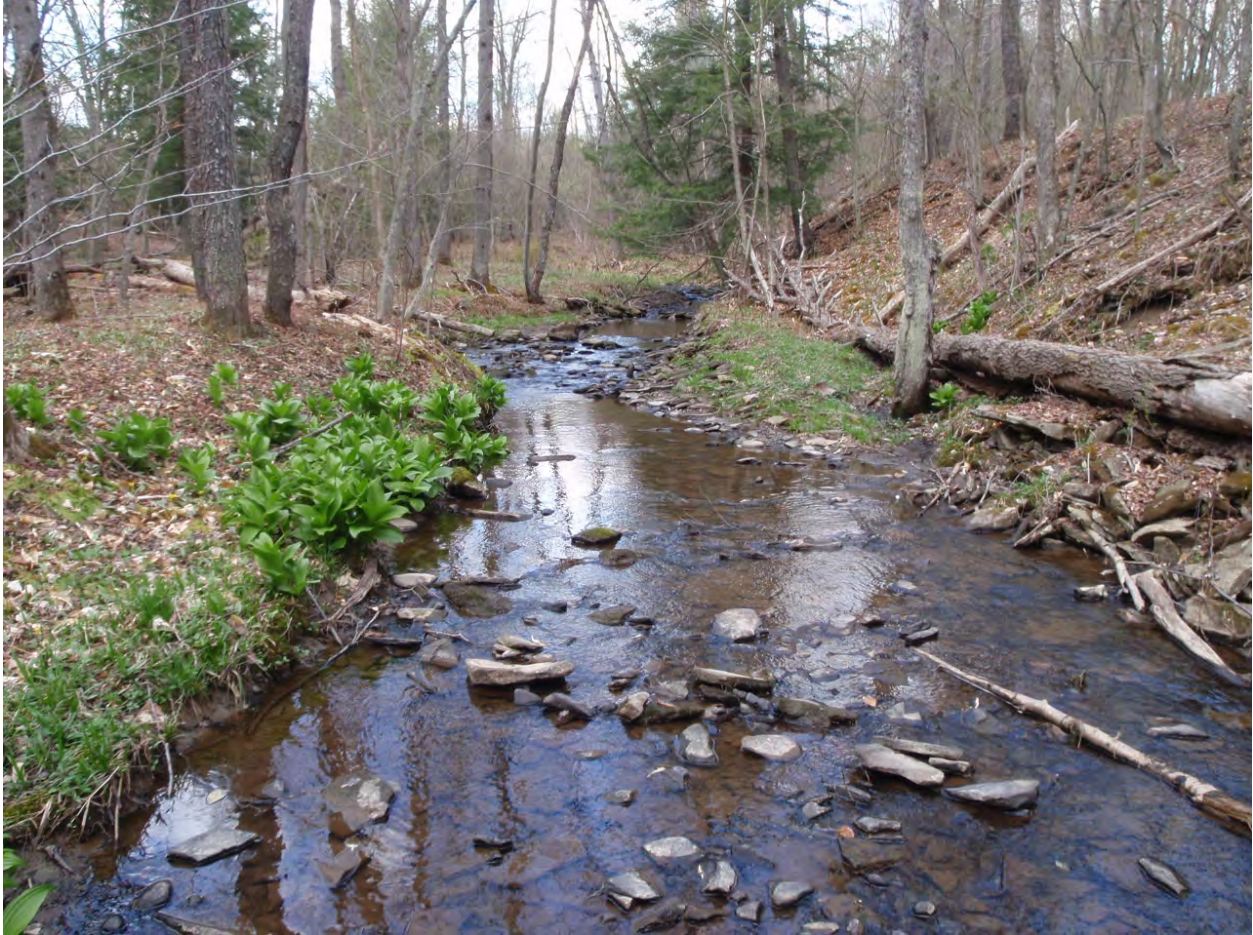
Deep Hollow Brook (DEEP)

Deep Hollow Brook, assessed near Danville, N.Y., received a biological condition rating of slightly impaired in 2011. Available physical habitat was deemed excellent as the stream is located in a mostly forested drainage. Deep Hollow Brook possessed a diverse macroinvertebrate community but was limited by a high proportion of a single dominant taxa. Alkalinity was determined to be 18 mg/L which falls under Pennsylvania's water quality criteria of 20 mg/L.

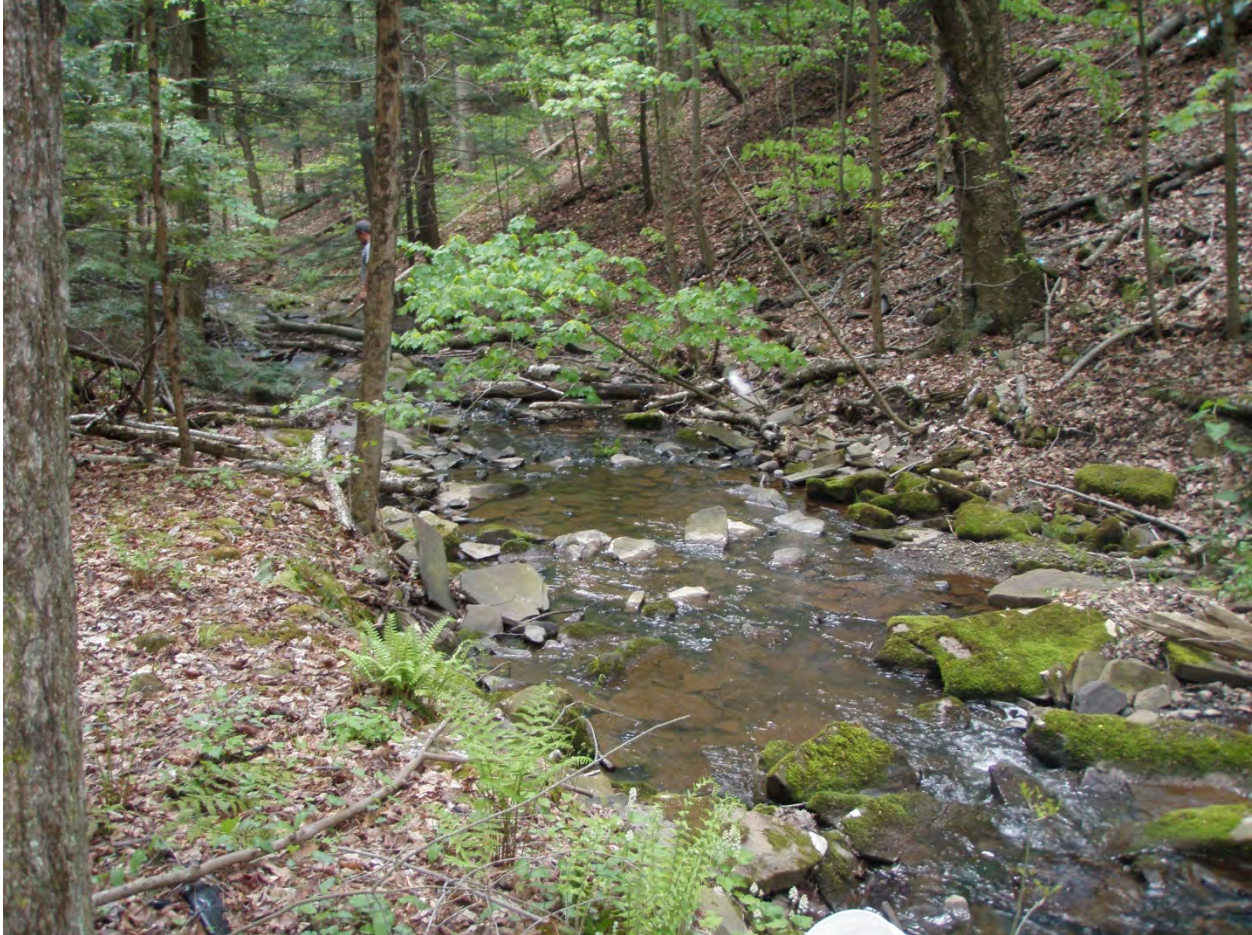
Denton Creek (DENT)

SRBC staff assessed Denton Creek near the Hawkins Pond Nature Area outside of Hickory Grove, Pa., in May 2011. The stream received a biological condition rating of moderately impaired. Limiting biological conditions were low overall taxonomic richness and a high (33 percent) proportion of pollution tolerant Chiromidae taxa. Measured alkalinity was found to be 12 mg/L which is below the Pennsylvania water quality criteria of 20 mg/L. Available physical habitat was rated as excellent with optimal epifaunal substrate and instream cover.

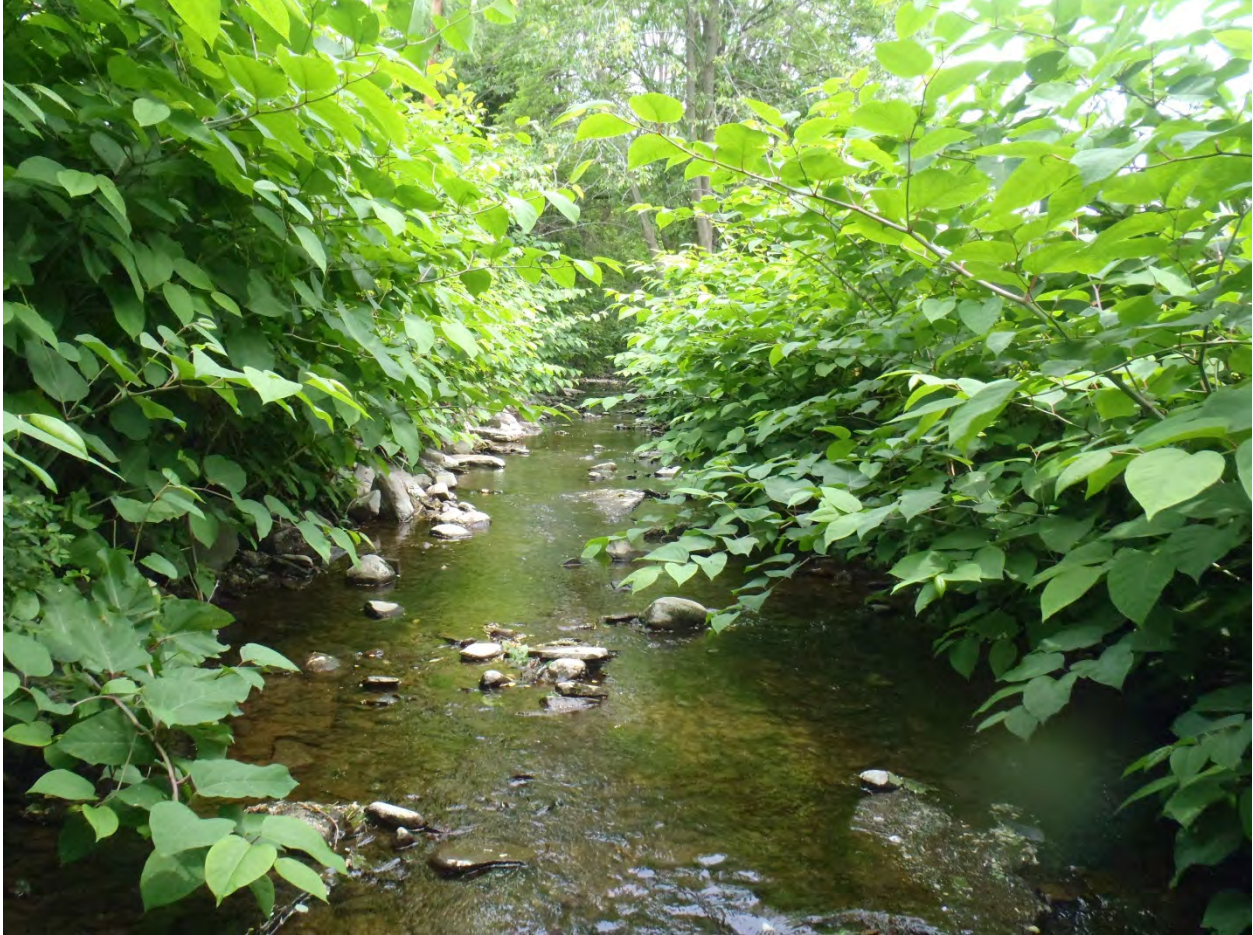
Dry Brook (DRYB)

Dry Brook, sampled in Waverly, Pa., possessed a moderately impaired biological community when sampled in May 2011. Available physical habitat was classified as supporting. Dry Brook continues to be one of the most impaired Group 3 streams within the monitoring project. Draining a highly developed and populated watershed, depressed biological conditions have persisted at this site throughout the majority of the duration of the Interstate Streams Monitoring Project. All measured water quality parameters tested within acceptable limits.

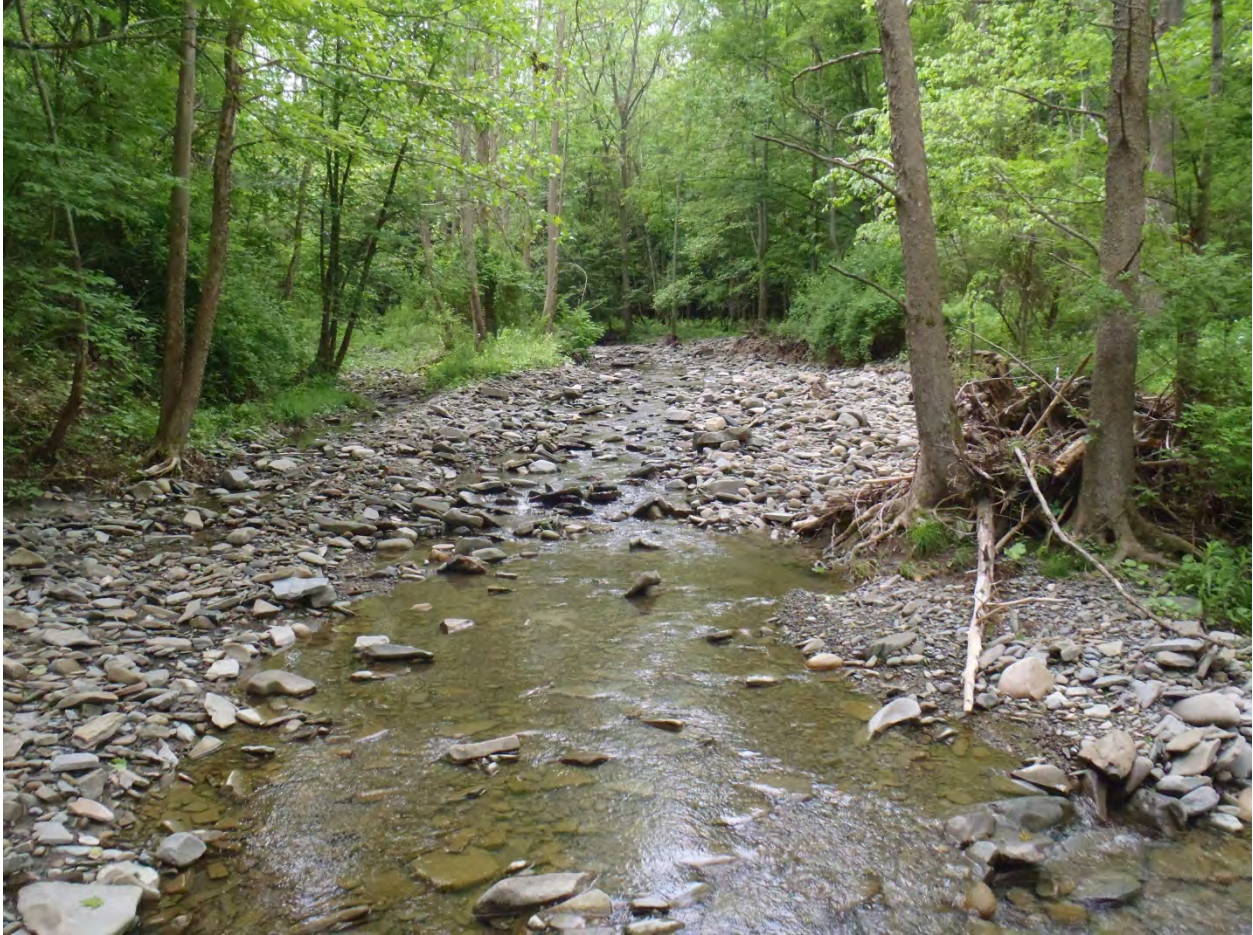
Little Wappasening Creek (LWAP)

Little Wappasening Creek near Nichols, N.Y., received a biological condition rating of slightly impaired when assessed by SRBC staff in May 2011. Supported by available physical habitat rated as excellent, the stream continued to score well across a variety of macroinvertebrate evaluation indices. All measured water quality parameters tested within acceptable limits.

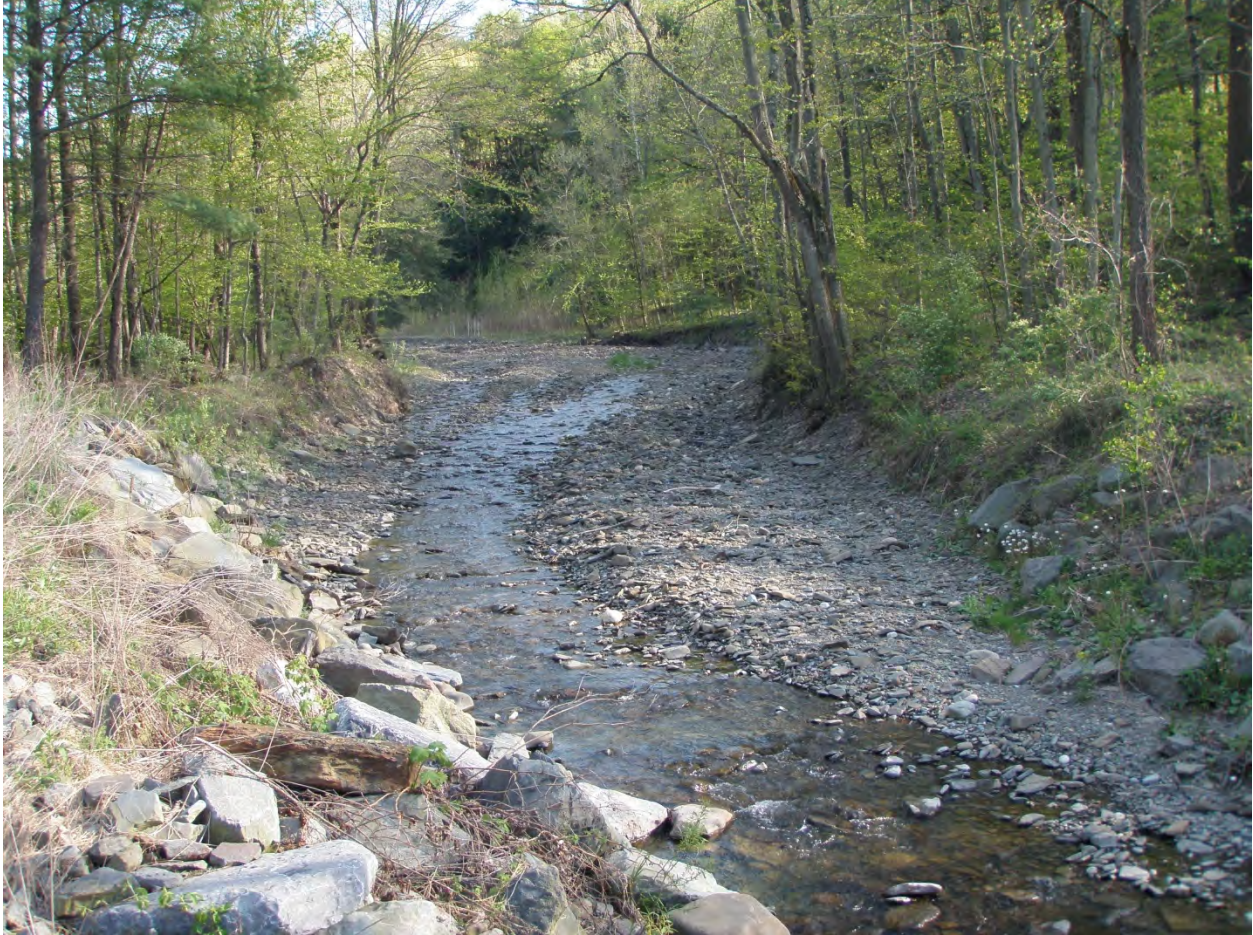
Parks Creek (PARK)

Parks Creek near Litchfield, N.Y., was designated as having a nonimpaired biological community in 2011 after receiving a rating of slightly impaired for the previous six years. The biological community received high scores in the Modified Hilsenhoff Index, percent Ephemeroptera, and percent Chironomidae in particular. Available physical habitat was classified as supporting. All measured field chemistry parameters were within acceptable limits at the time of sampling.

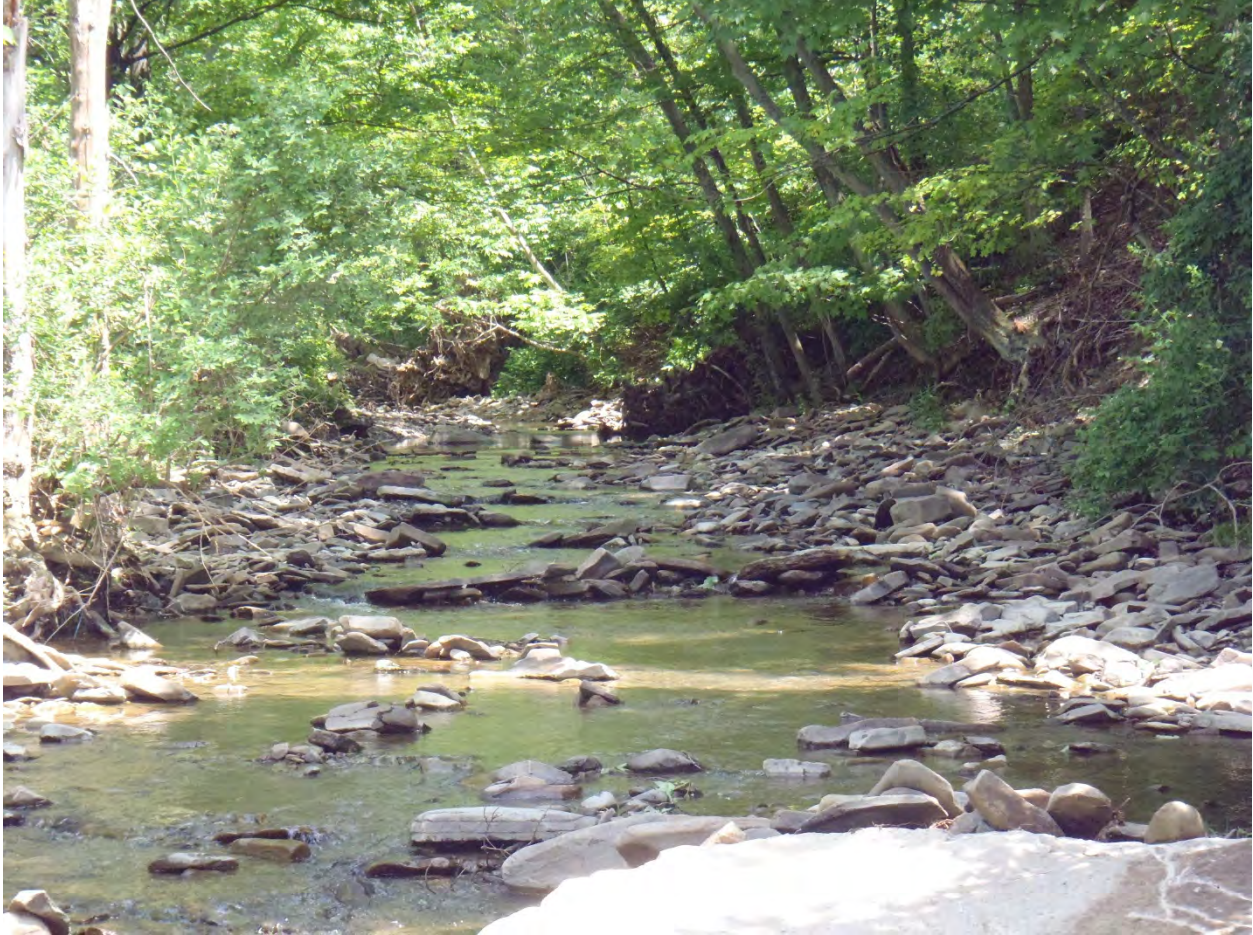
Prince Hollow Run near Cadis, Pa., received a biological condition rating of slightly impaired when sampled in May 2011. Despite the sub-optimal biological rating, the stream has continued to show gradual improvement from previous sampling efforts. The biological community scored well in most categories with the exception of the EPT Index. Available physical habitat was rated as supporting. All measured water quality parameters tested within acceptable limits.

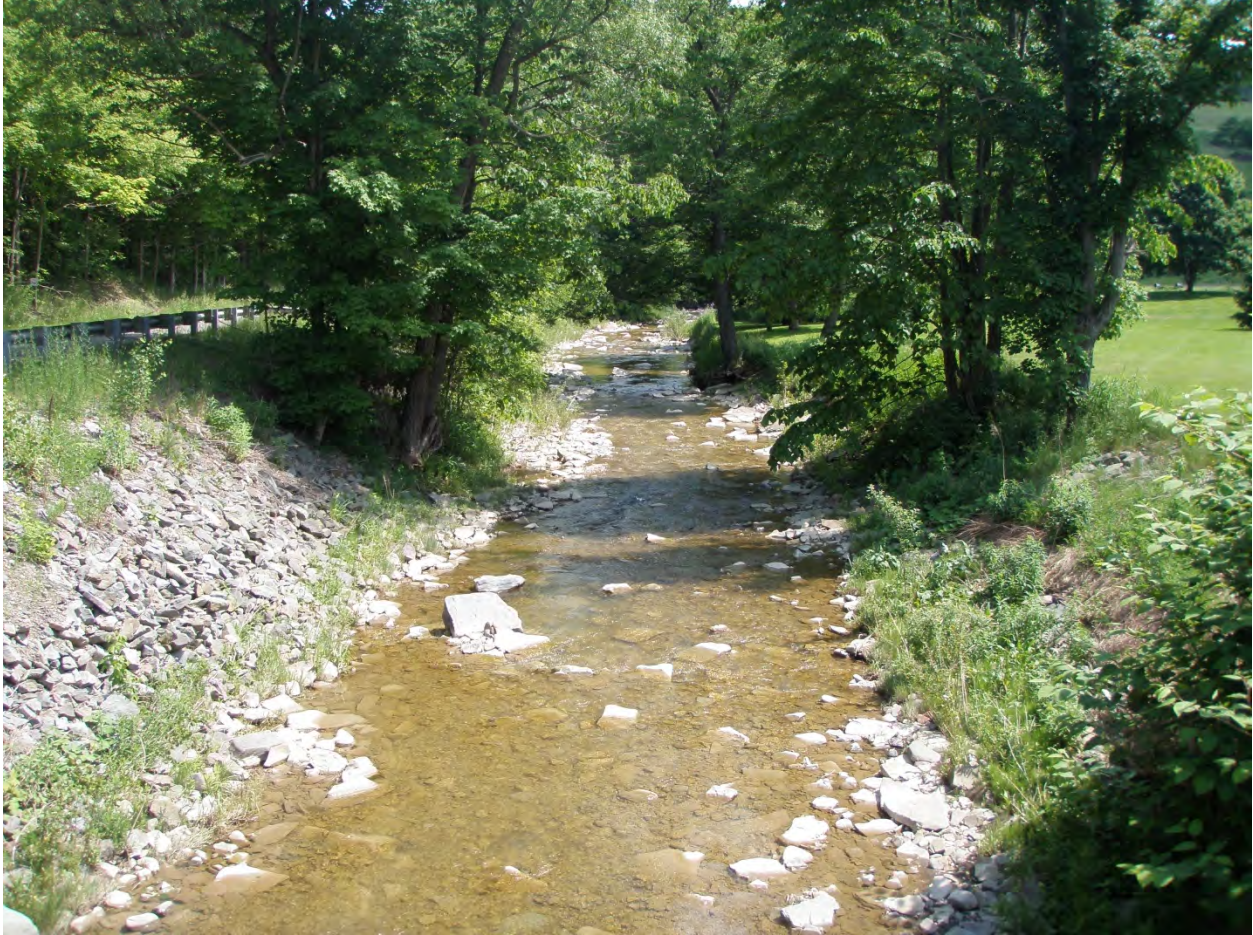
Redhouse Run/Beagle Hollow (REDH)

Redhouse Run (Beagle Hollow) located near Osceola, Pa., received a biological condition rating of slightly impaired in 2011. The stream did have a measured pH value of 8.65 which is above the water quality standards of the state of New York. Available physical habitat was rated as supporting. Habitat areas of concern are primarily on the left descending bank which lies adjacent to Holden Brook Rd. SRBC staff noted a narrow riparian buffer and a lack of vegetative protective cover.

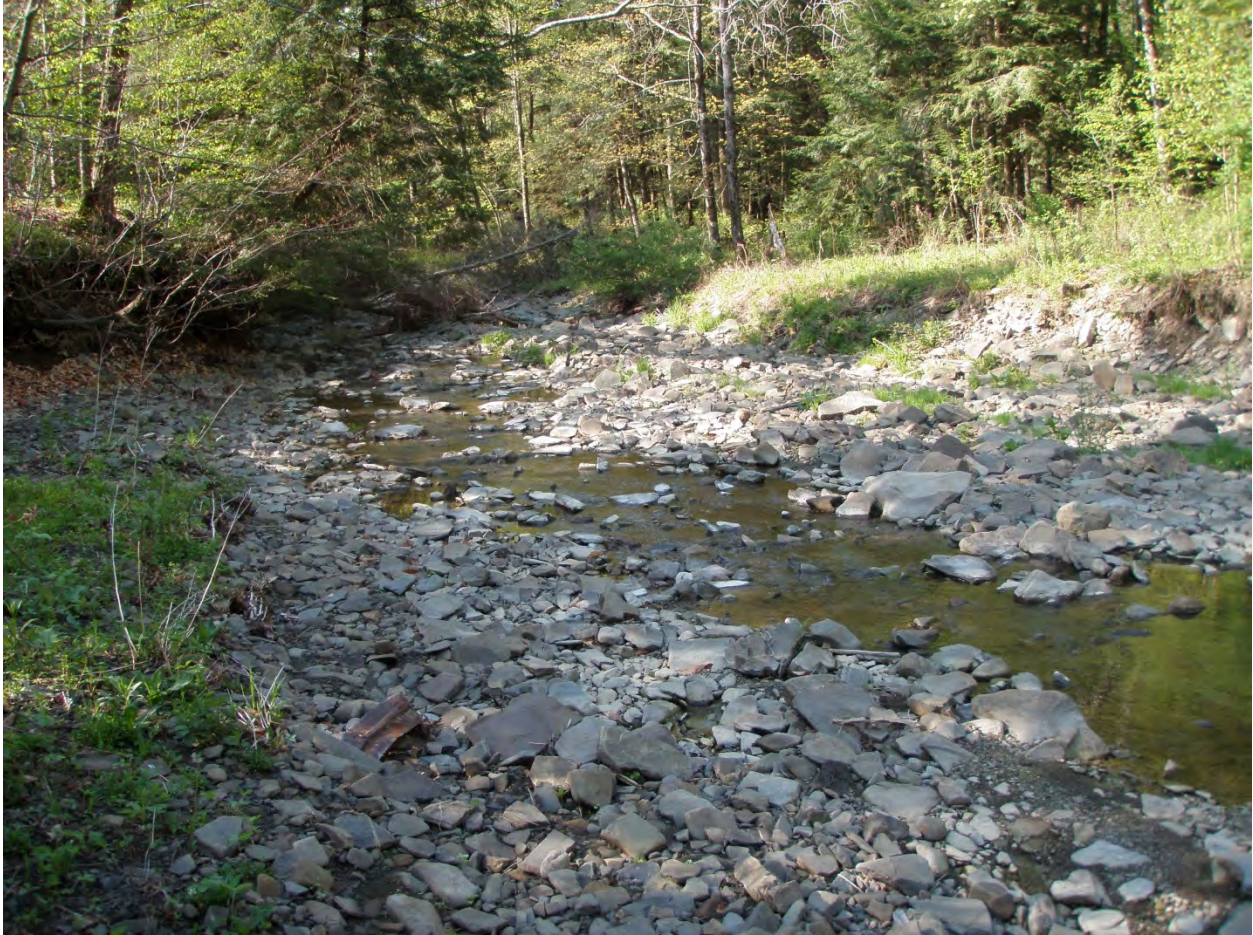
Russell Run (RUSS)

Russell Run near Windham, Pa., had a moderately impaired biological community when sampled in May 2011. This designation represents declining conditions when compared to previous data. In May 2006, the biological community was rated as nonimpaired. Physical habitat remains designated as supporting and all measured water quality parameters tested within acceptable limits.

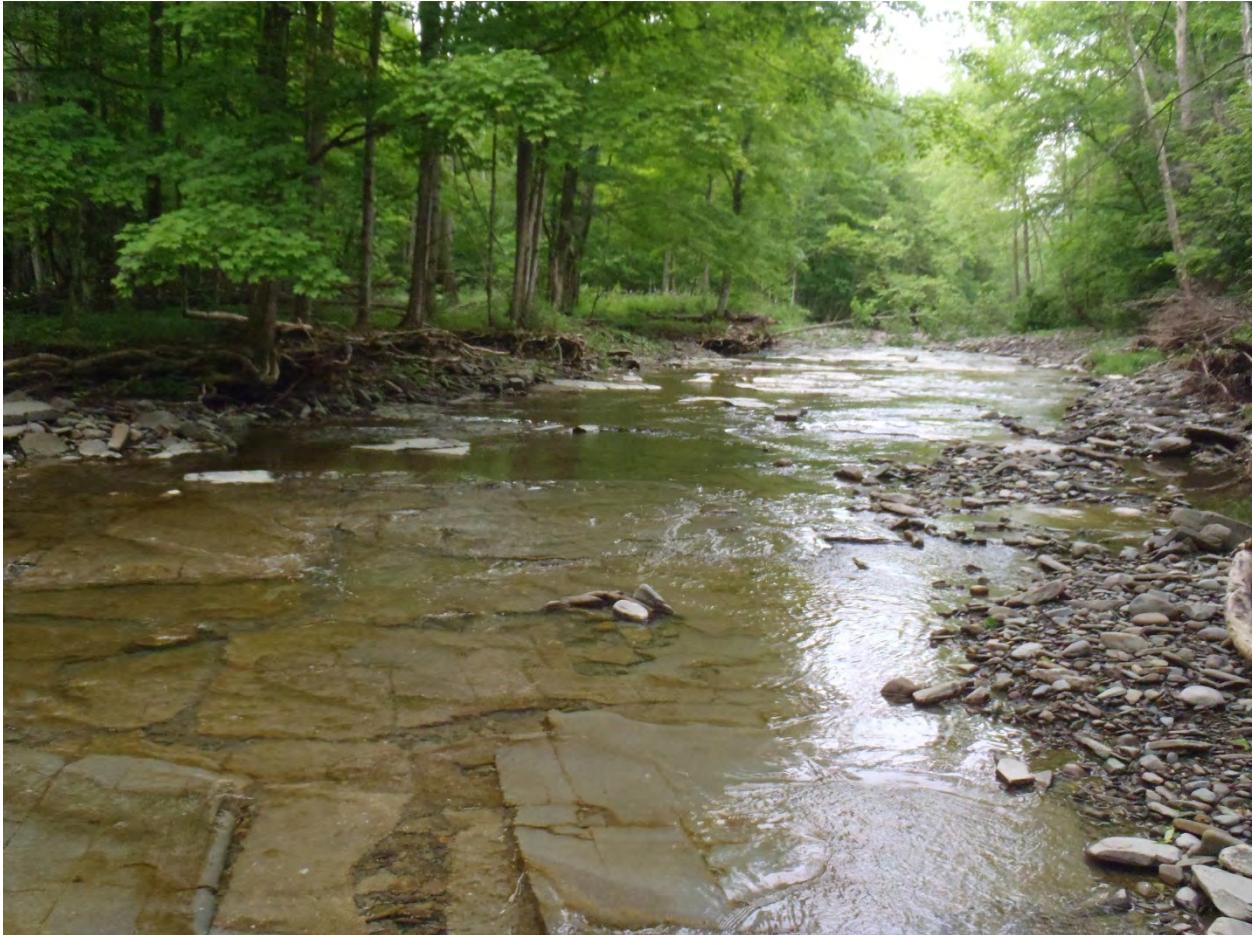
Sacket Creek (SACK)

SRBC staff surveyed Sackett Creek near Nichols, N.Y., in May 2011. The biological condition was rated as slightly impaired and available physical habitat was deemed supporting. Instream habitat features rated well, though the site appeared limited by unstable, eroding banks. Biological conditions were limited by few low taxonomic richness, particularly few EPT taxa. All measured water quality parameters tested within acceptable limits.

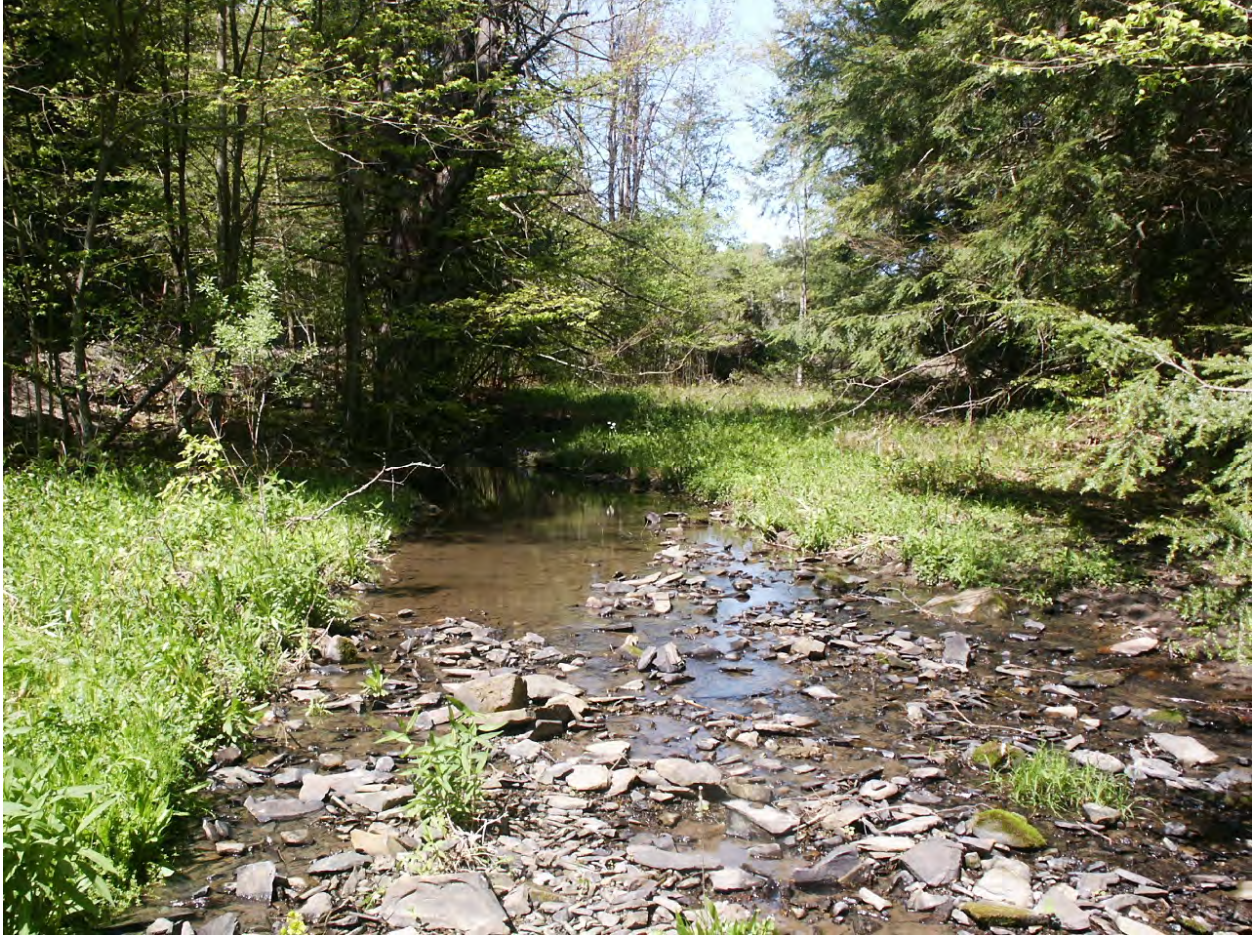
Smith Creek (SMIT)

Located near East Lawrence, Pa., Smith Creek was surveyed by SRBC staff in May 2011. In 2010, Smith Creek was designated as the reference site to which all other Group 3 streams were compared. While physical habitat remained excellent, the biological condition of the stream was rated as moderately impaired. It is noted that the macroinvertebrate sample for this site did not contain enough organisms for a quality subsample. Biological conditions reported in 2011 may not accurately reflect the condition of the stream. All measured water quality parameters tested within acceptable limits.

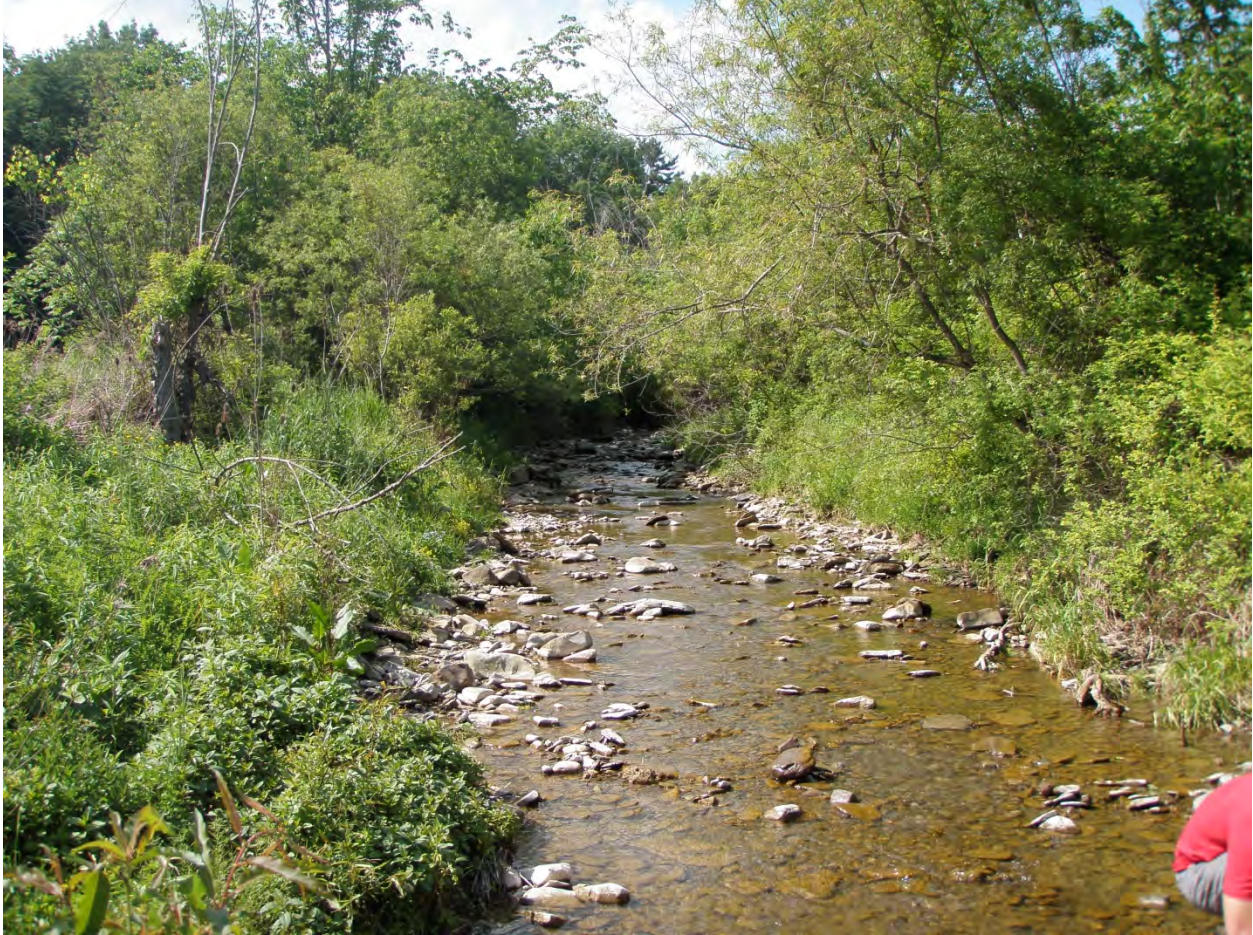
Strait Creek (STRA)

Possessing the highest biological condition score of all Group 3 streams in 2011, Strait Creek near Nelson, Pa., was designated as the reference stream to which all other Group 3 streams were compared. All measured water quality parameters tested within acceptable limits. Available physical habitat conditions continue to improve and were rated as excellent. In 2011, Strait Creek possessed the best combination of biological condition, water quality, and available physical habitat amongst all Group 3 streams.

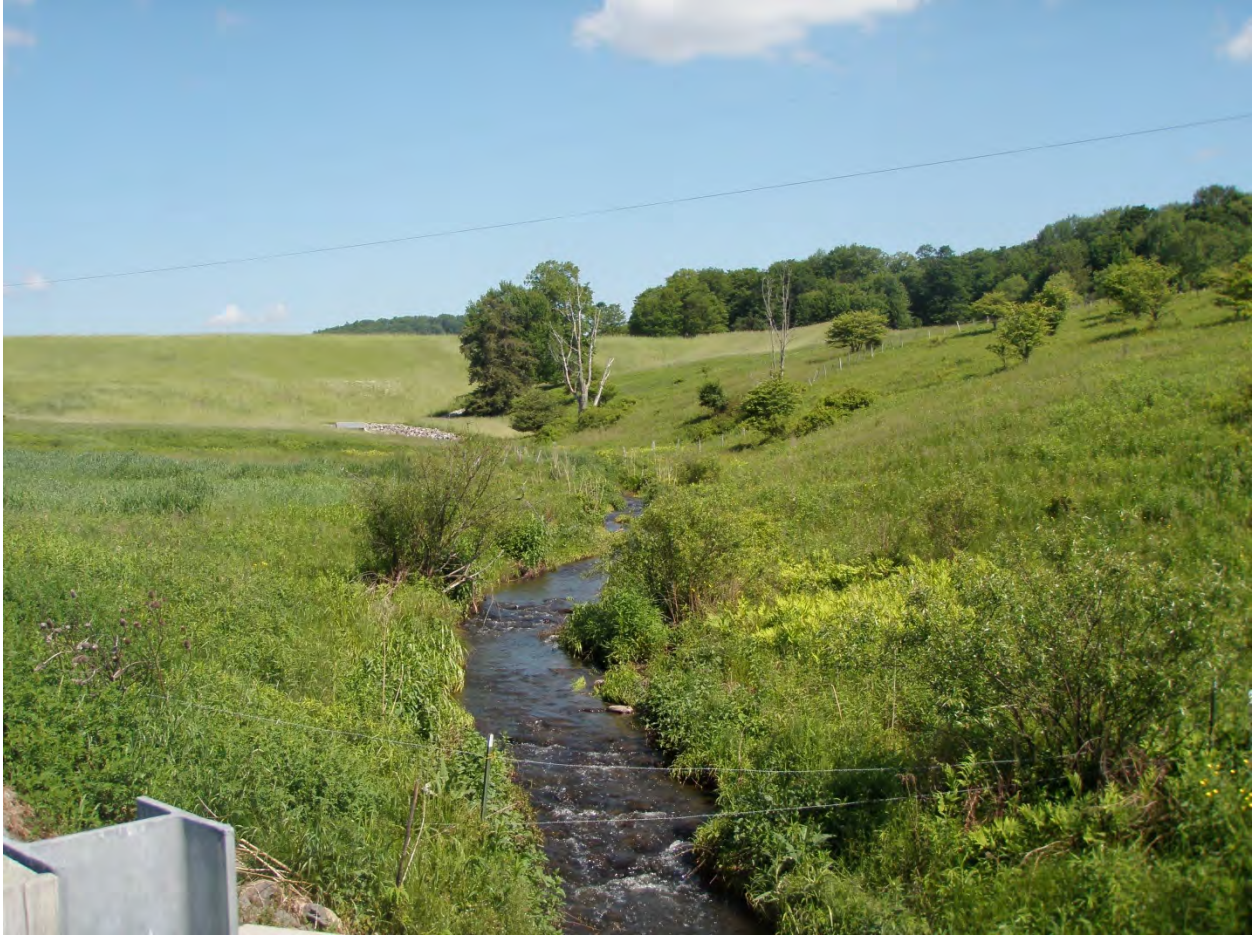
White Branch Cowanesque River (WBCO)

Located immediately downstream of a recently completed reservoir, the White Branch of Cowanesque River received a biological condition rating of severely impaired. This site is the only Group 3 stream to receive this designation. Water quality parameters were found to be within accepted limits but the presence of the reservoir upstream and associated impacts appears to be severely restricting the biological community of the stream at the sampling site. Physical habitat assessed downstream of the reservoir and its influence was rated as excellent.

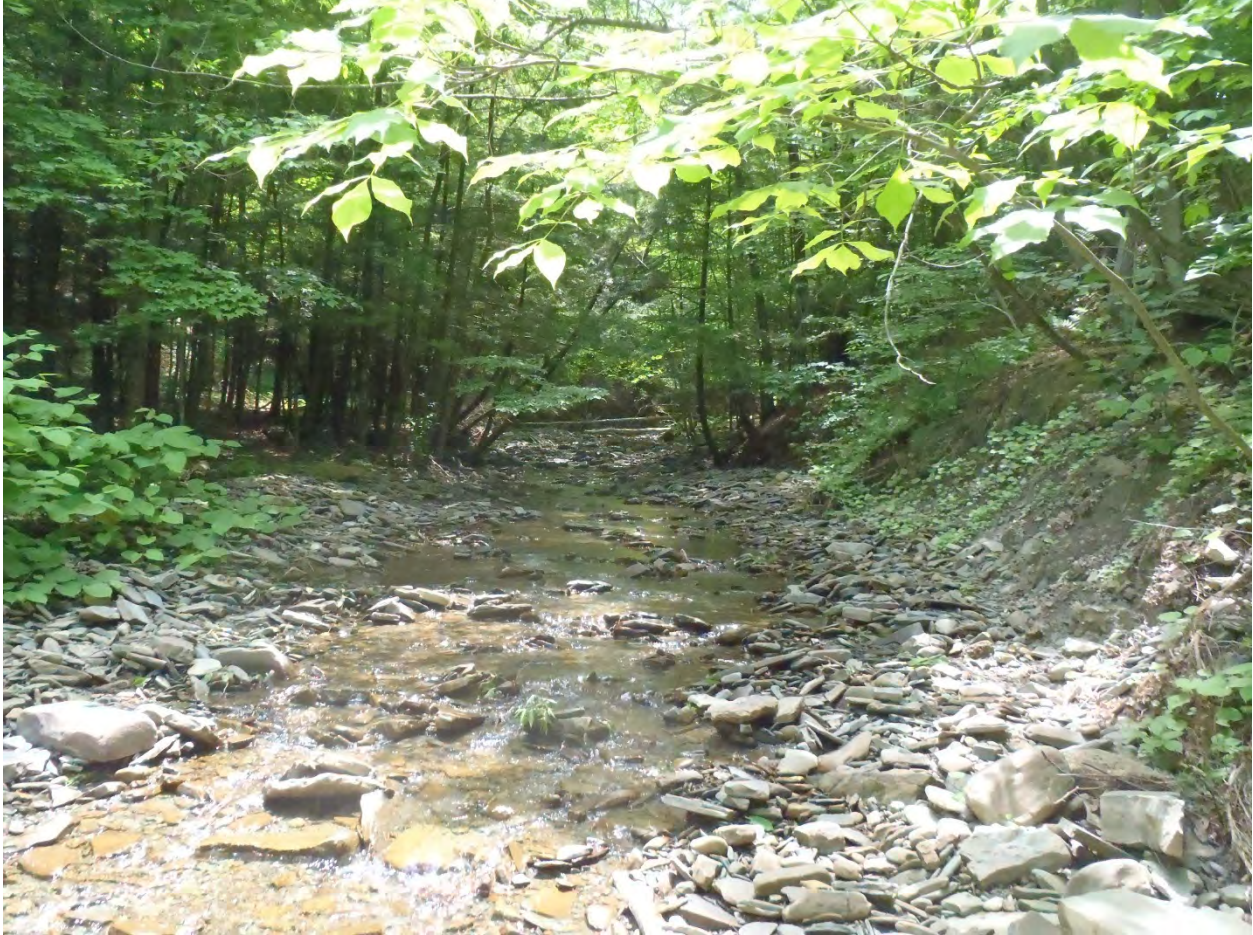
White Hollow (WHIT)

White Hollow, near Wellsburg, N.Y., received a biological condition rating of slightly impaired when sampled in May 2011. Available physical habitat was designated as excellent, featuring optimal riffle frequency and minimal channel alteration and embeddedness. Measured water quality parameters were all within acceptable limits.
