Chemung River Subbasin Year-1 Survey

Publication 287

A Water Quality and Biological Assessment June - July 2012

Report by Ellyn Campbell
Supervisor, Monitoring and Assessment

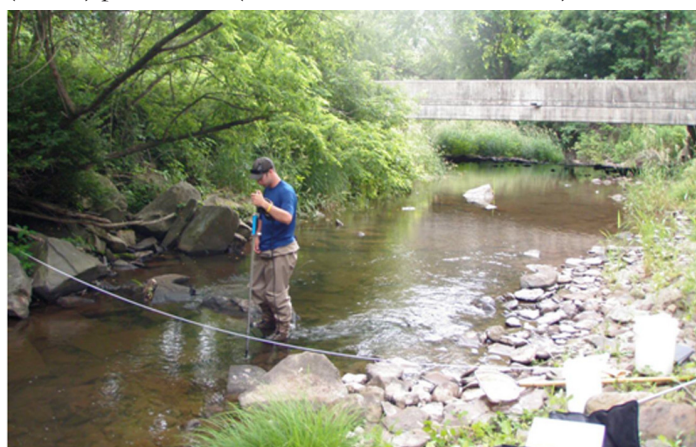
SRBC field staff measuring flow at Hills Creek at Crooked Creek, Pa. (HILL 0.2).

At each site visit, SRBC staff measured instream field chemistry while collecting water samples for laboratory analysis of parameters listed in Table 1. In light of more recent hydraulic fracturing activities within the region, SRBC began sampling parameters in 2012 that are indicators of these activities (i.e., bromide, barium, lithium, strontium, and gross alpha and beta) at select mainstem sites. Staff measured all field chemistry parameters (i.e., temperature, conductivity, pH, and dissolved oxygen) simultaneously using a multi-meter sonde. Staff rinsed the probes of all meters with distilled water and sample water prior to collecting water quality data and calibrated the sonde as detailed in the Quality Assurance Project Plan (QAPP). Staff used a FlowTracker and standard U.S. Geological Survey (USGS) procedures (Buchanan and Somers, 1969) to measure

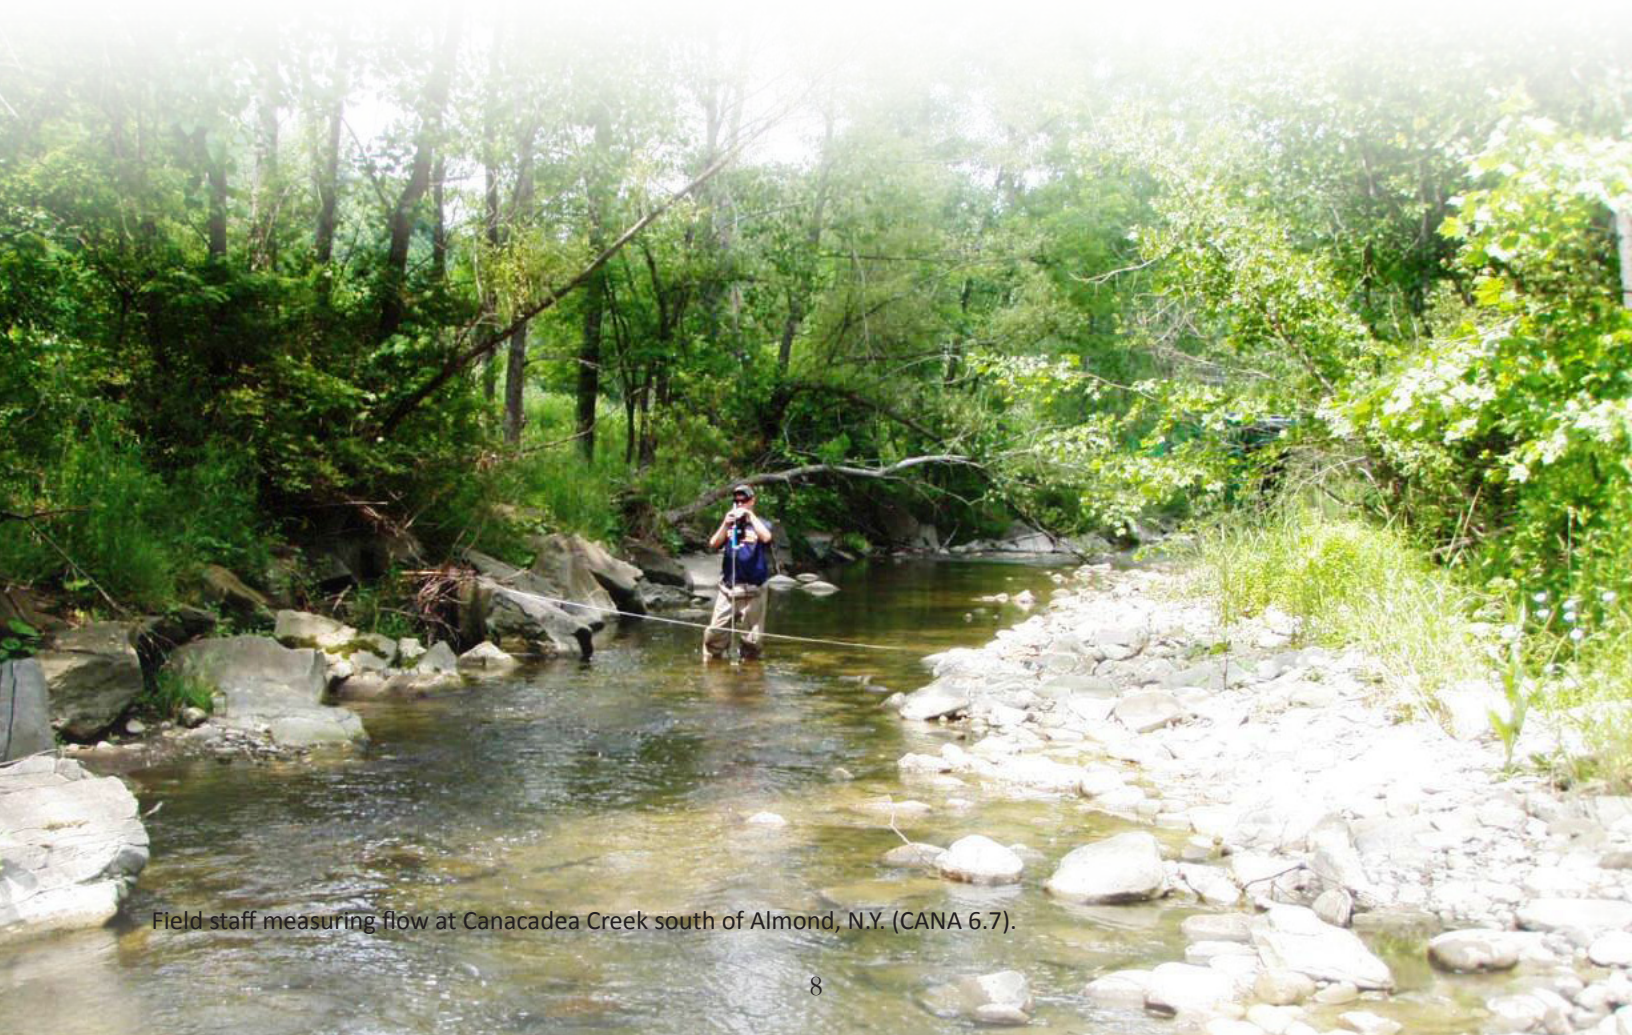
Field staff measuring flow at Canacadea Creek south of Almond, N.Y. (CANA 6.7).

SRBC assessed three sites in the Canacadea Creek Watershed—two sites on Canacadea Creek (CANA 1.7 and CANA 6.7) and one site on Karr Valley Creek (KARR 0.1). The most upstream site (CANA 6.7) had a slightly impaired biological community and excellent habitat, but it had lower water quality due to elevated total dissolved solids, nitrate, nitrogen, orthophosphate, and the second highest level of total sodium. The downstream site (CANA 1.7) had a moderately impaired community, supporting habitat, and middle water quality resulting from elevated total sodium. Karr Valley Creek (KARR 0.1), which is a tributary to Canacadea Creek, had a nonimpaired biological community, supporting habitat, and middle water quality resulting from elevated total sodium. SRBC assesses Canacadea Creek near Almond, N.Y., as part of the RWQMN project and has documented high levels of sodium through monitoring as part of that project.

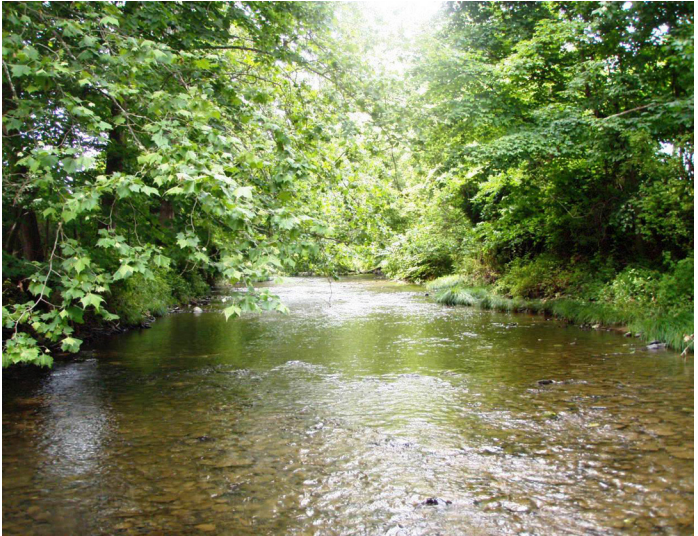
Canisteo River near mouth in Erwins, N.Y. (CNST 55.0) was one of seven sites that had the ideal combination of nonimpaired macroinvertebrate communities, excellent habitat, and higher water quality.

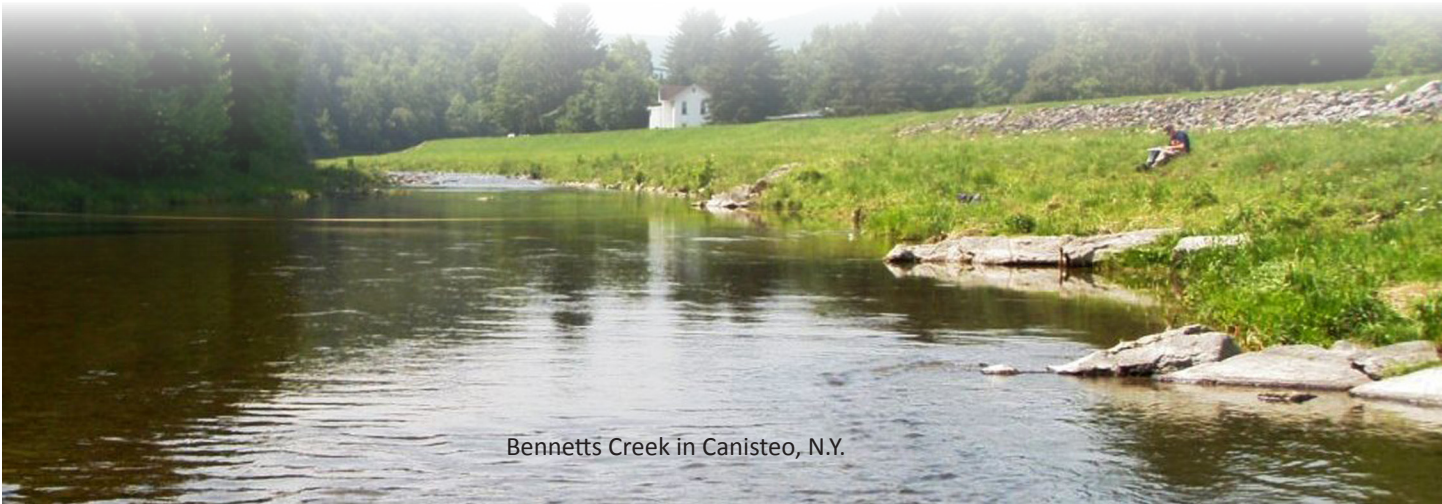
Bennetts Creek in Canisteo, N.Y.

Other Canisteo River tributaries sampled as part of this survey include Bennetts Creek (BENN 8.3 and BENN 1.2), Purdy Creek (PURD 0.3), and Colonel Bill's Creek (COLB 0.8). Bennetts Creek sites were either slightly impaired or nonimpaired and had excellent water quality. While the upstream Bennetts Creek site (BENN 8.3) had supporting habitat, the presence of an upstream dam at the downstream Bennetts Creek site (BENN 1.2) affected instream habitat and flow regimes and resulted in a partially supporting rating. While Purdy Creek (PURD 0.3) and Colonel Bill's Creek (COLB 0.8) both had higher water quality and slightly impaired communities, only PURD 0.3 had supporting habitat. COLB 0.8 had nonsupporting habitat resulting from a gravel-collecting operation, which is affecting the instream and riparian integrity of the stream.

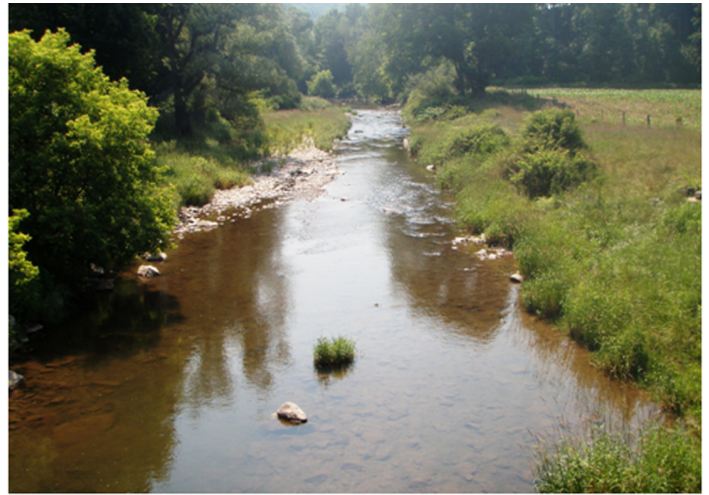
Downstream view of the Cowanesque River at Westfield, Pa. (COWN 29.6).

This watershed is mostly forested and agricultural land cover with small towns and villages. The overall quality of the entire watershed was good, with 37 percent of sites having nonimpaired biological communities and 50 percent having slightly impaired communities. Thirteen percent of sites had moderately impaired communities, and no sites had severely impaired communities. Thirteen percent of the sites had excellent habitat, with supporting habitat conditions at 37 percent of sites. The remaining 50 percent had partially supporting habitat conditions. All of the sites had higher water quality designations, with no water quality parameters exceeding levels of concern.

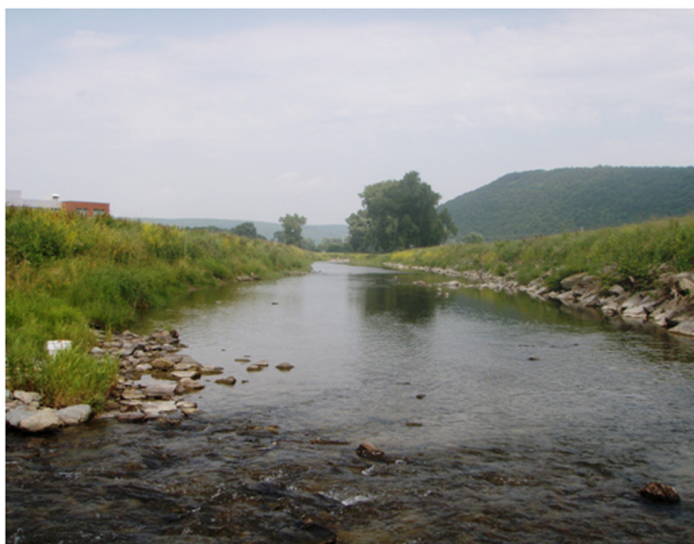
The downstream Tuscarora Creek site (TUSC 0.4) had a nonimpaired community, supporting habitat, and middle water quality resulting from the highest total nitrogen concentration (4.3 mg/l) seen in the study.

elevated total sodium. The downstream site (TUSC 0.4) had a nonimpaired community, supporting habitat, and middle water quality resulting from the highest total nitrogen concentration (4.3 mg/l) seen in the study. One site on the North Branch Tuscarora Creek (NBTC 0.3) had a nonimpaired community, supporting habitat, and higher water quality. SRBC assesses Tuscarora Creek near Woodhull, N.Y., as part of the RWQMN project. Year-1 results at TUSC 12.9 are consistent with the results observed during RWQMN monitoring of Tuscarora Creek.

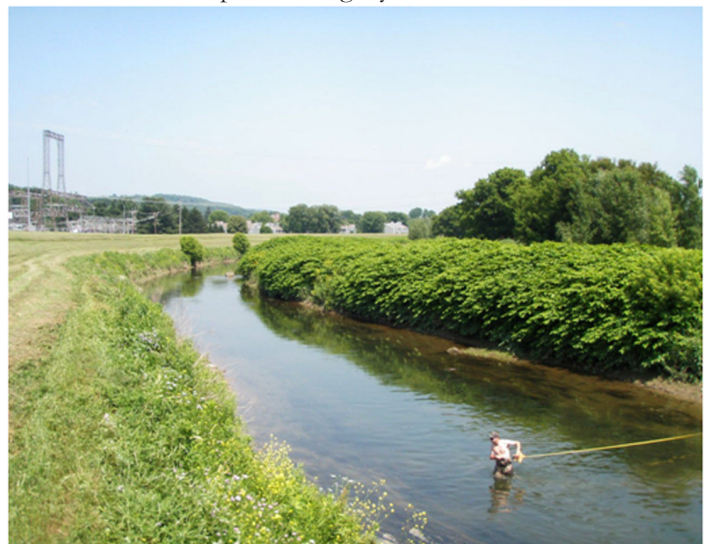
Upstream view of Canisteo River in South Hornell, N.Y. (CNST 38.7). This site also had the highest total nitrate level in the study at 2 mg/l.

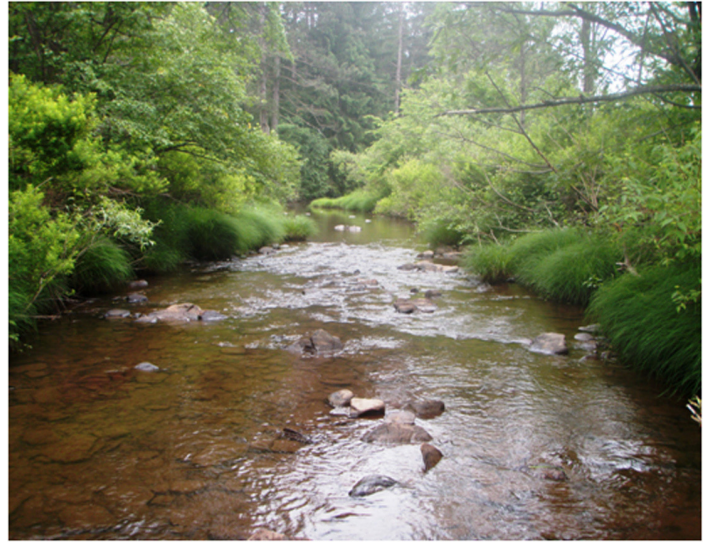
Downstream view of the Tioga River near Chases Mills, Pa. (TIOG 49.2). This site had a nonimpaired community, but the density of organisms at this site and all of the Tioga River sites was much lower than at sites on any other sampled stream within the subbasin.

SRBC located seven sites along the Tioga River mainstem, 24 miles of which are impaired by mine drainage (PADEP, 2012). Located above the mine drainage influence, the most upstream site (TIOG 49.2) reflected good headwater conditions including supporting habitat and higher water quality. TIOG 49.2 had a nonimpaired community, but the density of organisms at this site and all of the Tioga River sites was much lower than at sites on any other sampled stream within the subbasin.

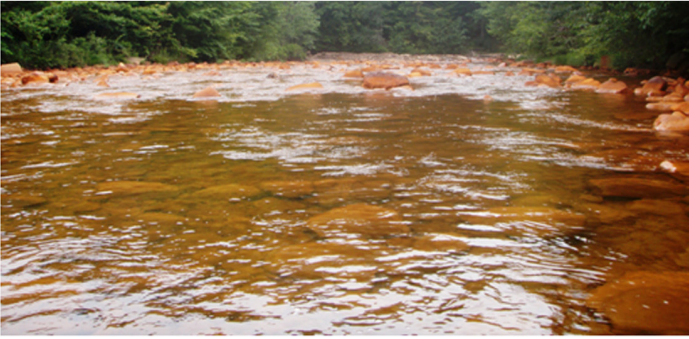
Upstream view of the Tioga River near Mansfield, Pa. (TIOG 29.8)

Mine drainage influences these two tributaries of the Tioga River. Extremely low diversity, lack of EPT taxa, and a dominance of pollution-tolerant midges were found in these severely impaired communities.

Once mine drainage begins to influence the Tioga River, the biological communities begin to deteriorate from moderately (TIOG 42.3) to severely impaired (TIOG 39.6, TIOG 35.4, and TIOG 29.8) because of extremely low diversity, a lack of EPT taxa, and a dominance of pollution-tolerant midges. Three of these four sites had supporting habitat and middle water quality resulting from elevated total aluminum and depressed pH and alkalinity levels, including the lowest alkalinity level (1 mg/l) at

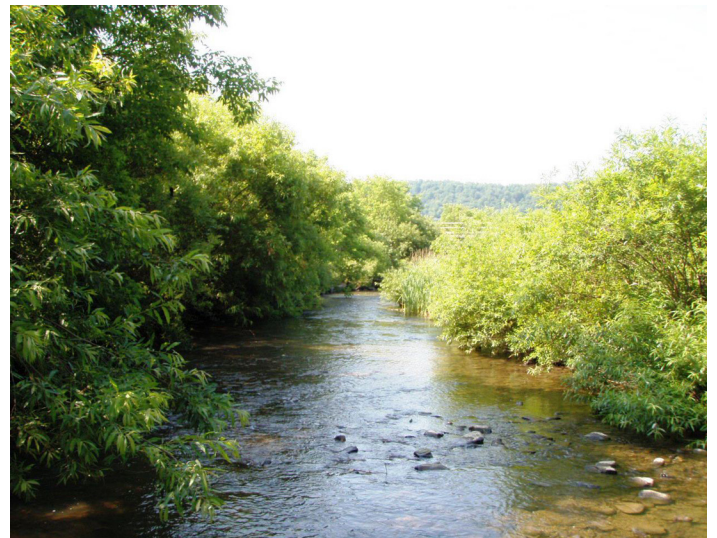
Upstream view of Twelvemile Creek at Wallace, N.Y. (TWVE 0.5). Twelvemile, Tenmile, and Five Mile Creeks had nonimpaired communities, either supporting or excellent habitat, and middle or higher water quality.

Twelvemile, Tenmile, and Five Mile Creeks drain the northeastern portion of the Cohocton River Watershed. All three sites had nonimpaired communities, either supporting or excellent habitat, and middle or higher water quality. Middle water quality at Twelvemile Creek (TWVE 0.5) and Five Mile Creek (FMIL 1.1) resulted from elevated nitrate and total nitrogen, but FMIL 1.1 also had elevated total sodium. TWVE 0.5 functioned as a 2012 reference site for the Ecoregion 60s classification.

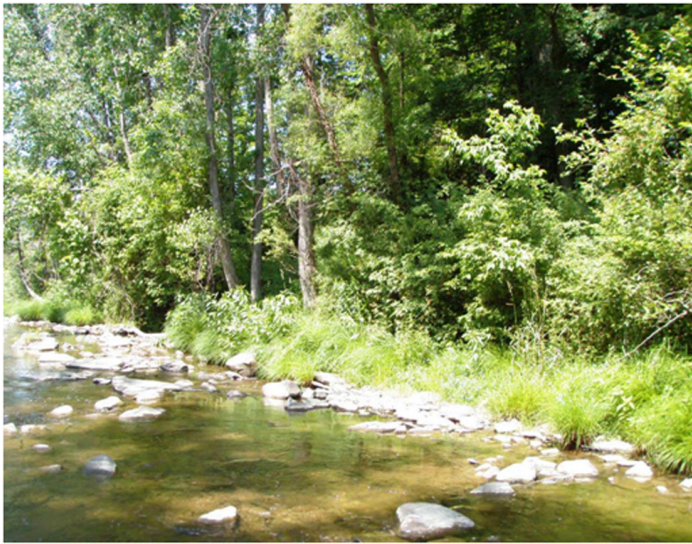
Campbell Creek near Knight Settlement, N.Y. (CMBL 0.1). This site had nonimpaired communities and excellent habitat.

Goff Creek, Campbell Creek, and Stocking Creek enter the Cohocton River from the west around its mid-point. GOFF 3.1 had a moderately impaired biological community from low EPT diversity and a dominance of pollution-tolerant midges, supporting habitat, and middle water quality from elevated total nitrate, nitrogen, and sodium. Campbell Creek (CMBL 0.1) and Stocking Creek (STOK 0.3) both had nonimpaired communities and higher water quality, while CMBL 0.1 had excellent habitat, and STOK 0.3 had supporting habitat.

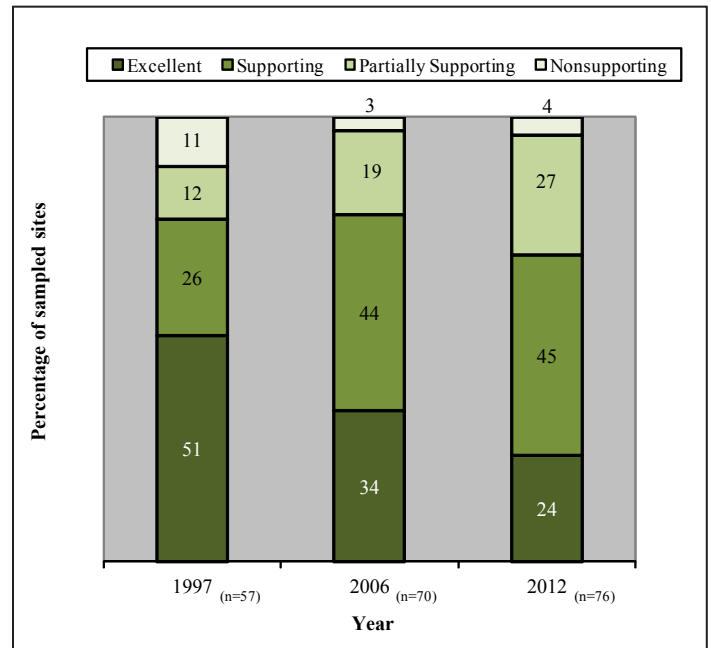
Figure 9. Historical Habitat Condition Categories Among Sampled Sites in the Chemung Subbasin Surveys

Throughout the basin, the percentage of sites having excellent habitat continually decreased from 1997 through 2012 while the percentages of sites with supporting habitat continually increased from 1997 to 2012 (Figure 9). The total percentages of sites with combined excellent and supporting habitat in 2012 (69 percent) was less than the 77 and 78 percent observed in 1997 and 2006, respectively. The percentage of partially supporting habitat steadily increased from 1997 to 2012. The percentage of sites with nonsupporting habitat was highest in 1997 before dropping to levels seen in both 2006 and 2012. Making comparisons between habitat assessments between sampling event years is difficult due to inherent variability in scoring judgments.

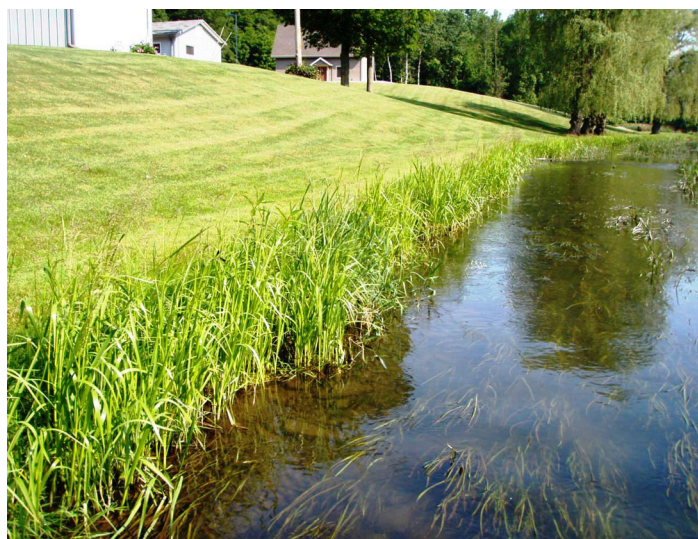
Cohocton River north of Cohocton, N.Y. (COHO 37.5). This site is an example of poor vegetation along the banks, which are mowed nearly to the water's edge. Many of the poor habitat ratings in this survey resulted from inadequately vegetated riparian zone widths.

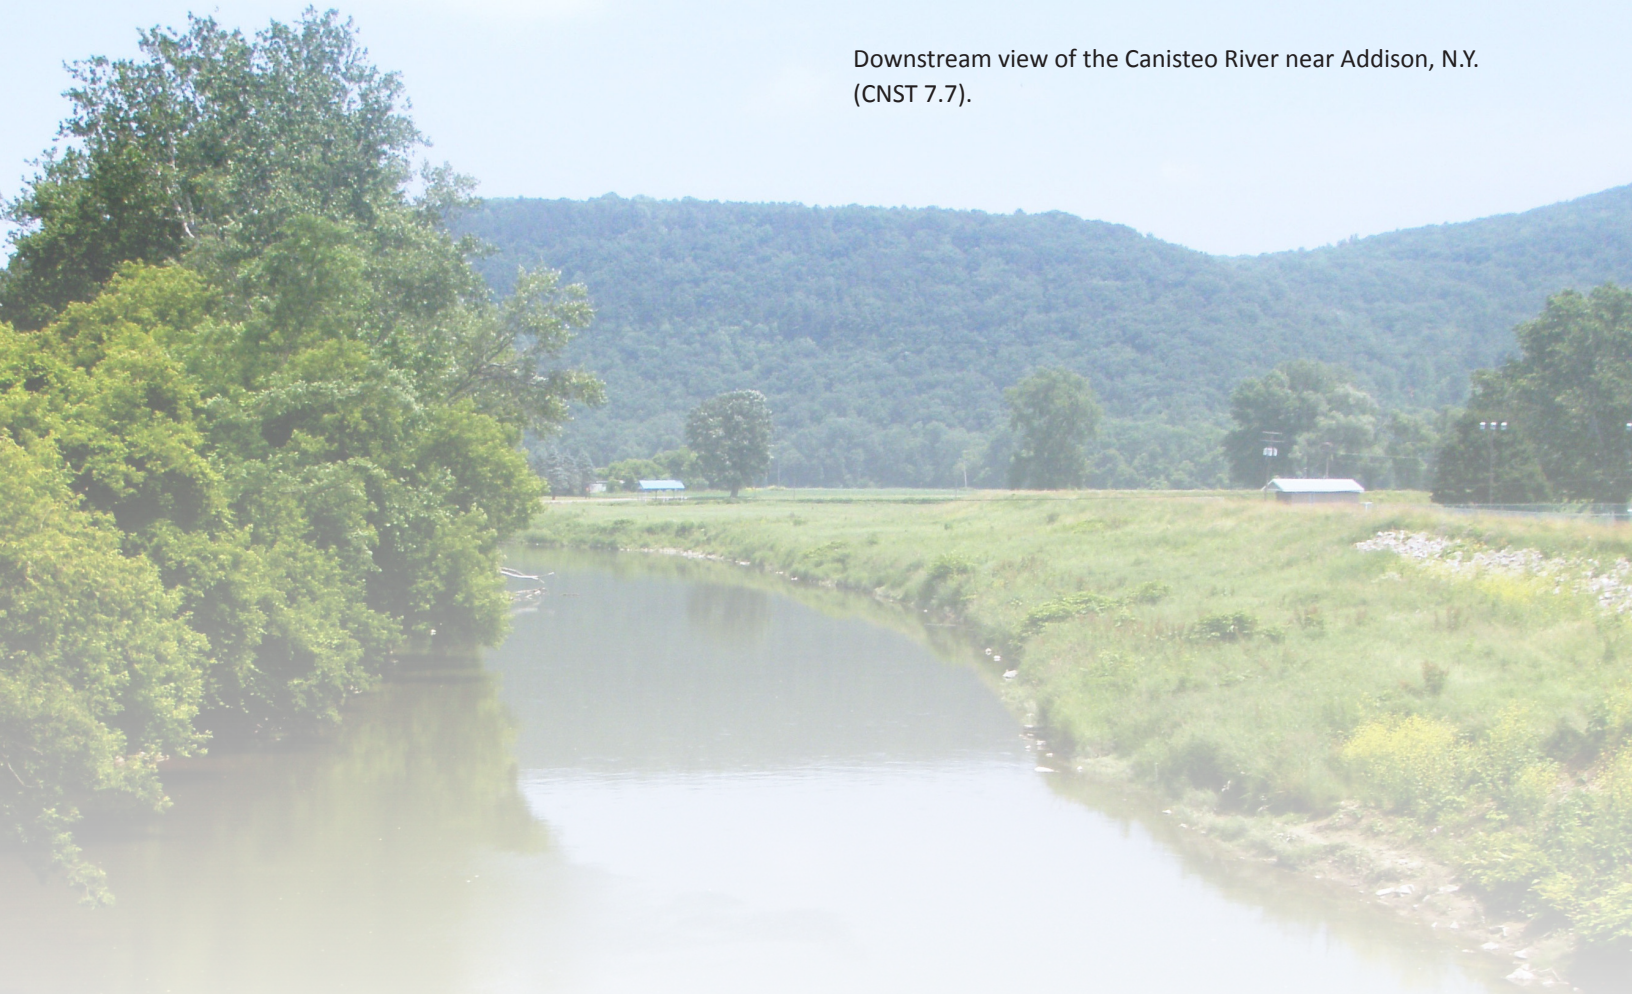
Downstream view of the Canisteo River near Addison, N.Y. (CNST 7.7).

Five of the six sites on the mainstem Canisteo River (CNST 55.5, CNST 33.0, CNST 22.6, CNST 7.7, and CNST 1.0) had either slightly impaired or nonimpaired communities and either excellent or supporting habitat. CNST 1.0 functioned as a 2012 reference site for the Ecoregion 60L classification. The site CNST 38.7 was located just downstream of the urban area of Hornell, N.Y., had a moderately impaired community from a dominance of pollution-tolerant midges, and had nonsupporting habitat from poor substrate quality and riparian conditions.

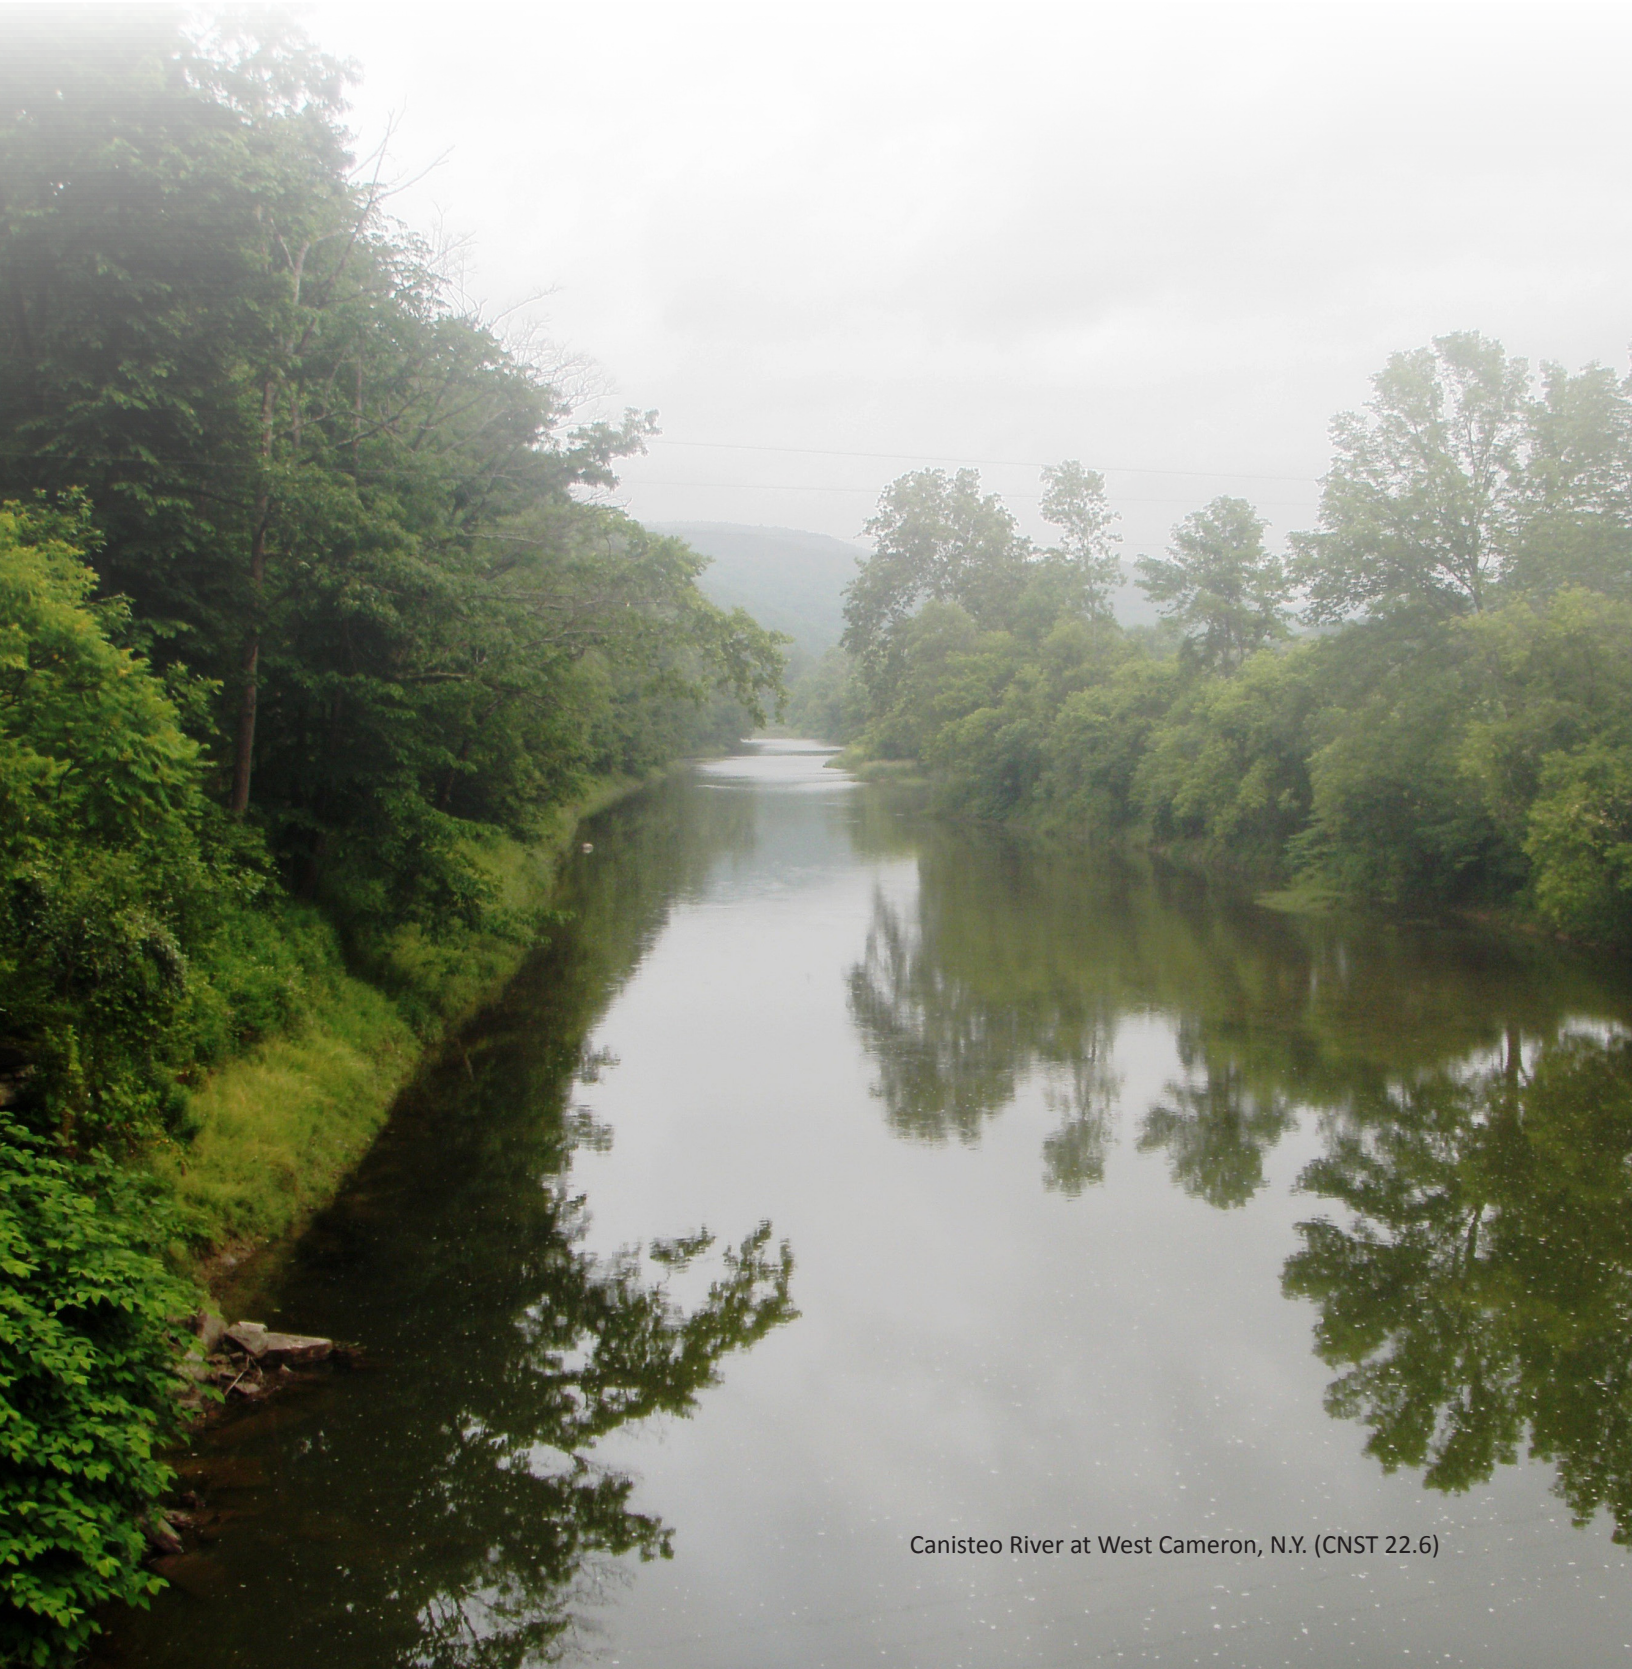
Canisteo River at West Cameron, N.Y. (CNST 22.6)
