Large River Monitoring Technical Report 2020-2022

Publication No. 335

October 2023

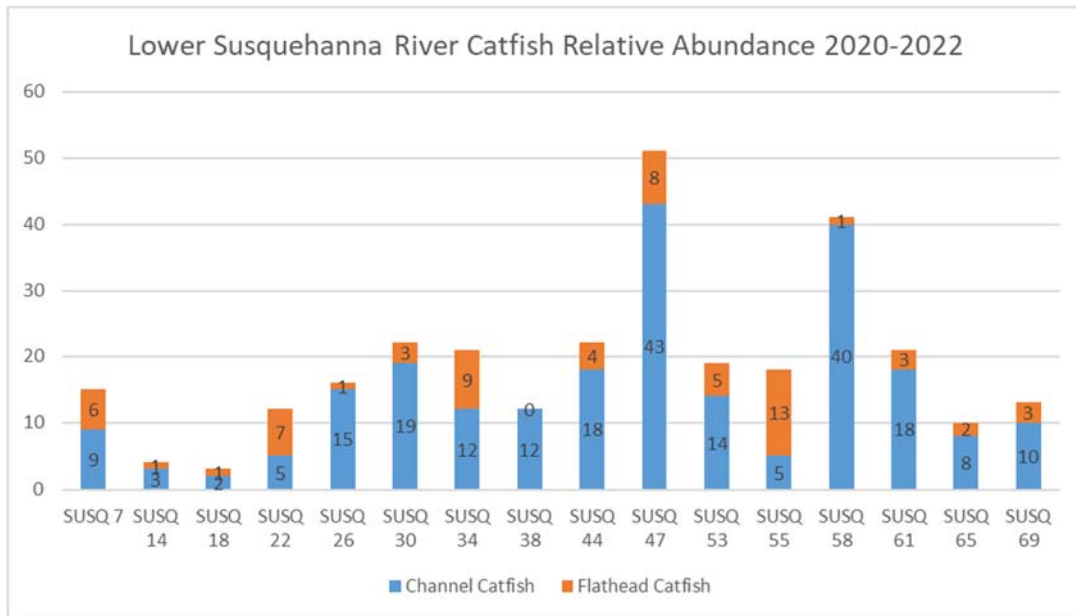
Figure 3. Relative Catfish Abundance in the Lower Susquehanna River 2020-2022

in the area. Flathead catfish, another non-native species first detected in this section of river 20 years ago, was distributed throughout the study area. Flathead catfish were collected at all sites except SUSQ 38. Of the 301 Ictalurids captured throughout this study, channel catfish comprised 77% of the total sample compared with flathead catfish comprising 22% (Figure 3). Multiple age classes of flathead catfish were documented including several large adults weighing in excess of 20 kilograms (Photo 6).

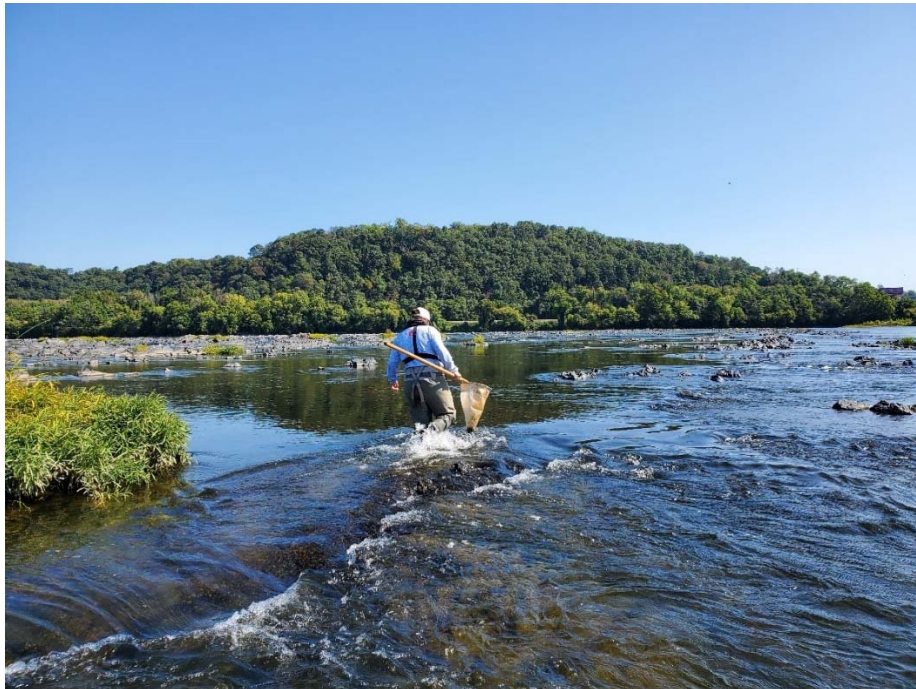
Photo 2. Staff collecting macroinvertebrates at riffle created by water gap at SUSQ 44

Macroinvertebrate samples were successfully collected at 100% of free-flowing wadeable sites utilizing the D-frame net. Over the course of the study, 58 D-frame samples were collected with 29 (50%) supporting aquatic life use (Table 4). Sites SUSQ 7, SUSQ 61A, and SUSQ 69C never received a supporting life use score. Only 75% of passive Hester-Dendy samplers were ultimately recovered. Of those able to be recovered, 28% did not possess a significant enough number of animals to generate an estimated assessment score.

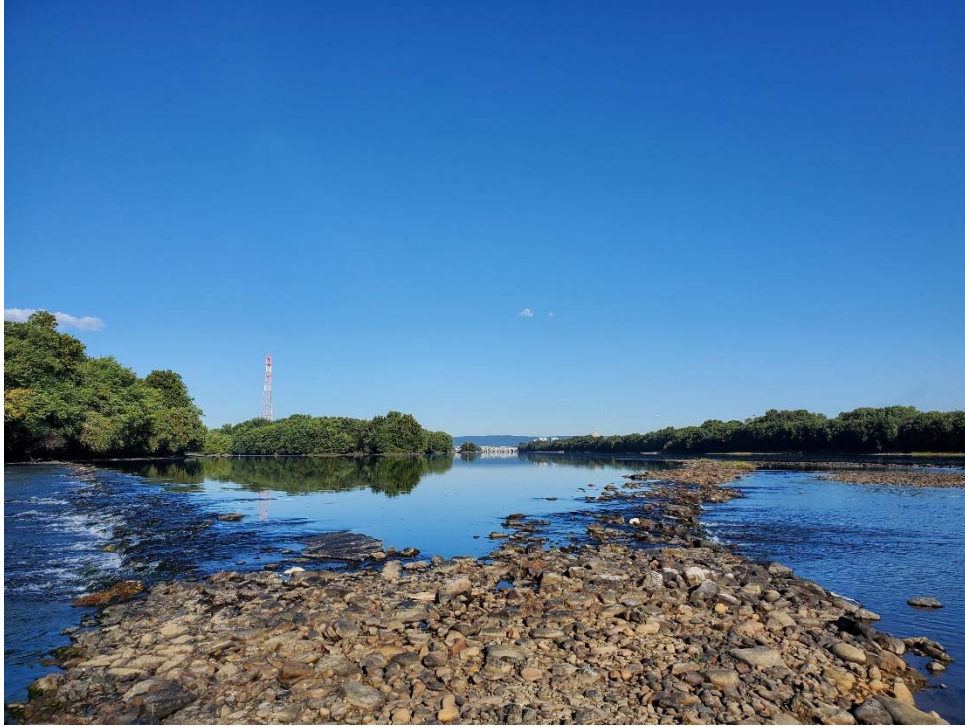
Photo 3. Riffle habitat created at site of former fishing weir under low flow conditions at SUSQ 69

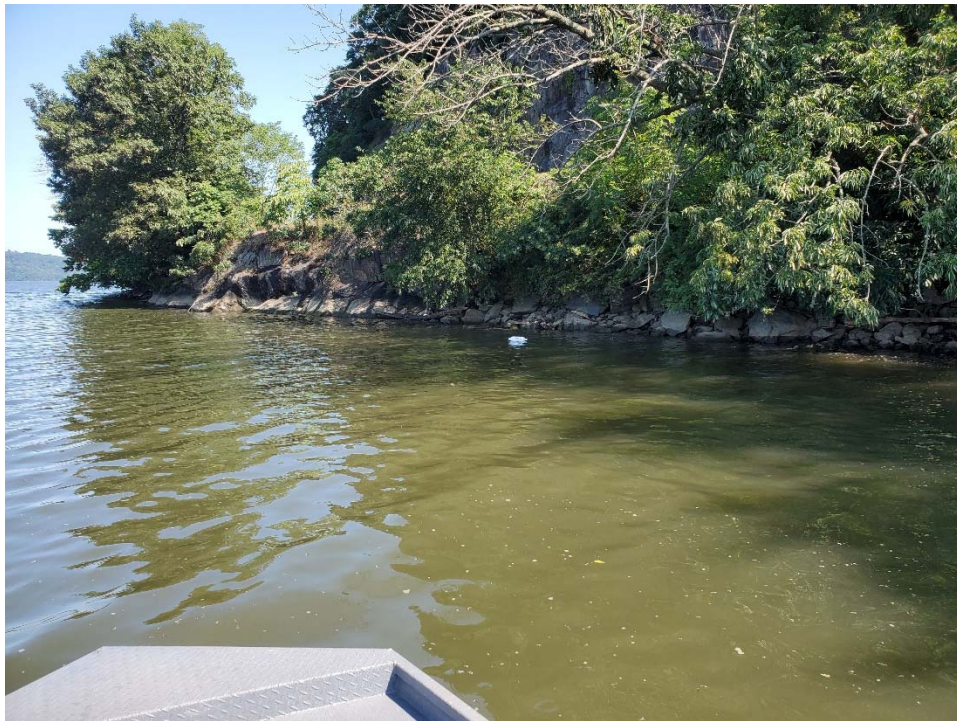
Photo 4. SUSQ 14C Hester-Dendy deployment buoy along steep eastern bank

Habitat conditions varied greatly throughout the study reach. The sites impounded by Conowingo, Holtwood, and Safe Harbor Dams (SUSQ 14 through SUSQ 38) possessed similar conditions with steep banks typically comprised of exposed boulders or large cobble (Photo 4). The Western shoreline throughout this reach was mostly forested with ample riparian corridors but sporadic adjacent development. The Eastern shore possesses similar substrates but with more artificial grading along the bank due to the presence of railroad tracks running adjacent to the river from Wrightsville, PA, to Conowingo, MD. Within the impounded site group, SUSQ 22 possessed unique island habitats consisting of massive boulder and bedrock outcroppings resembling river conditions pre-hydroelectric development (Photo 1). SUSQ 58, classified as impounded due to its location behind York Haven Dam, deviated from other impounded sites due to the relatively minor hydrologic alteration created by the facility. River flows in excess of 17,000 cfs are spilled over this dam along its 2.5 km long dam face. Pool depth behind the dam seldom exceeded 2.5 meters and slack water diminished 5 km upstream of the dam. Conversely, Safe Harbor Dam created a non-wadeable pool that exceeded 18 km with measured depths that routinely exceeded 7 meters.

Hester-Dendy samplers were found to be effective devices for obtaining macroinvertebrate assemblage data from the impounded and consequently deeper sites. Careful sampler placement within the river and sampler buoy markings were critical components of successful deployments. Hester-Dendy samplers placed in protected areas, lees of islands, protected coves, etc., were usually recovered. Placing samplers in at least two meters of water and affixing 3-4 meters of buoy line minimized the risk associated with unanticipated water level fluctuations. Concealing marking buoys as nondescript floats resembling debris or trash minimized tampering throughout the deployment. Using Hester-Dendy samplers throughout the impounded portions of the Susquehanna River is appropriate where water depths preclude safe wading and the likelihood of recoverability is high.

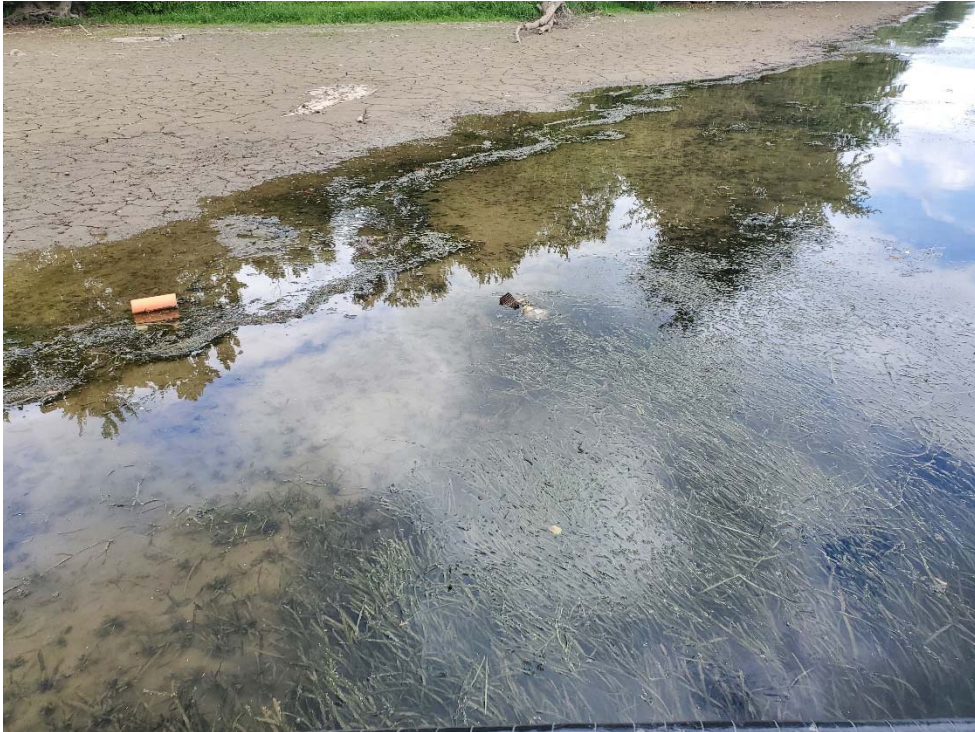
Photo 5. Partially desiccated Hester-Dendy sampler compromised by water level fluctuations at SUSQ 58

Sampling during the summer boating season (Memorial Day – Labor Day) is necessary as dam operators are required to maintain minimum pool elevations during this period. Outside of this window, greater surface water elevation deviations are permitted which severely limit the safe navigability of the impounded sections and subsequently inhibits the ability to consistently collect

representative samples. These fluctuations also have the ability to desiccate passive sampling gear such as the Hester-Dendy samplers or submerged continuous data loggers.
