Large River Monitoring Project
Lower Susquehanna River System
Interim Technical Summary (2021/Year 3)

Publication No. 329

November 2022

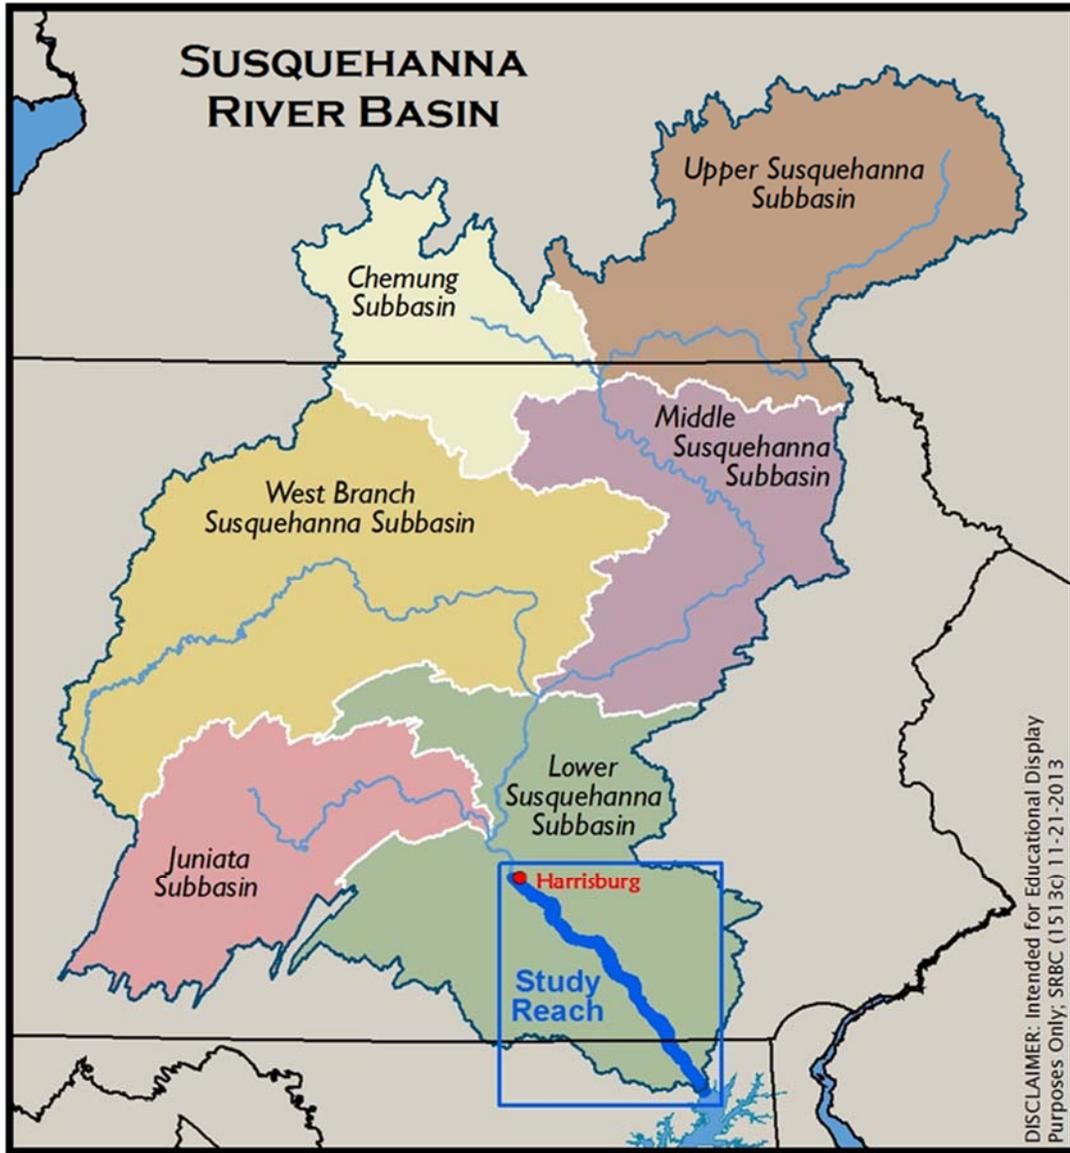
Figure 1. Lower Susquehanna River Study Area within the Susquehanna River Basin

The final 70 miles of the river (Lower Susquehanna River) is a unique transitional system, where the Susquehanna River leaves the Ridge and Valley ecosystem and enters the Piedmont ecoregion before flowing into the Chesapeake Bay. This Lower Susquehanna River system is affected by numerous anthropogenic activities including the presence of four man-made impoundments created by major hydroelectric dams (Figure 1):

1. Lake Frederick created by York Haven Hydroelectric Dam
2. Lake Clarke created by Safe Harbor Dam
3. Lake Aldred created by Holtwood Dam
4. Conowingo Pond created by Conowingo Hydroelectric Plant (furthest downstream)

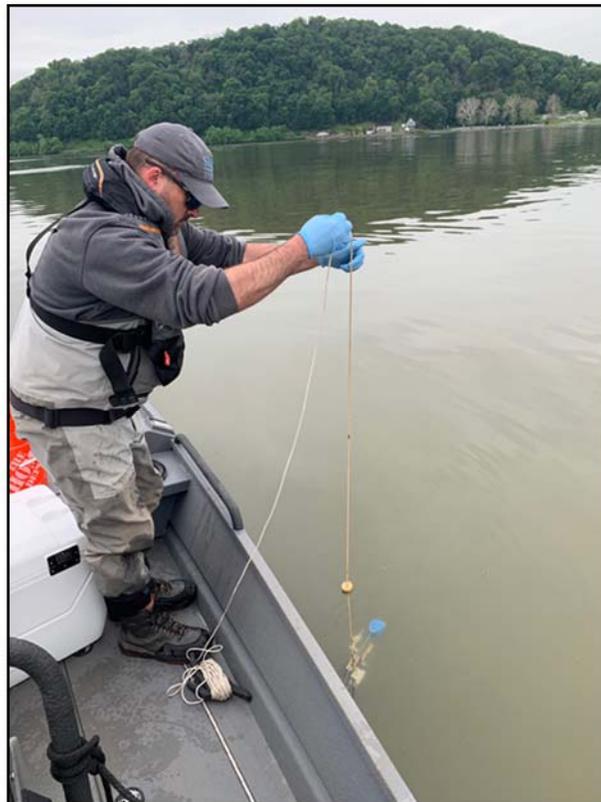
Figure 3. SRBC Staff Using a Van Dorn Sampler to Collect a Depth-integrated Sample

Water quality measurements of dissolved oxygen, turbidity, temperature, specific conductance, and pH were recorded using a field meter along both banks and at the channel midpoint. At impounded transects, a vertical profile was developed by taking these measurements at 1-m increments with a Van Dorn sampler (Figure 3). Water samples were sent to Pace Analytical for analysis of aluminum, iron, manganese, nitrate, orthophosphorus, phosphorus, total organic carbon, chloride, sodium, sulfate, turbidity, total dissolved solids, and total suspended solids.

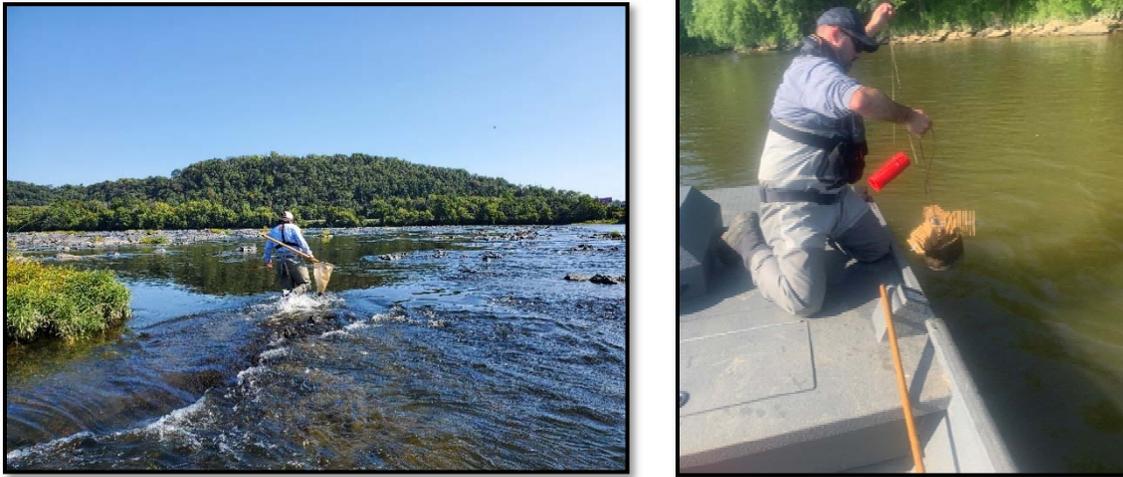
Figure 4. SRBC Staff Utilizing Habitat-specific Methodology to Collect Macroinvertebrates (A D-frame net (left) is used in a riffle at SUSQ 44 and a Hester-Dendy passive sampler (right) is set at SUSQ 22.)

Macroinvertebrate samples were successfully collected from 14 of 16 total sites (Figure 4). All eight free-flowing locations were sampled between August 3 and August 17. The macroinvertebrate data were analyzed with the PADEP Multimetric Index for Large Semi-wadeable Rivers (PADEP, 2018). The Summer SWMMI scores from these free-flowing locations range from 3.1 at SUSQ 7 to 81.4 along SUSQ 69 (Appendix D).

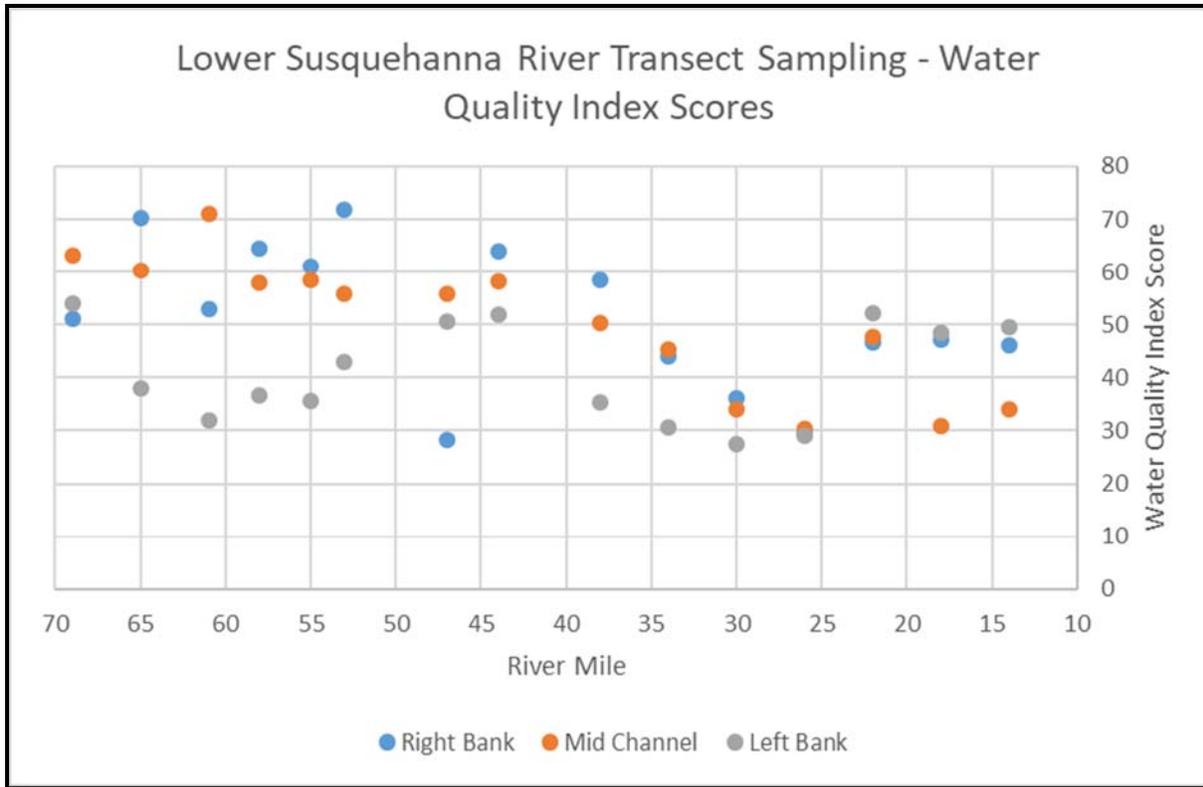
Figure 5. *Water Quality Index (WQI) scores from 2021 Large River sampling (Left Bank (grey), Mid Channel (orange) and Right bank (blue) samples)*

As previously shown in prior monitoring efforts, the water quality characteristics of the Susquehanna River showed considerable variation within a relatively narrow geographic reach. This variation effectively disappeared as the river becomes impounded in the vicinity of river mile 40 where the influence of Safe Harbor Dam is realized. Most WQI scores ranged from 30-70, and overall WQI scores trended lower as sampling progressed downstream (Figure 5). The left bank of the river generally experienced the lowest WQI scores until river mile 22, while the left bank had the highest WQI scores.

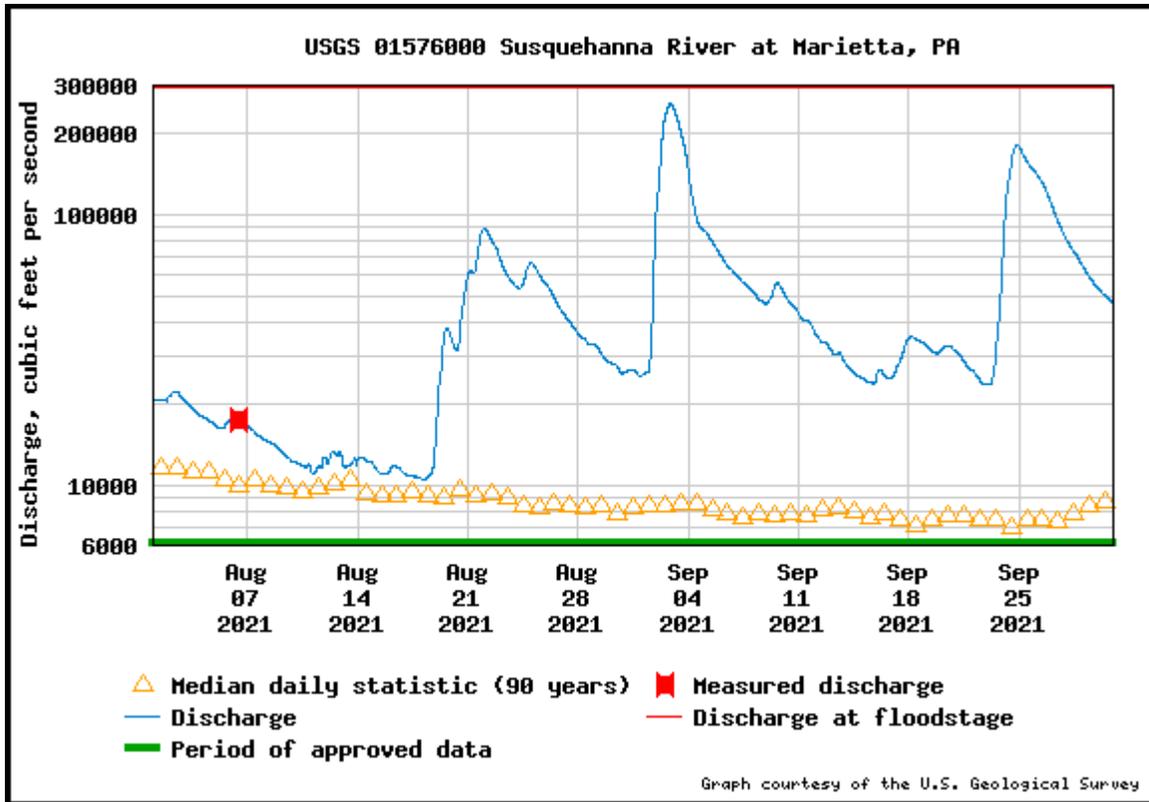
Figure 6. Discharge at USGS Gage at Marietta, PA, For the Study Period

During the 2021 sampling period (August–September), river flow was slightly above median conditions for much of August when the majority of samples were collected (Figure 6). A large basin-wide precipitation event in early September caused minor flooding and raised river level significantly above normal for the remainder of the month. Stable, yet sufficient enough river flows to provide safe boating depth were critical to completing the monitoring. Deployment of Hester-Dendy samplers proved difficult with multiple samplers being lost to high flows or theft/vandalism. Hester-Dendys must also be deployed at a sufficient water depth to anticipate possible desiccation from river level fluctuations caused by hydroelectric project operations. Typically Hester-Dendy samplers were deployed in at least 2 m of water to prevent desiccation from drawdowns.
