STORMWATER BMP SITES IN PAXTON CREEK WATERSHED

BMP Types: Centennial Acres Park Rain Garden & Stream Buffer

Centennial Acres Park Rain Garden

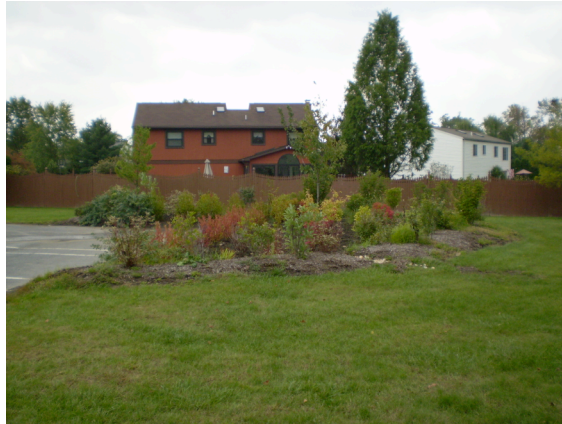
Site Features: The rain garden at Centennial Acres Park is designed to infiltrate and process (partially remove pollutants) from stormwater running from a small parking area that serves the park. The rain garden initially underperformed briefly, because of improperly amended site soils (too much clay for good drainage), and unexpected additional runoff associated with a clogged drain on Continental Drive, which ran excess runoff into the parking area. Road repairs and additional adjustments to the soils, and garden bed (deeper infiltration with a small spillway) solved the problem. Rain gardens do their work through actions of soils, vegetation, mulch, and other layers of materials. Expected pollutant removals in fully functioning rain gardens are approximately: total suspended solids (mainly dirt) and total phosphorus, 85% each; nitrate, 30%. The pollutant removal efficiencies vary by season (greater removal in spring and summer), and according to garden age or condition (vegetation health and soil porosities can change). A facts sheet about this site, and a project overview brochure are available at www.srbc.net The rain garden is a project of a Targeted Watershed Grant (TWG) for stormwater projects, administered by Susquehanna River Basin Commission in partnering with PCWEA, Parks and Recreation of Lower Paxton Township, and others to develop innovative and cooperative stormwater management approaches for PA communities.

A small tributary of Upper Paxton Creek North subwatershed crosses the park near the rain garden. The erosion pattern in this stream (deep, to bedrock in places) indicates the past runoff has been significant. Upstream from the park suburban residents have sparse woody vegetation along the creek, and mow their yards to edges of these creek banks (an erosion-causing practice evident in many places). Vegetation alongside streams, known as riparian buffers, hinders and diminishes overland stormwater flows (with pollutants) from reaching streams. Where space permits, buffers often are planned

for 3 zones of vegetation of various types, densities, and widths. The buffer at this site, not part of the TWG, is too narrow. Trees were planted along existing vegetation to increase buffer width. Its sparseness, however, and tree covers (tubes for resisting deer predation) indicate inadequate maintenance (dead tree stock and fallen tubes). Pollutant removal effectiveness by adequate buffers at maturity would likely be approximately 65% of total suspended solids (mainly dirt); 50% of total phosphorus; nitrate, 20%). These pollutant removal efficiencies also vary by season (minimal in winter when vegetation metabolism is least, and soils are frozen). This project aims at raising public awareness about the importance of stormwater management, and demonstrates BMP implementation at a high profile facility.
