STORMWATER BMP SITES IN PAXTON CREEK WATERSHED

BMP Type: Linglestown Methodist Church Riparian Buffer

Name and Location: Linglestown United Methodist Church, 1430 North Mountain Road (north of Rt. 39 square in Linglestown), Lower Paxton Township.

Project Site Number and BMP Type Code: 54C

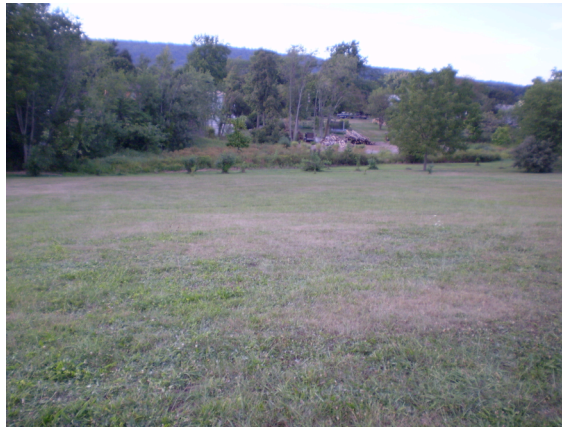
Methodist Church Riparian Buffer

Site Features: Riparian buffers are vegetation (trees, shrubs, herbaceous perennials) alongside waterways. Buffers provide many benefits: partial protection from overland stormwater runoff (containing pollutants) that can enter the creek; shade for the creek that helps cool stream waters, and enhance dissolved oxygen levels in water; habitat (living places) for water and land-based creatures; other benefits. Buffers are the single, most important type of best management practice for runoff, particularly for headwaters and slightly degraded streams. Buffers are often designed for 3 vegetative zones, extending from tops of creek banks for 35 or more feet (100 feet recommended for most areas). Expected pollutant removals in fully functioning riparian buffers are approximately: total suspended solids (mainly dirt), 65%; total phosphorus, 50%; nitrate, 50%. In the rear of Linglestown United Methodist Church is a long grassy slope draining to a wetland. Parents and boys of Cub Scout Pack 360 (Holy Name of Jesus Catholic Church), with PCWEA, church members, and others planted a tree and shrub buffer of native vegetation in 2006. Of the approximately 50 trees and shrubs installed with tree covers, plastic tubes for protecting vegetation from deer and rodent predation (mainly bark girdling), only 18 remain. The demise of most vegetation is due to multiple factors: inadequate watering of planted vegetation in subsequent weeks after planting; black tree covers (4" drain pipe) that were opaque to light (greatly limiting potential photosynthesis by the plants); mowing around the trees even to the wetland edge (which compacted soils, and reduced stormwater infiltration). The main lesson to be learned: maintenance agreements need to be in place before project installations begin.
