Description of the Morrison Cove Valley

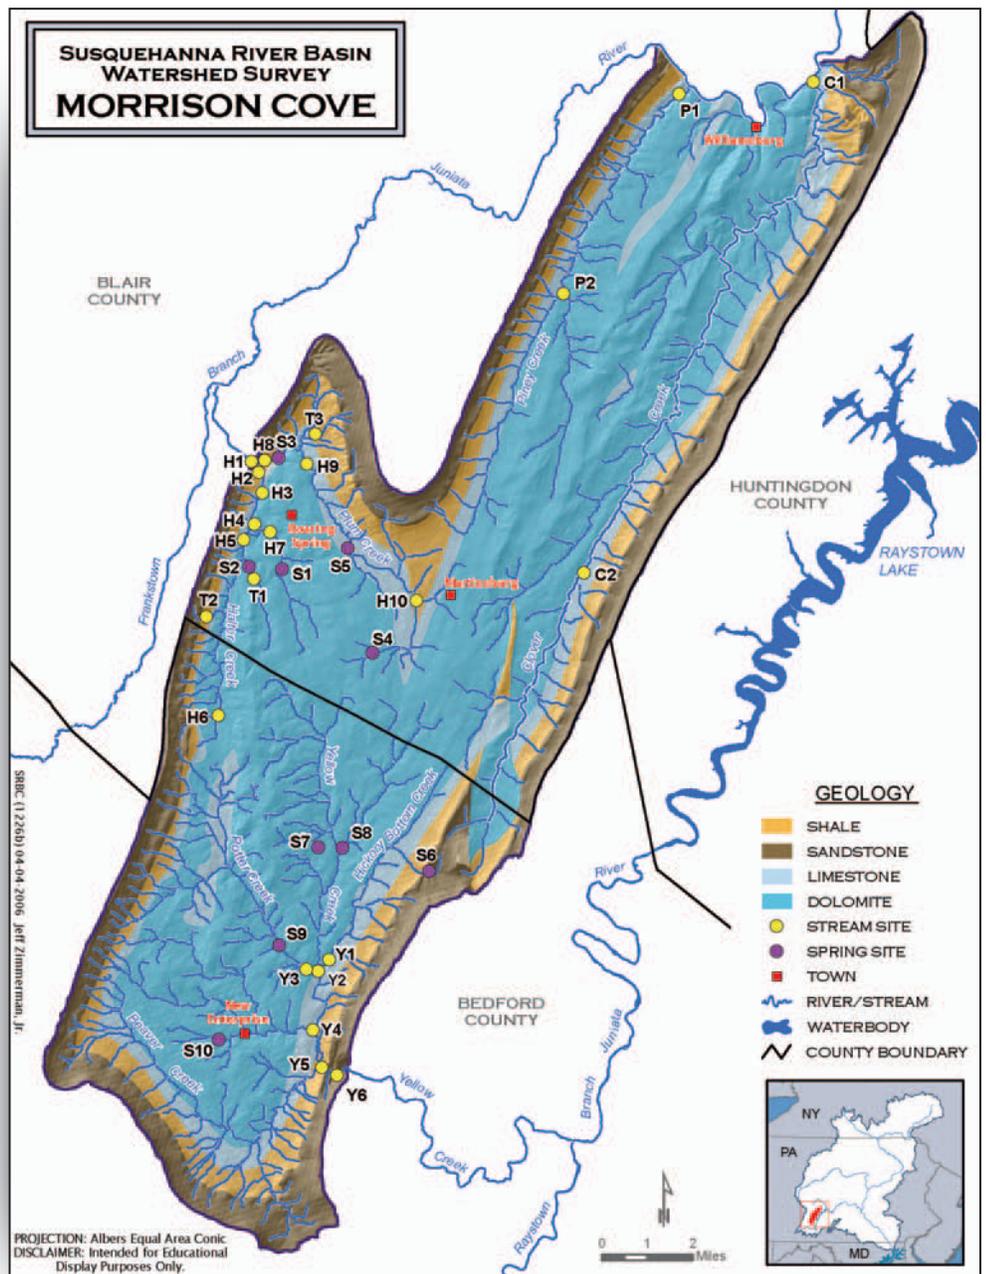
Figure 2. Geology and Sampling Site Locations in Morrison Cove

The underlying geology of Morrison Cove is folded bedrock that primarily consists of Cambrian and Ordovician age limestone and dolomite. The ridges around the valley consist of sandstones, siltstones, and shale (Figure 2). The limestone and dolomite in the valley are easily weathered, and the elemental compositions of those rock types, calcium and magnesium, often are found in the water. Because carbonate rocks are soluble in water, underground rock is dissolved, leaving channels and conduits that allow for high yielding aquifers. Groundwater in carbonate areas also augments stream flow, which enables relatively stable surface flow even during dry periods.

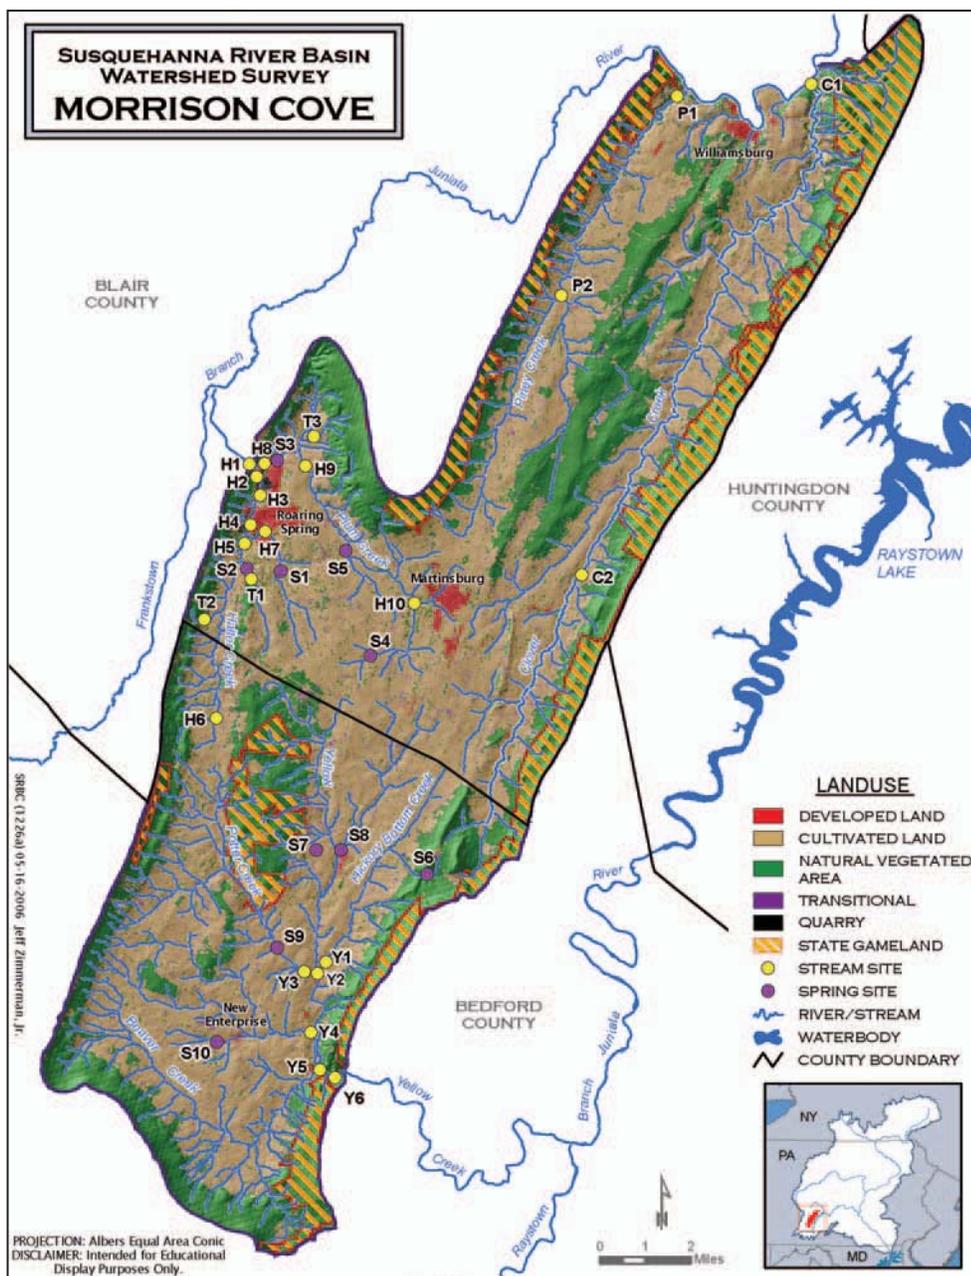
Figure 3. Land Use and Sampling Site Locations in Morrison Cove

The largest population centers in Morrison Cove are Roaring Spring, in the downstream reaches of Halter Creek Watershed, and Martinsburg, in the headwaters of Plum Creek. Yellow Creek flows through the small towns of Woodbury and Waterside, and then exits the Cove just east of Loysburg. The dominant land use in the Morrison Cove valley is agriculture, which accounts for about 55 percent of the Cove by area, followed by forested land at approximately 40 percent. Developed areas make up slightly more than one percent of the entire valley. State game lands encompass more than 2,000 acres

in the middle of the Cove, in the headwaters of Potter and Yellow Creeks (Figure 3).
