SUSQUEHANNA RIVER  
BASIN COMMISSION

# Upper Susquehanna Subbasin

## A Water Quality and Biological Assessment

Travis W. Stoe, Biologist

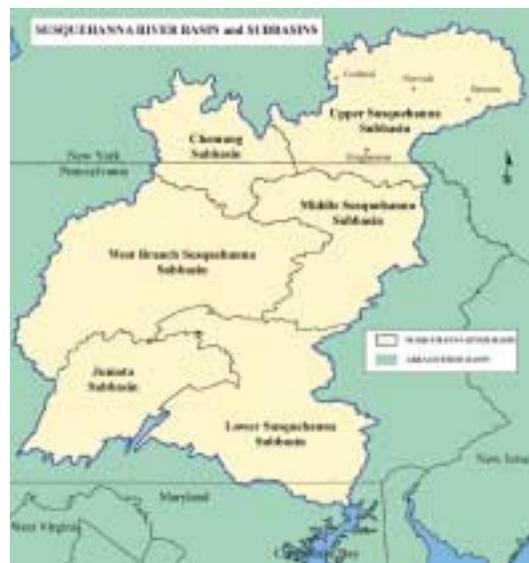
Figure 1. Susquehanna River Subbasins

The Susquehanna River Basin Commission (SRBC) conducts a water quality and biological assessment of each of the six major subbasins (Figure 1) about every 10 years on a rotating schedule. The SRBC assessment has provided information used to:
