RESULTS

Figure 4. Bacteria levels in the Yellow Breeches Creek Watershed.

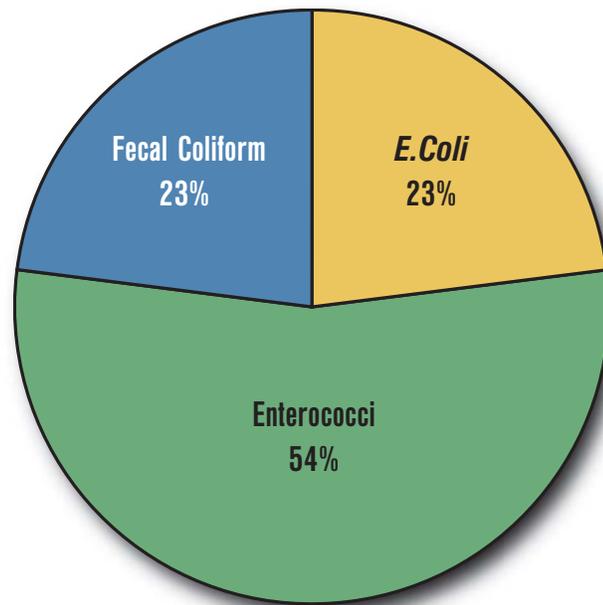
Figure 5. Percentage of Geometric Mean Violations for Indicator Bacteria in the Yellow Breeches Creek Watershed During the Recreational Season.

During the recreation season (May-September), 5 of the 11 sampling sites exceeded the geometric mean standard for *E. coli* and fecal coliform during at least one of the months (Figure 4). In addition, all 11 of the sampling sites exceeded the geometric mean standard for enterococci for at least one of the months.

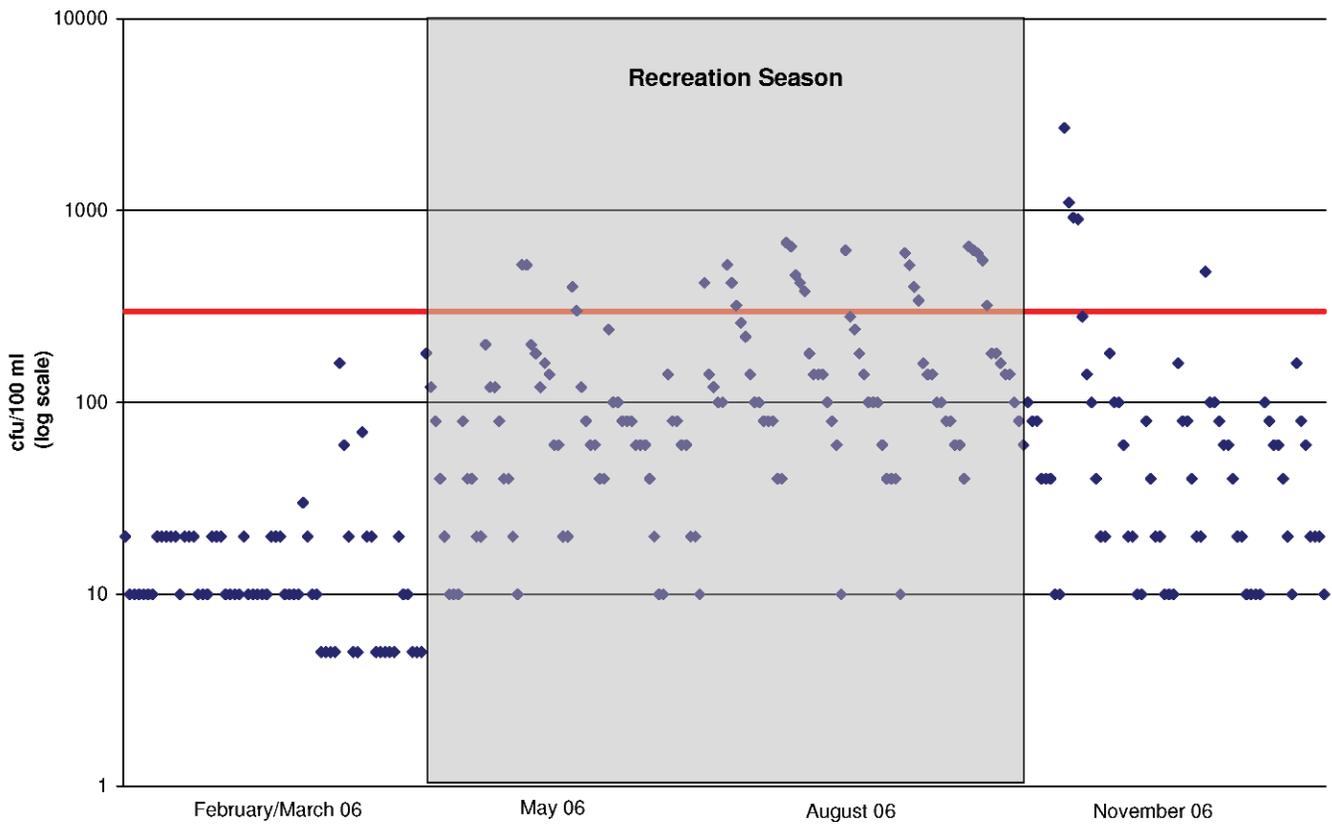
Figure 6. Single Sample *E. Coli* Concentrations
(red line indicates EPA recommended single sample maximum)

The other element of the USEPA-recommended criterion is based on single sample maximums, which were exceeded in the Yellow Breeches Creek 28 times (11 percent) for *E. coli* and 113 times (43 percent) for enterococci (Figure 6 and Figure 7). The current single sample regulations for fecal coliform in Pennsylvania apply only to the recreation season, and this maximum value of 400 cfu/100 ml was exceeded

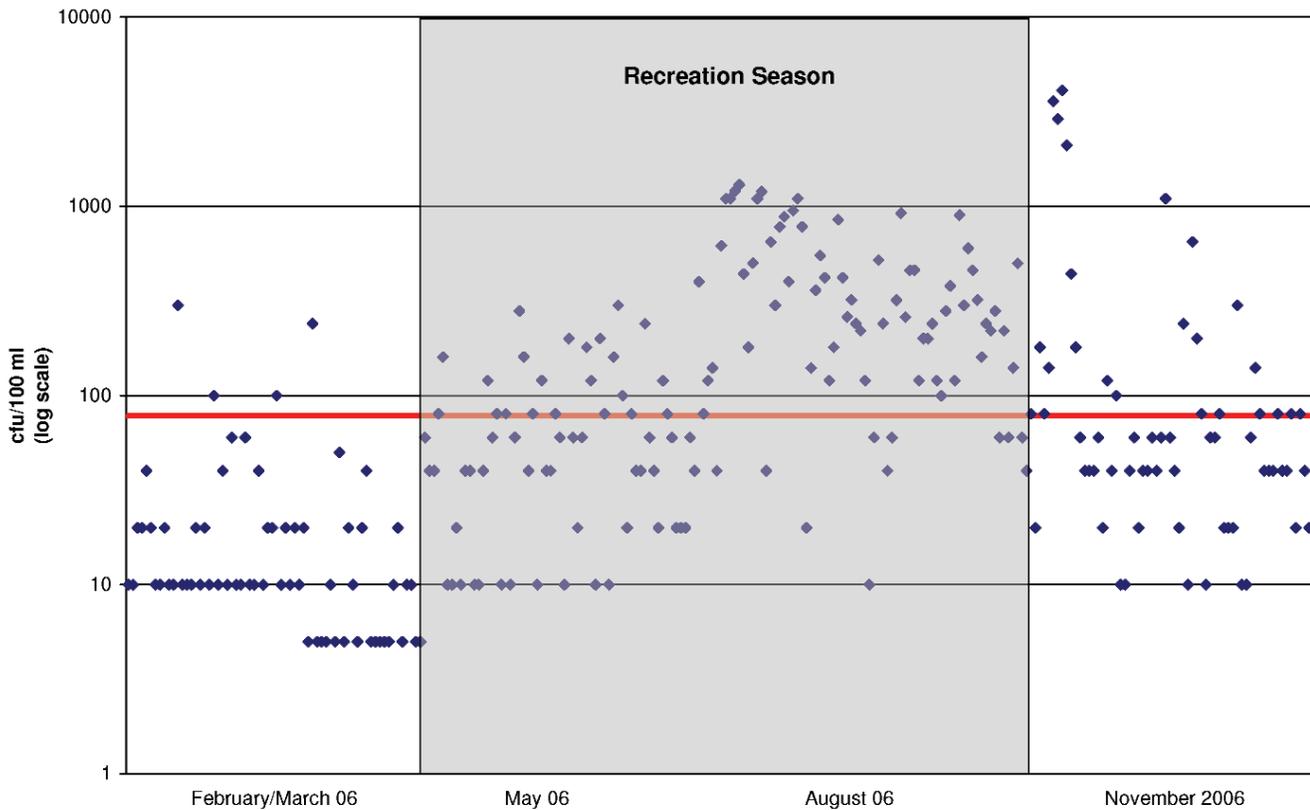
Figure 7. Single Sample Enterococci Concentrations
(red line indicates EPA recommended single sample maximum)

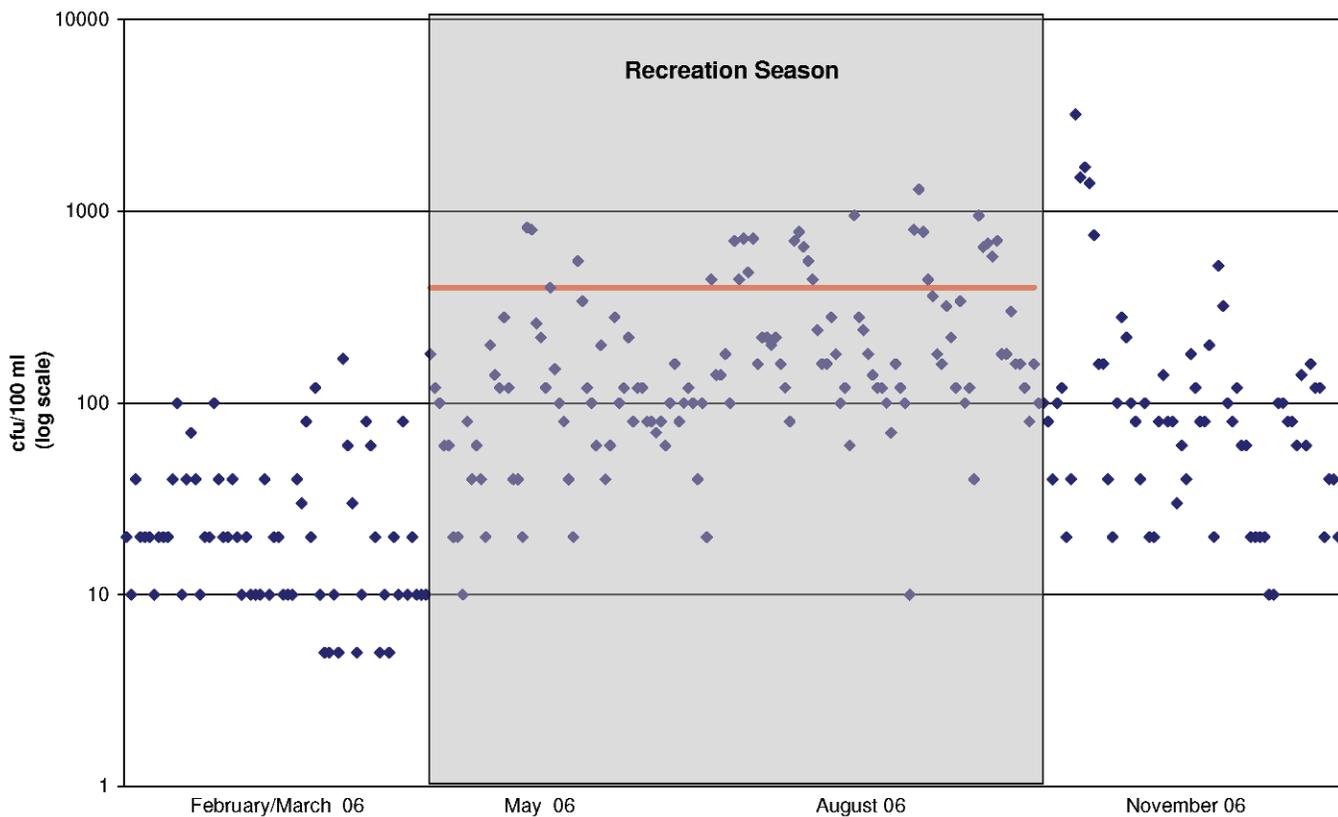
Figure 8. Single Sample Fecal Coliform Concentrations
(red line indicates current PADEP standards for single sample maximum for May-September)

24 times, which is 9 percent of the samples (Figure 8). There were other very high single sample values outside of the recreational season that are not considered violations under current PADEP regulations. For single sample violations during the recreation season, there were 23 for *E. coli*, 24 for fecal coliform, and 84 for enterococci.
