Subject: Inspection of fishways at the Safe Harbor Hydroelectric Project (FERC #1025)

A seasonal inspection of the fish passage facilities at the Safe Harbor Hydroelectric Project (Project) was performed at 9:00 am on Wednesday, 05/07/2014. The Project is owned and operated by the Safe Harbor Water Power Corporation. The Service's review team was led by Sheila Eyler from the US Fish and Wildlife Service. Consultants to the owner from Gomez and Sullivan Engineers, PC, and Normandeau Associates, Inc., and personnel from the Maryland Department of Natural Resources and their consultants from Environmental Resources Management were present.

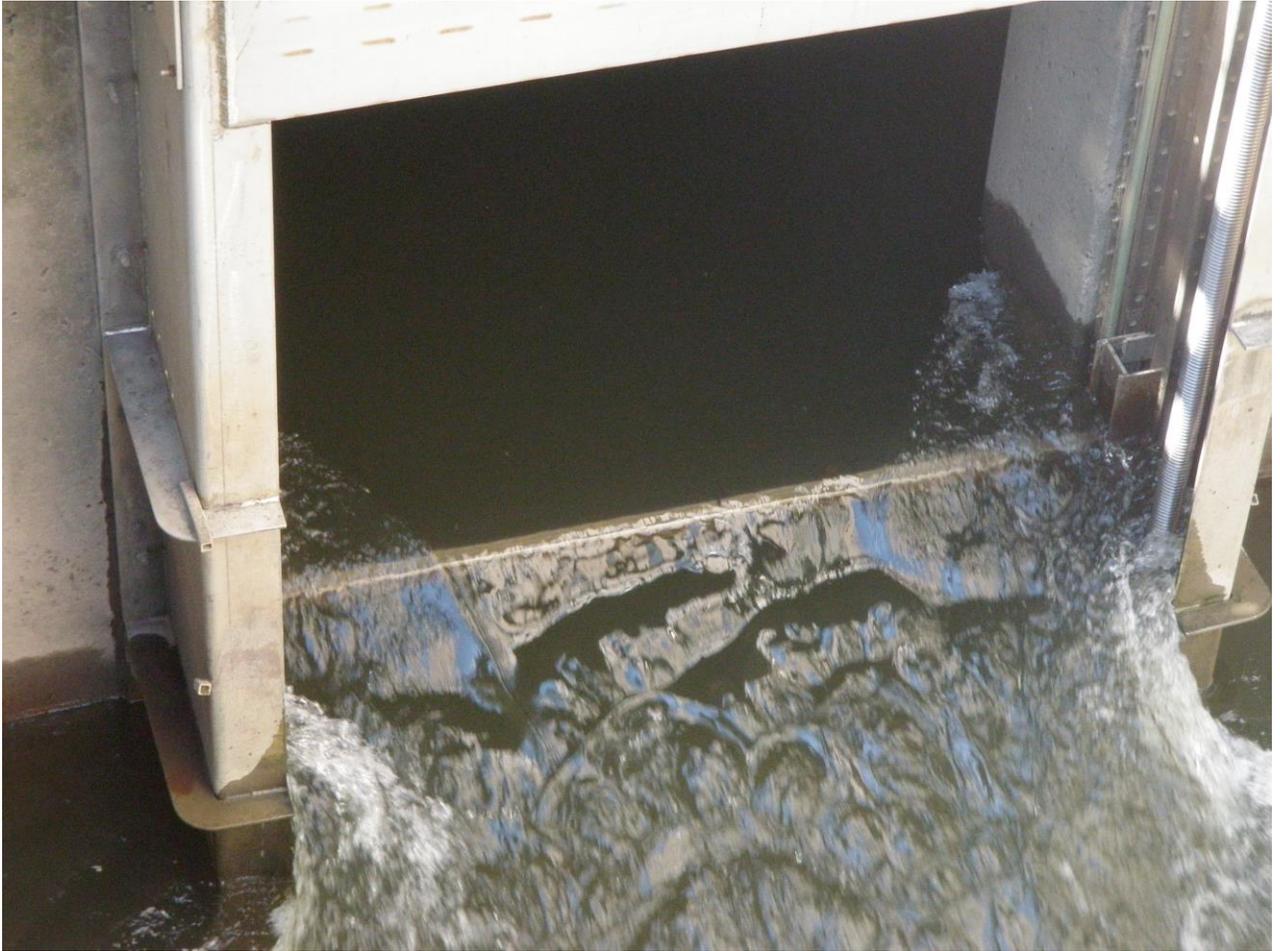
- Horizontal steel bars are still present at the openings of entrance gates A and C. USFWS Fish Passage Engineers have previously requested these bars to be removed in order ensure safe passage to all migratory fish entering the lift. The location of the bars causes them to protrude into the flow path of the fish. The Service preference is that fish not be exposed to protrusions, sharp edges, and other objects in the flow path that could cause injury. As noted by the Project managers, removing these bars would compromise the structural stability of the gates. Able to

identify a large number of other fish passage facilities with gates that don't have horizontal bars in the flow path of the fish, the Service once again requests that the licensee removes or relocates these bars above and outside of the water column. Figure 1 in the Appendix shows the steel bar at gate C.

Figure 1: Gate C steel bar crossing through the water column, right at the path that fish would use to move into the fishway
