SUSQUEHANNA RIVER BASIN COMMISSION

Middle Susquehanna River Subbasin Small Watershed Study: Wyalusing Creek Watershed

*A Water Quality and Biological Assessment,
October 2002 - September 2003*

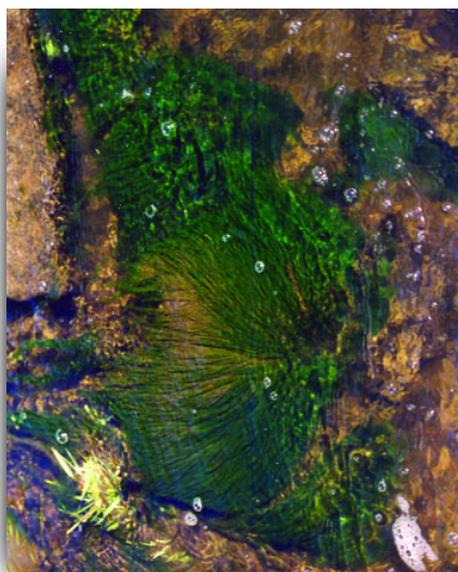
Biology was severely impaired at PETT 0.1 with the lowest taxonomic richness (15), percent Ephemeroptera (2.74 percent), and number of EPT taxa (5) of all the sites in the Wyalusing Creek Watershed. The site was highly dominated by midges (Chironomidae) and water penny beetles (*Psephenus*). The habitat was rated excellent at the sampling site although vegetative cover and stream buffer width needed improvement. Algae were very thick and prevalent at this site.

Algae in Pettis Creek west of Montrose, Susquehanna County

Degraded sites such as PETT 0.1, BREW 0.1, LAKE 0.1, NBWC 5.0, ROCK 5.0, CAMP 0.1, and EBWC 5.0 can be remediated. Fencing cattle from streams is good for both the health of the streams and the health of the cattle (Carline, 2004). There are numerous funding programs available (Table 5: B, C, D, H); some of which will pay farmers a rental fee and stipend to help maintain a vegetated stream buffer. For information on stream buffer projects already in the watershed go to: http://www.dep.state.pa.us/WaterManagement_Apps/WatershedManagement/stream/reports.asp or contact the Stream ReLeaf Program at PADEP Bureau of Watershed Management
