Juniata River Subbasin Survey

*A Water Quality and Biological Assessment,
June - November 2004*

SUSQUEHANNA RIVER
BASIN COMMISSION

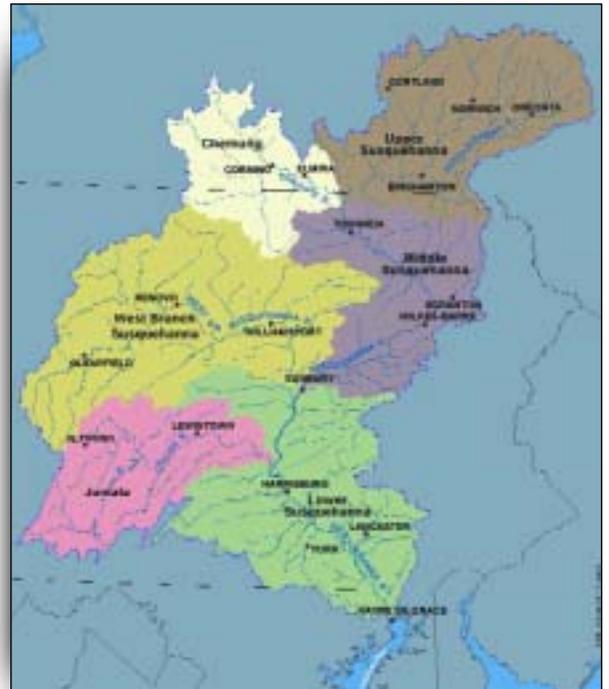
Figure 1. *The Susquehanna River Subbasins*

The Susquehanna River Basin Commission (SRBC) conducted a survey of the Juniata Subbasin from June to November 2004. This survey was part of SRBC's Subbasin Survey Program, which is funded in part through the United States Environmental Protection Agency (USEPA). This program consists of two-year assessments in each of the six major subbasins (Figure 1) on a rotating schedule.

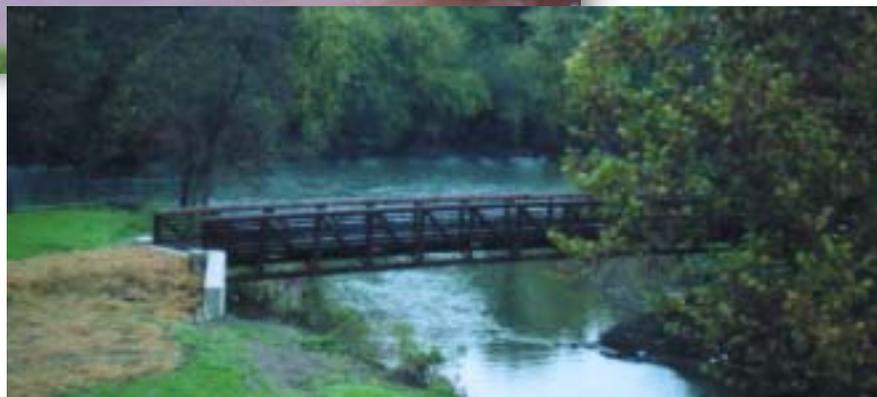
Photo at left: September Flooding of Juniata River and Crooked Creek from remnants of Hurricane Frances, Huntingdon, Pa.

Photo below: Confluence of Crooked Creek and Juniata River at normal flow, Huntingdon, Pa.

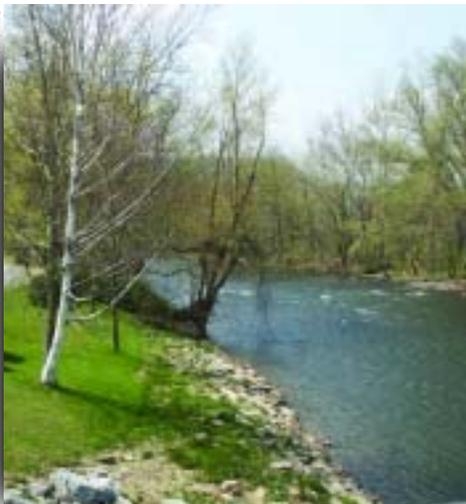
*Frankstown Branch Juniata River
(FRNK 1.6) in Alexandria, Pa.*

Site conditions for the Frankstown Branch Juniata River and the Raystown Branch Juniata River are depicted in Figure 4. The Frankstown Branch drains the urban area of Altoona, Pa., some AML, agricultural lands, and forested areas with sections of state game lands. Of the streams sampled in the Frankstown Branch, none of the sites had “higher” water quality. Two sites (BURG 0.5 and HALT 0.6) had seven parameters exceeding levels of concern, and one (BVDB 5.0) had six parameters exceeding levels of concern (Table 4). Water quality impairment was due to agricultural practices, urban influences, and AMD conditions.

Only one site in the Frankstown Branch had nonimpaired macroinvertebrate conditions, two sites were slightly impaired, two sites were moderately impaired, and two sites were severely impaired. BLRG 2.5 had nonimpaired biology, but the water quality was rated “lower” due to slightly high aluminum. This site drained mostly state game lands; however, it also drained some AML, had an industrial discharge point, and was near a biosolids land application (PADEP, 2005). These are all potential sources for the slightly high aluminum value. The severely impaired sites,

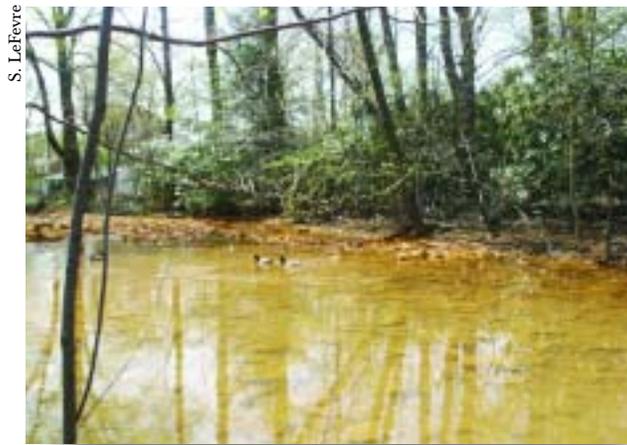
BURG 0.5 and BVDB 5.0, were impaired by AMD with iron precipitate coating the streambeds. BURG 0.5 had the most severe AMD conditions of the Juniata Subbasin sampling sites, with the highest levels of metals and the lowest pH and alkalinity. BVDB 0.1, downstream of BVDB 5.0, also was impacted by AMD; however, the biological conditions improved to moderately impaired. BVDB 0.1 also had lower levels of metals than BVDB 5.0; however, the total nitrogen and total nitrate-n values increased, possibly due to urban influences such as lawn fertilizers, stormwater runoff, and a wastewater treatment plant. BVDB 0.1 had the highest level of chloride (35.2 mg/l) of all the Juniata Subbasin sites, possibly caused by the wastewater treatment plant and urban runoff influences.

AMD conditions on Burgoon Run (BURG 0.5) at Leopold Park near Altoona, Pa.

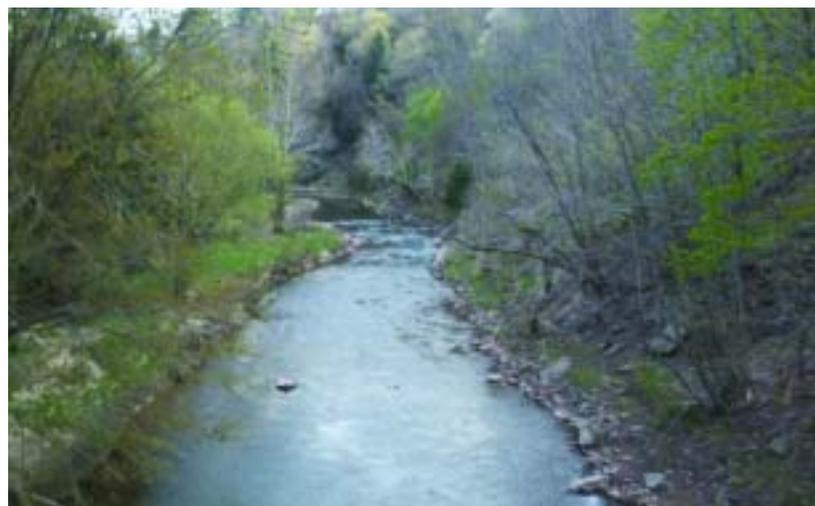
Brush Creek (BRUS 0.1) west of Breezewood, Pa.

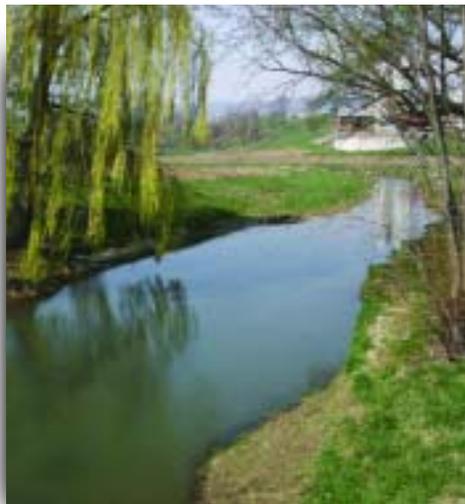
*Kishacoquillas Creek (KISH 15.6)
in Bellville, Pa.*

Kishacoquillas Creek drains an agricultural limestone valley between Jacks Mountain and Stone Mountain and maintains a popular trout fishery. The three sites on Kishacoquillas Creek and the two tributaries, Honey and Tea Creeks, had “middle” quality mostly due to total nitrogen and nitrate-n. KISH 5.5 also had an orthophosphate value slightly above the level of concern, and Tea Creek had slightly high aluminum. Tea Creek Watershed is another watershed that has documented land applications of biosolids (PADEP, 2005) as a possible source of the aluminum. The highest total nitrogen and nitrate-n values in Kishacoquillas Creek Watershed were found at KISH 15.6 (Table 4). These were the highest levels recorded in the Lower Juniata River section. The lowest levels of nitrogen and nitrate-n in the Kishacoquillas Creek Watershed were in Honey Creek, where levels slightly exceeded natural background concentrations. All sites had slightly impaired macroinvertebrate populations except Honey Creek, which had nonimpaired conditions.
