Morrison Cove Water Resources Availability Study

Publication No. 277

December 31, 2011

SUSQUEHANNA RIVER BASIN COMMISSION

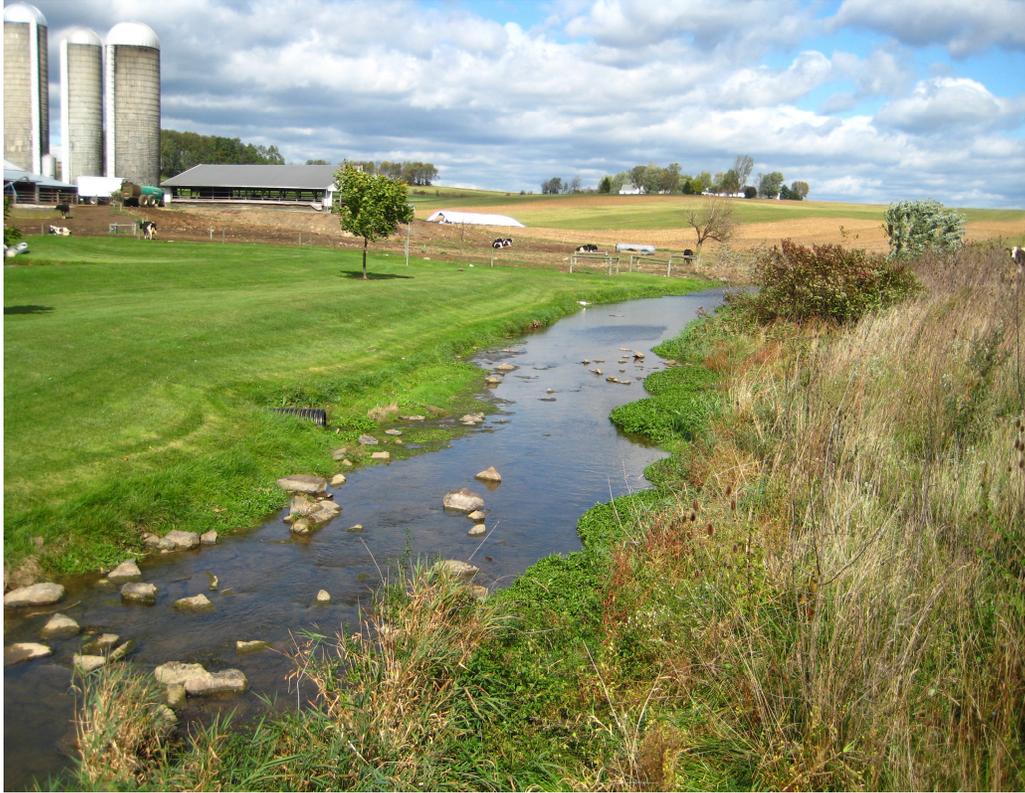
Figure 7-3. Example of Lack of Riparian Buffer and Agriculture along Clover Creek

The headwaters of Clover Creek are located in heavily forested lands, with riparian areas almost entirely intact. Along the lower headwater segments, at the beginning of the mainstem Clover Creek, riparian areas appear to have been cleared along agricultural lands bordering the stream (Figure 7-3). For the majority of the stream channel flowing along the valley floor through agricultural lands, most riparian areas have been cleared, or where existing, consist of marginal grasses.

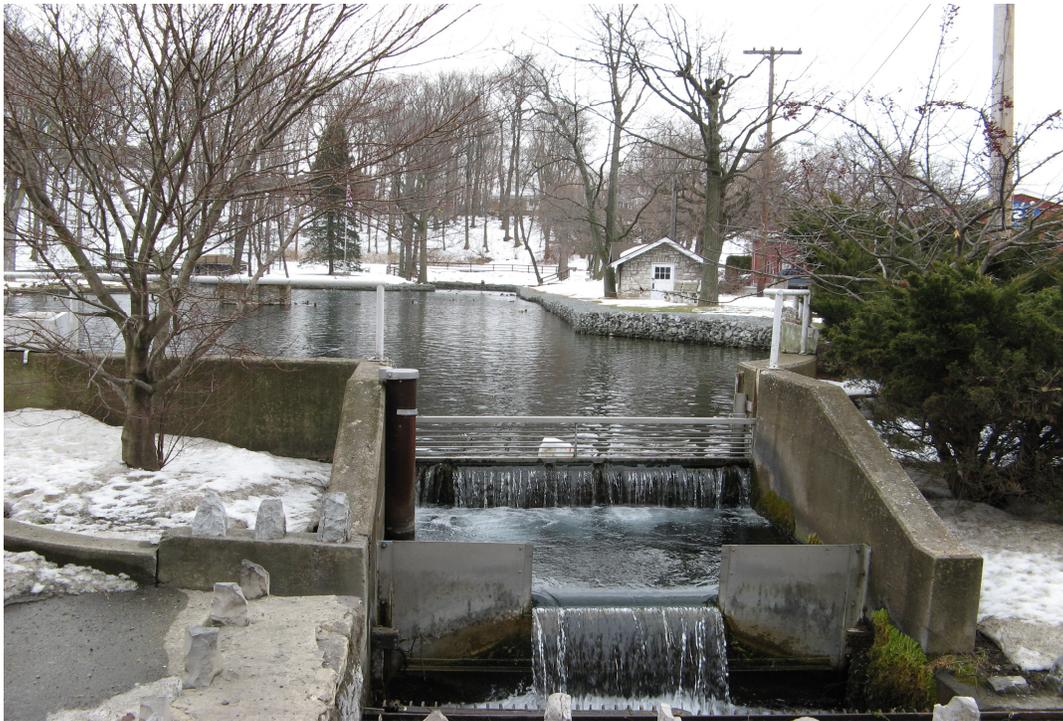
Figure 7-6. Roaring Spring Outflow (Instrumented weir provided daily flow measurements for use in this study.)

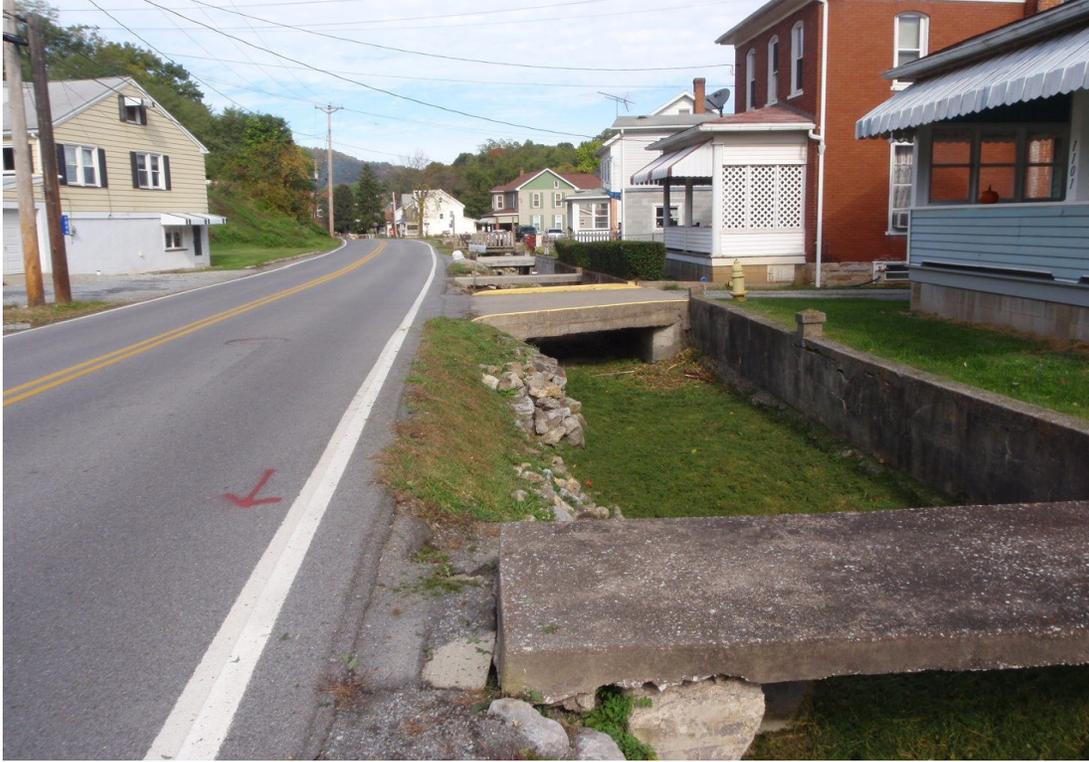
Figure 7-7. Cabbage Creek Flowing under the Driveways of Homes in Roaring Spring (The plant growth in the stream is predominantly watercress.)

Developed lands constitute a relatively large portion of the watershed, at 19 percent. As Cabbage Creek flows through the southern outskirts of the Borough of Roaring Spring, minimal riparian areas are present (Figure 7-7). At the confluence of Cabbage Creek and Halter Creek, there is a small portion of forested land that does include vegetated riparian areas. It is in this most downstream reach that riparian cover, bank condition, and vegetative zone width were highest.

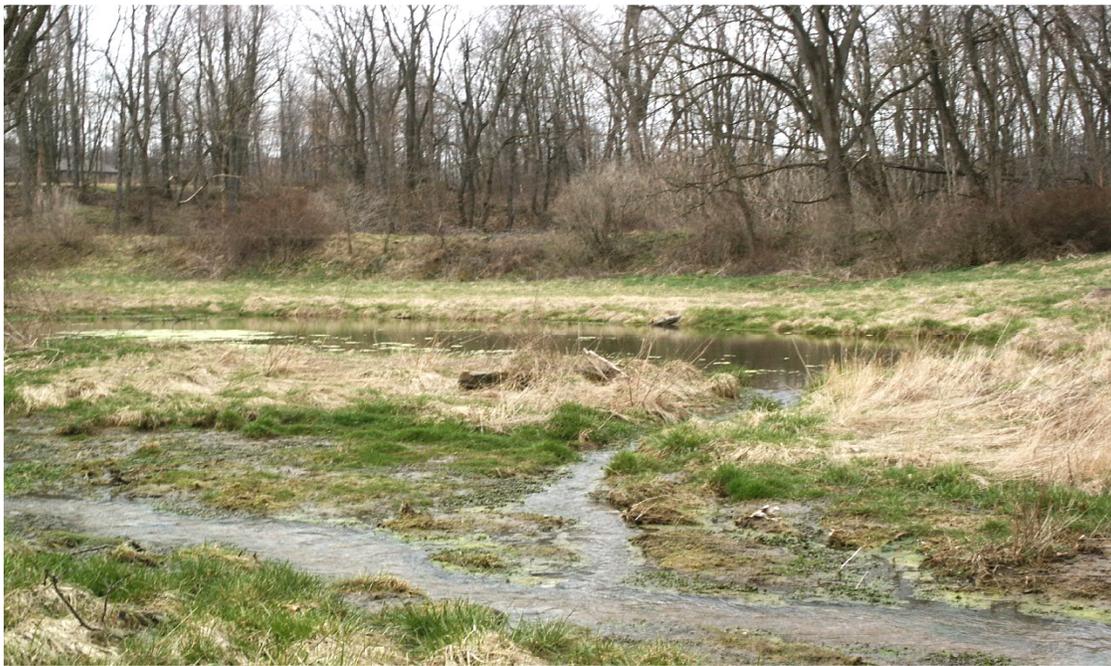
Figure 7-8. Spring Complex along Cabbage Creek

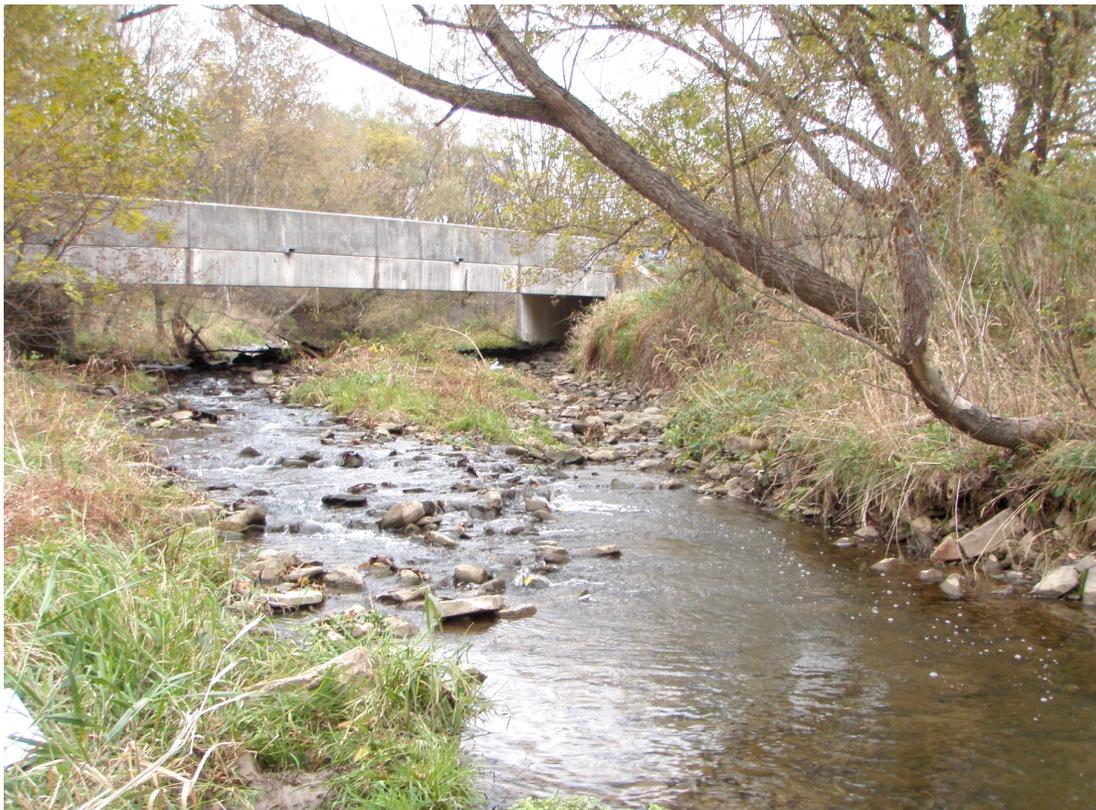
Figure 7-9. *Within the High Quality–Cold Water Fishery Section of Plum Creek*

Plum Creek joins Halter Creek just below the quarry in Roaring Spring (Figure 7-9). Plum Creek has its own unique set of water quality issues. Plum Creek has nitrate concentrations above 5 mg/l and as high as 8 mg/l throughout the watershed. Additionally, chloride concentrations are five to ten times higher in Plum Creek than in any other stream in Morrison Cove. In the headwaters of Plum Creek, concentrations were routinely more than 100 mg/l, and the other sites on the stream had an average chloride concentration of more than 45 mg/l. This is likely due to effluent from the Martinsburg Wastewater Treatment Plant. Although Plum Creek is highly spring-fed (Figure 7-10), flow measurements indicate a likely natural decrease of up to 90 percent between spring and fall.

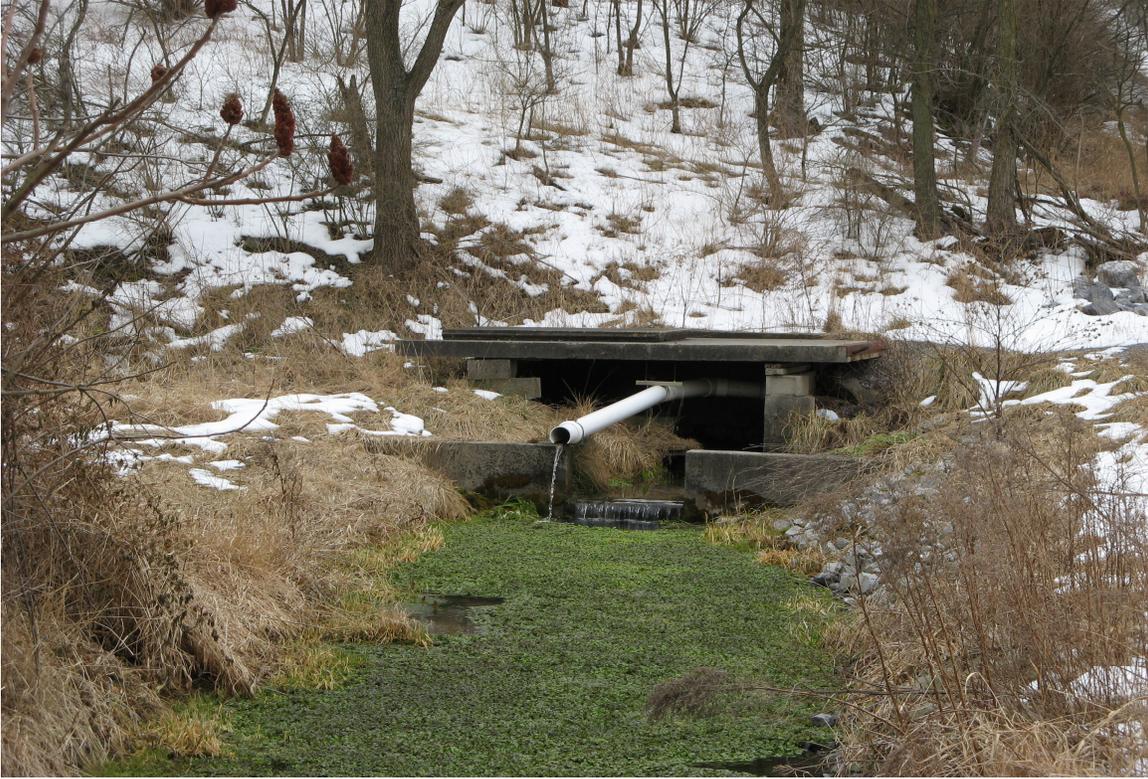
Figure 7-10. Outflow from Spring Complex near the Mouth of Plum Creek (Green vegetation in stream is watercress.)

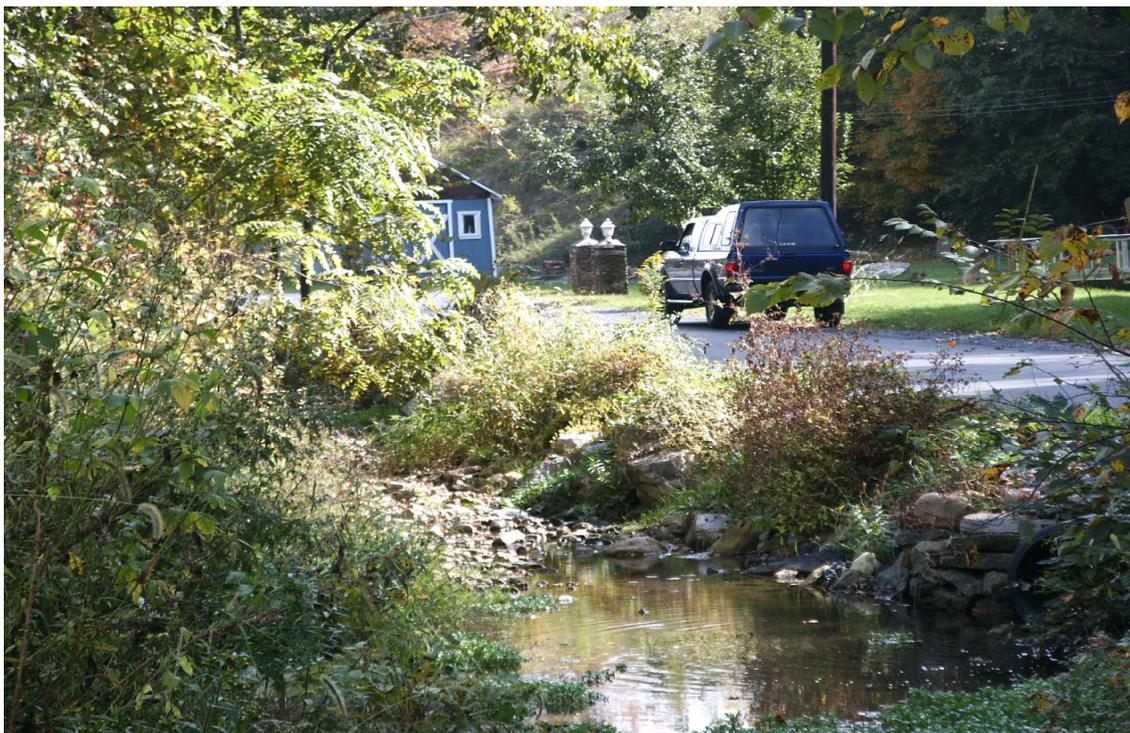
Figure 7-12. Hickory Bottom Creek (Note all flow is coming from Hipple's Cave, a conduit in the toeslope carbonates, under the road and to the right. Hickory Bottom Creek above this point was dry (channel diverging to the left).)

Two sites on Yellow Creek (one above Potter Creek and one near where the stream exits Morrison Cove) have at least five sampling data points, as does one site at the mouth of each of the major tributaries. Hickory Bottom has a PADEP Chapter 93 Designated Use Classification of HQ-CWF. Many other sites on Yellow Creek and its tributaries were sampled one time, and these data provide added spatial context to some of the data results. In the Yellow Creek Watershed, the mainstem of Yellow Creek and all major tributaries except Hickory Bottom Creek show a dolomite signature with Ca/Mg ratios less than 1.6. Hickory Bottom seems to originate from a more limestone-based geology with a Ca/Mg ratio of 2.6. A majority of the flow into Hickory Bottom Creek, especially in the summer and fall months, comes from an outflow of Hipple's Cave (Figure 7-12).

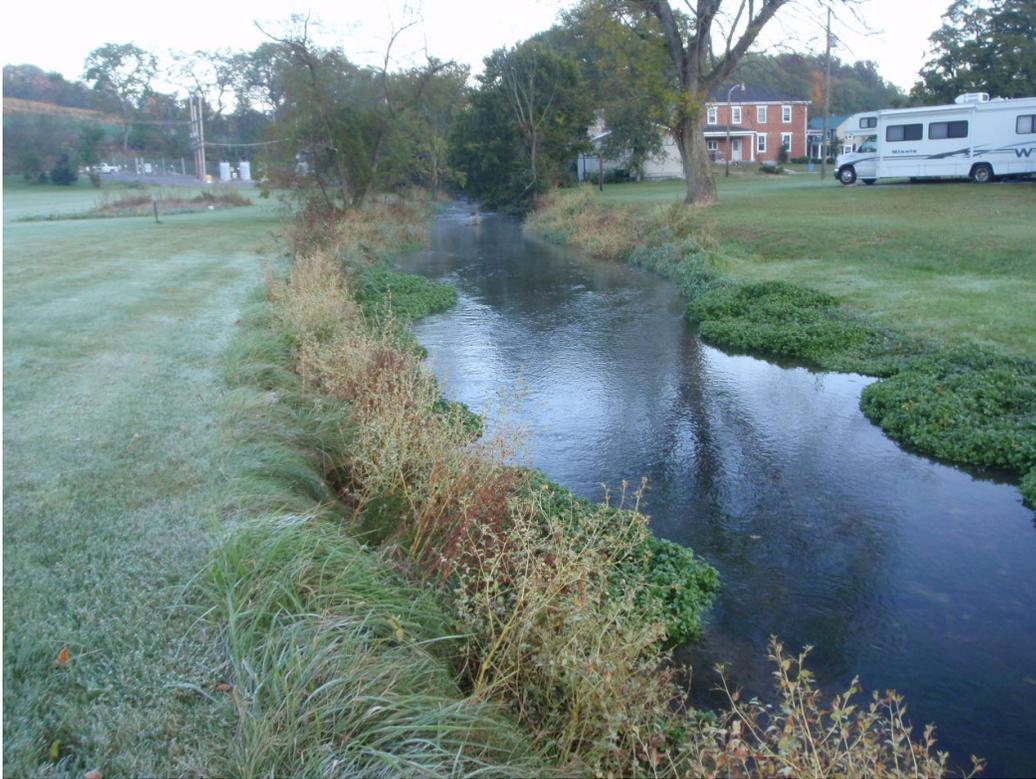
Figure 7-13. Lack of Riparian Vegetation and Channel Cover along Potter Creek

All three main headwater areas draining to the mainstem of Potter Creek are located in heavily forested lands, primarily hillslopes or ridgelines, with riparian areas almost entirely intact. All other headwater tributaries draining off Dunning Mountain appear to include intact forested riparian areas. Along the Potter Creek mainstem, riparian areas appear to have been maintained along limited portions of the stream and cleared along many of the agricultural lands bordering the stream (Figure 7-13).

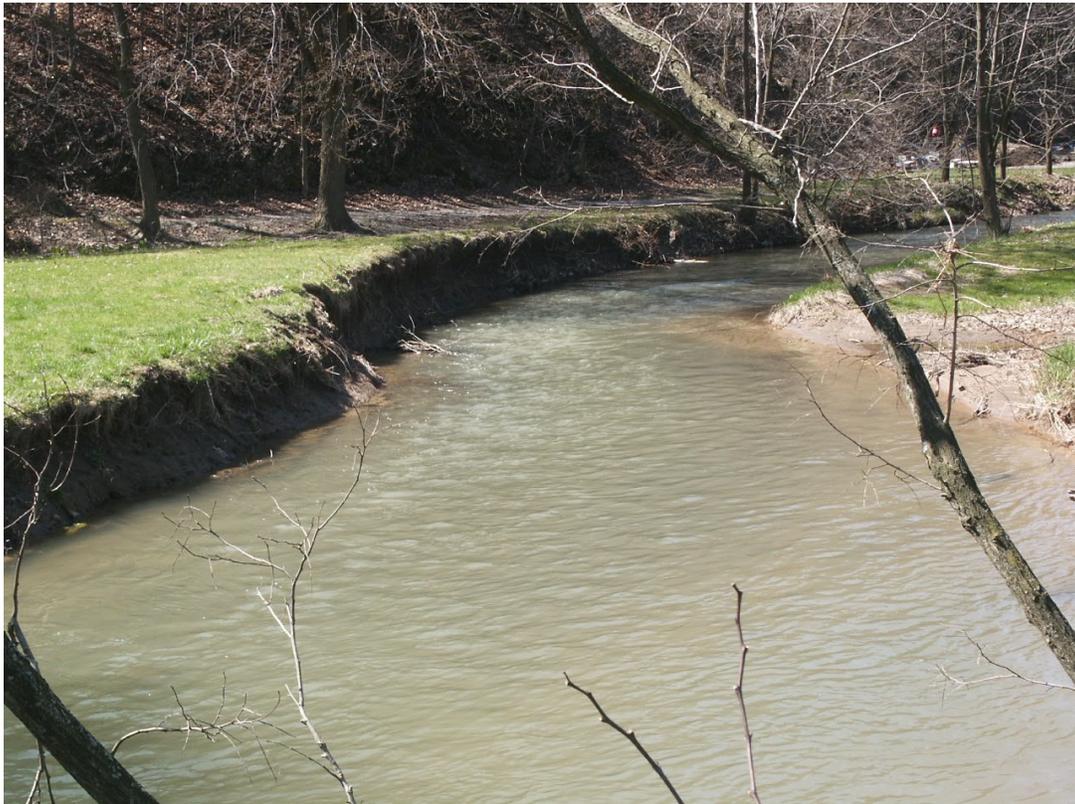
Figure 7-15. Erosion and Sedimentation along a Meander on Beaver Creek near the Mouth

sedimentation was also noted at this sample point (Figure 7-15). With no riparian area to buffer runoff events from surrounding lands, instream habitat parameters were likely impacted, as reflected in marginal scores for embeddedness and sedimentation, thereby diminishing available interstitial habitat for benthic macroinvertebrates. All other instream habitat parameters presented suboptimal scores. Beaver 1 was located at the lower end of the subwatershed, near the confluence with Yellow Creek. Land use surrounding this sample point was primarily residential. No riparian area existed at the site. Instream parameters scored suboptimal (instream cover, embeddedness, sediment deposition, channel alteration) and optimal for epifaunal substrate, channel flow status, and frequency of riffles.
