Lower Susquehanna River Subbasin Year-1 Survey

Publication 282
September 2012

A Water Quality and Biological Assessment April - July 2011

Report by Ellyn Campbell
Supervisor, Monitoring and Assessment

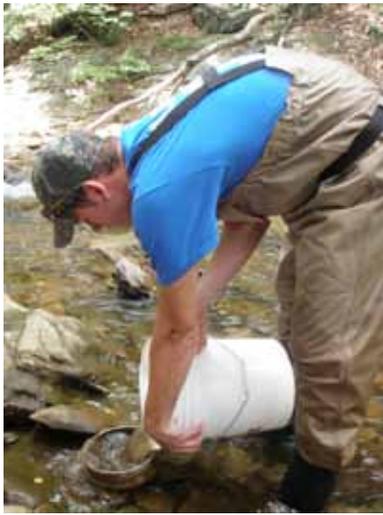
SRBC staff processing a macroinvertebrate sample in the field.

Remaining Pennsylvania streams were sampled from May through July 2011. Six D-frame (500-micron mesh) samples were obtained at each 100-meter station reach by collecting the dislodged material loosened through disturbance of the substrate of six representative riffle/run areas. The six D-frame samples were composited into one sample, which was

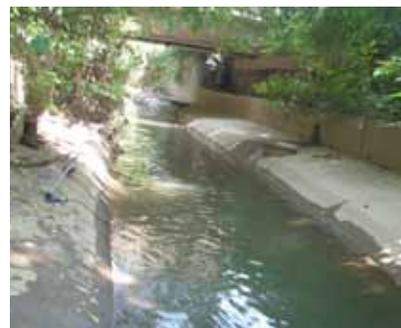
Downstream view of Paxton Creek, Dauphin Co., Pa.

in organism abundance and diversity and devoid of pollution sensitive taxa, nonsupporting habitat, and lower water quality from elevated nitrogen and total sodium. Severely impaired conditions at PAXT 0.5 are not surprising since the site is located in a concrete-lined channel in highly

urbanized Harrisburg, Pa., and receives strong stormwater pulses and combined sewer overflows. Paxton Creek was identified from 1996 through 2004 as impaired, requiring a TMDL for nutrients, siltation, organic enrichment, low dissolved oxygen, and suspended solids caused by agriculture, combined sewer overflows, urban runoff, storm sewers, construction, and unknown causes.
