SUSQUEHANNA RIVER BASIN COMMISSION

UPPER SUSQUEHANNA RIVER SUBBASIN

Year-1 Survey

A WATER QUALITY AND BIOLOGICAL ASSESSMENT

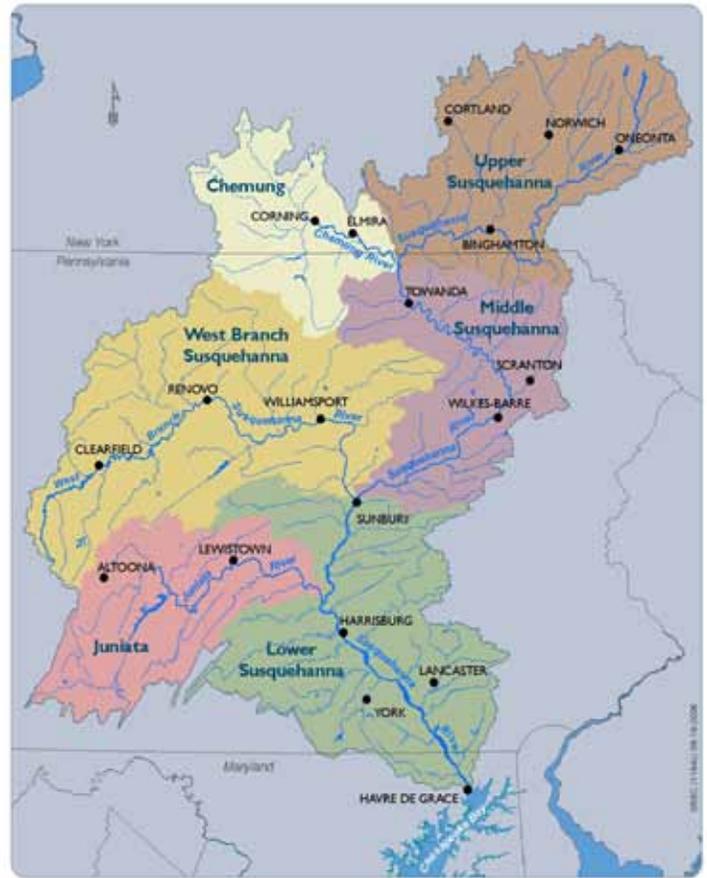
Figure 1. Six Major Subbasins of the Susquehanna River

The Upper Susquehanna River Subbasin is an interstate watershed that drains approximately 4,520 square miles of southcentral New York and 424 square miles of northeastern Pennsylvania. The Susquehanna River flows from the headwaters at Otsego Lake, N.Y., to the confluence of the Susquehanna and Chemung rivers near Athens, Pa. Three major watersheds — the Unadilla, Chenango, and Tioughnioga rivers — as well as many smaller watersheds contribute water along the way.

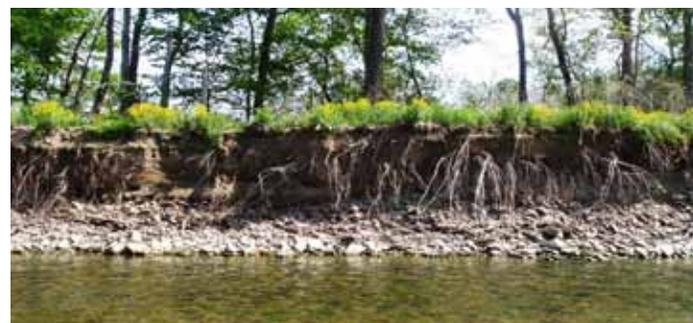
Severely eroded right bank on Wappasening Creek near the Pa./N.Y. state line (WAPP 2.5).

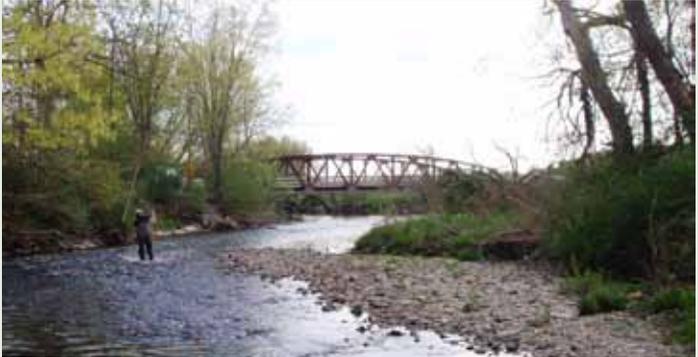
<p>Staff sampling macroinvertebrates on Otego Creek at Mount Vision, N.Y. (OTGO 13.1).</p>
Calcium	≤ 100 mg/l	g	
Conductivity	≤ 800 μ hos/cm	h	
Total Bromide	< 0.05 mg/l	i	
Total Hardness	≤ 300 mg/l	j	
Total Lithium	< 0.7 mg/l	k	
Total Nitrate	≤ 0.6 mg/l	l	
Total Nitrite	≤ 1 mg/l	d	
Total Nitrogen	≤ 1 mg/l	m	
Total Organic Carbon	≤ 10 mg/l	n	
Total Orthophosphate	≤ 0.02 mg/l	m	
Total Phosphorus	≤ 0.1 mg/l	j

SRBC staff sampled the biological community along a 100-meter reach at each site by collecting benthic macroinvertebrates, which are organisms that live on the stream bottom, including aquatic insects, crayfish, clams, snails, and worms. Six D-frame (500-micron mesh) net samples were collected along the reach by allowing the dislodged material loosened through disturbance of the substrate of representative riffle/run areas to flow into

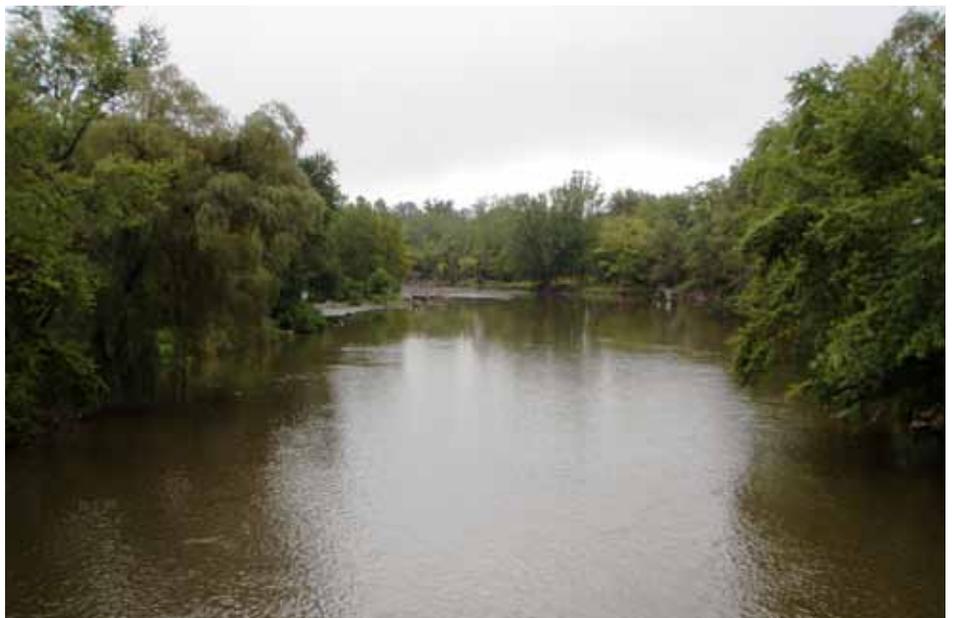
Unadilla River at Rockdale, N.Y. (UNAD 5.4).

Half of the evaluated sites had either excellent or supporting habitat, and the other half had partially supporting habitat largely resulting from compromised bank and riparian conditions and issues with substrate quality. One site on the lower portion of the Unadilla River (UNAD 5.4) had a moderately impaired biological community from low EPT diversity and dominance of oligochaetes. Most of the sites (57 percent) had higher water quality. The remaining sites, all of which were located on the Unadilla mainstem, had middle water quality resulting from elevated nutrients. The most upstream site on the Unadilla (UNAD 42.7) had the highest concentration of total nitrate (2 mg/l) in the study, perhaps caused by surrounding agricultural land use.

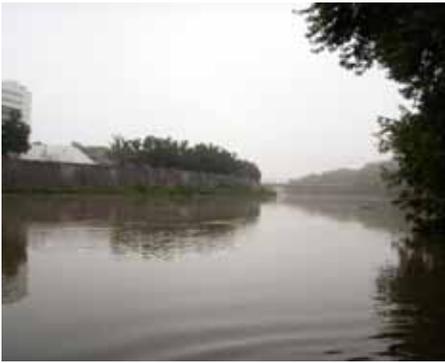
All sites had excellent habitat, with the exception of the most downstream site on the Chenango River (CHEN 0.9), which could not be completely assessed because of high water conditions. Most sites had middle water quality resulting from slightly elevated nitrates, except for CHEN 0.9, which had elevated orthophosphate, aluminum, iron, and the highest turbidity levels seen during the study (59.1 NTU). CHEN 0.9 is downstream of much of Binghamton and is heavily disturbed. The upstream site on Genegantslet Creek (GENE 10.9) had slightly depressed alkalinity (18 mg/l).

Chenango River north of Route 17 bridge in Binghamton, N.Y. (CHEN 0.9).

Elevated sodium concentrations, which can be an indicator of urbanization, were found only in the Tioughnioga section. Elevated aluminum and iron were only observed in the Chenango and Tioughnioga sections. Only one site (CHEN 0.9) had an elevated turbidity level, which is not surprising since the site is located in a large urban center and has been exposed to heavy bridge construction disturbance and storm activity.
