SUSQUEHANNA RIVER BASIN COMMISSION

UPPER SUSQUEHANNA RIVER SUBBASIN Year-1 Survey

Publication 294
September 2014

A WATER QUALITY AND BIOLOGICAL ASSESSMENT

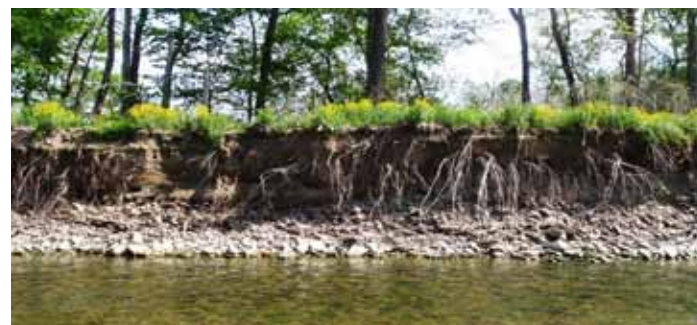
Severely eroded right bank on Wappasening Creek near the Pa./N.Y. state line (WAPP 2.5).

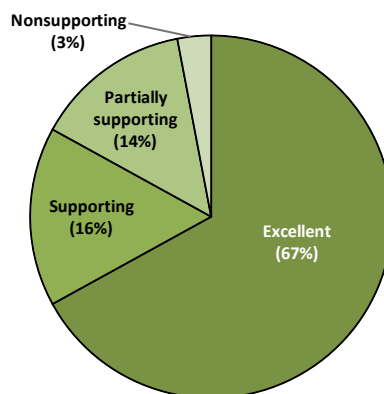
Figure 6. 2013 Habitat Condition Categories for Sampled Upper Susquehanna Subbasin Sites

Sixty-seven percent of the evaluated sites had excellent habitat, 16 percent had supporting habitat, 14 percent had partially supporting habitat, and 3 percent had nonsupporting habitat (Figure 6). Most compromised habitat resulted from poorer substrate quality, riparian conditions, or flow regime. Habitat conditions could not be fully evaluated at two sites because of high water.

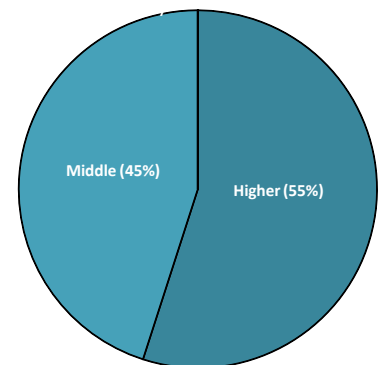
Figure 7. 2013 Water Quality Condition Categories for Sampled Upper Susquehanna Subbasin Sites

Fifty-five percent of the sites had no parameters that exceeded levels of concern and were designated as higher water quality (Figure 7). Forty-five percent of the sites were designated as middle water quality. No sites had lower water quality. Three sites had three or more parameters exceed levels of concern (Table 3). The site on West Branch Tioughnioga River (WBTF 3.3) had three parameters exceed levels of concern, and two sites — one on the Chenango River (CHEN 0.9) and one on Tioughnioga River (TIOF 28.7) — had four parameters exceed levels of concern.

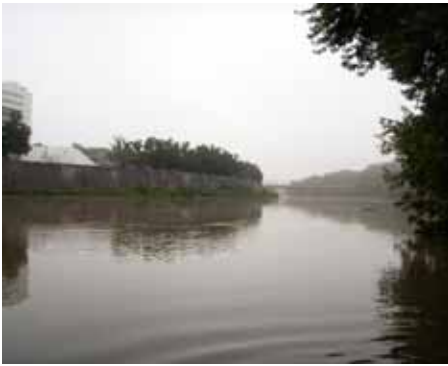
Chenango River north of Route 17 bridge in Binghamton, N.Y. (CHEN 0.9).

All sites had excellent habitat, with the exception of the most downstream site on the Chenango River (CHEN 0.9), which could not be completely assessed because of high water conditions. Most sites had middle water quality resulting from slightly elevated nitrates, except for CHEN 0.9, which had elevated orthophosphate, aluminum, iron, and the highest turbidity levels seen during the study (59.1 NTU). CHEN 0.9 is downstream of much of Binghamton and is heavily disturbed. The upstream site on Genegantslet Creek (GENE 10.9) had slightly depressed alkalinity (18 mg/l).

Elevated sodium concentrations, which can be an indicator of urbanization, were found only in the Tioughnioga section. Elevated aluminum and iron were only observed in the Chenango and Tioughnioga sections. Only one site (CHEN 0.9) had an elevated turbidity level, which is not surprising since the site is located in a large urban center and has been exposed to heavy bridge construction disturbance and storm activity.

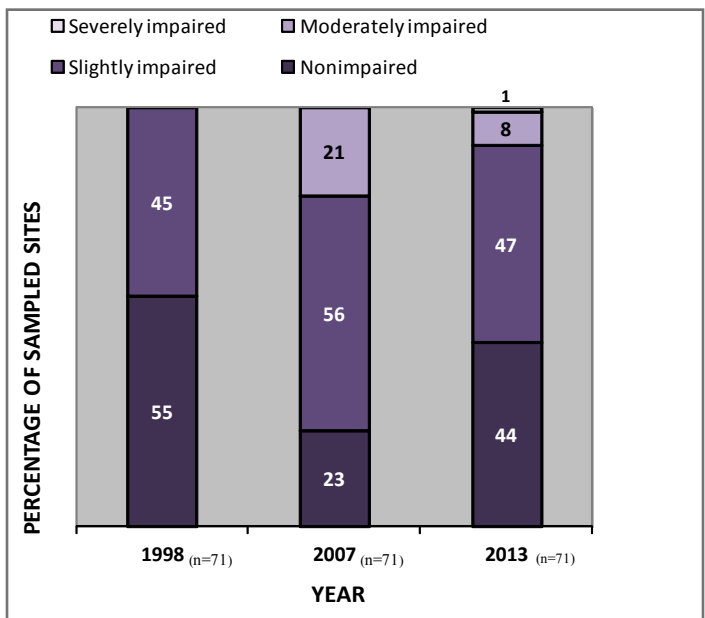
Figure 8. Historical Biological Condition Categories Among Sampled Sites in the Upper Susquehanna Year-1 Subbasin Surveys

SRBC compared the data collected in the subbasin at the 71 sites that were sampled in 1998, 2007, and 2013. Figures 8 through 10 depict the results for biological, habitat, and water quality conditions for these three years. Table 4 shows how condition categories within each section changed from the last survey. Overall, a large percentage of biological, habitat, and water quality condition categories remained stable or improved since the last subbasin survey.

percent of sites demonstrated no change in biological condition rating, with the Tioughnioga section having the most stability in site ratings (70 percent of sites). Thirty-seven percent of sites throughout the subbasin improved biological conditions, and the most improvement was observed in the Unadilla section (43 percent of sites). Degraded conditions were noted in 7 percent of sites overall but were concentrated in the Binghamton to Sayre section (18 percent of those sites). No degradation was observed in the Great Bend, Chenango, or Tioughnioga sections.

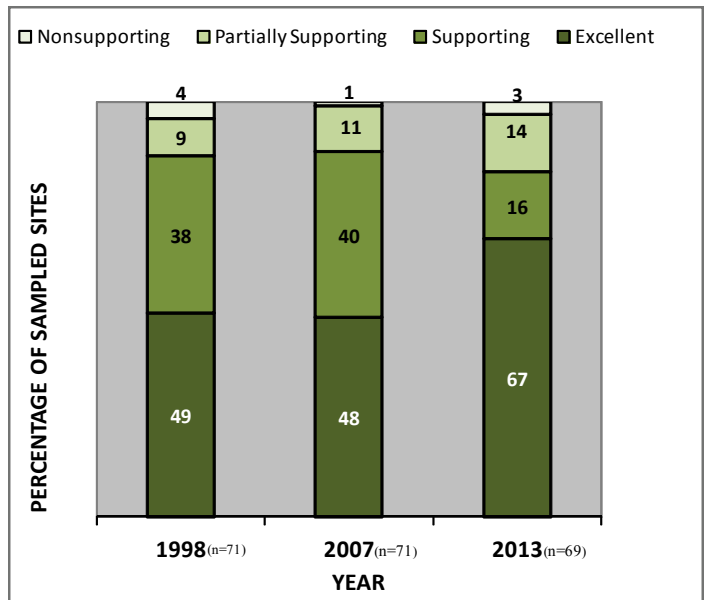
Figure 9. Historical Habitat Condition Categories Among Sampled Sites in the Upper Susquehanna Year-1 Subbasin Surveys

Throughout the subbasin, the percentage of sites having excellent habitat increased overall from 1998 through 2013 while the percentages of sites with supporting habitat decreased overall (Figure 9). The total percentage of sites with combined excellent and supporting habitat in 2013 (approximately 83 percent) was less than the 87 percent observed in 1998 and 2007. The percentage of partially supporting habitat steadily increased from 1998 to 2013. The percentage of sites with nonsupporting habitat was similar in 1998 and 2013 and dropped in 2007. Making detailed comparisons between habitat assessments between sampling event years is difficult due to greater variability in subjective scoring judgments; however, nonsupporting conditions in 2013 were caused by temporary stream disturbances.

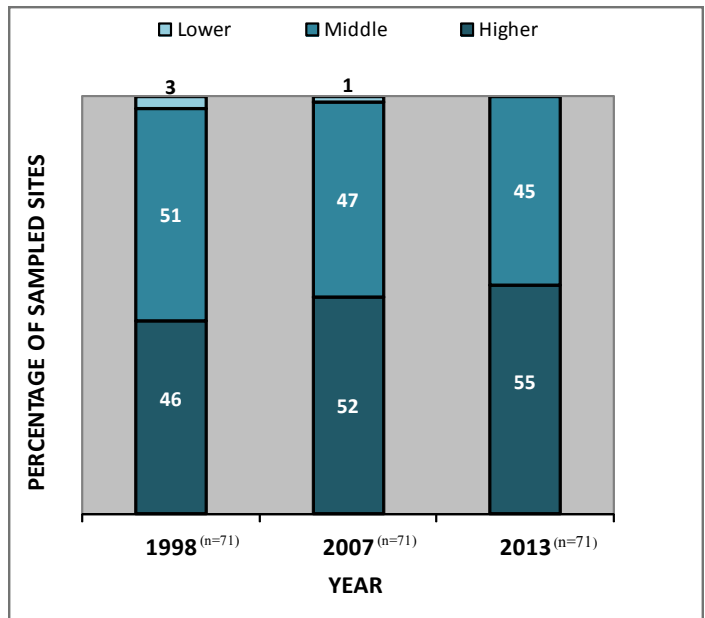
Figure 10. Historical Water Quality Categories Among Sampled Sites in the Upper Susquehanna Year-1 Subbasin Surveys

Overall, water quality in the Upper Susquehanna subbasin appears to have improved over the years (Figure 10). The percentage of sites with higher water quality in 2013 exceeded the percentages observed in 2007 and 1998. In contrast, the percentage of sites with lower water quality continually decreased from 1998 to 2013, with no sites having lower water quality in 2013. The percentage of sites with middle water quality in 2013 also continuously fell from 2007 and 1998.
