Restoration Monitoring of American Eel (*Anguilla rostrata*) In Three Southcentral Pennsylvania Streams In the Susquehanna River Basin: 2021 Monitoring Data Summary Update

Publication No. 327

November 2022

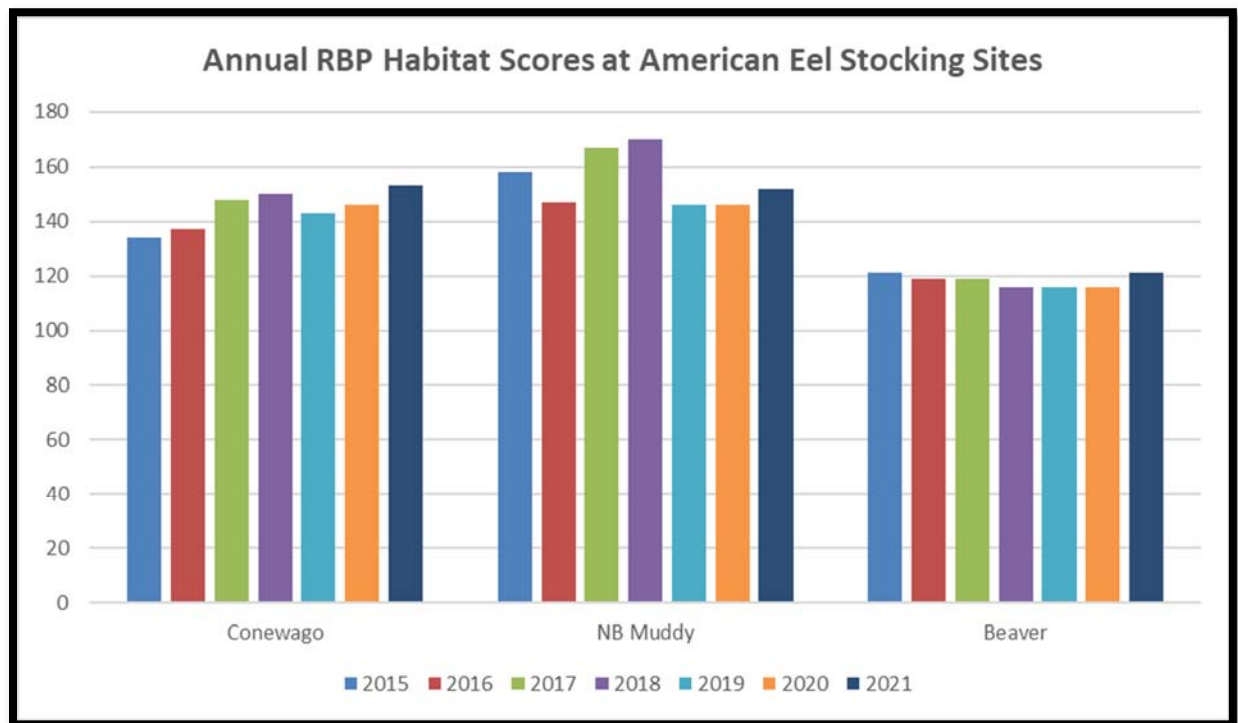
Overall habitat scores at each site were consistent with scores documented in previous years (Figure 5). Habitat scores at Beaver Creek are lower than scores at Conewago and North Branch Muddy Creeks, mainly due to persistently marginal epifaunal substrates and a lack of instream cover.

Figure 5. Annual Rapid Bioassessment Protocol Scores At Sites Receiving American Eels

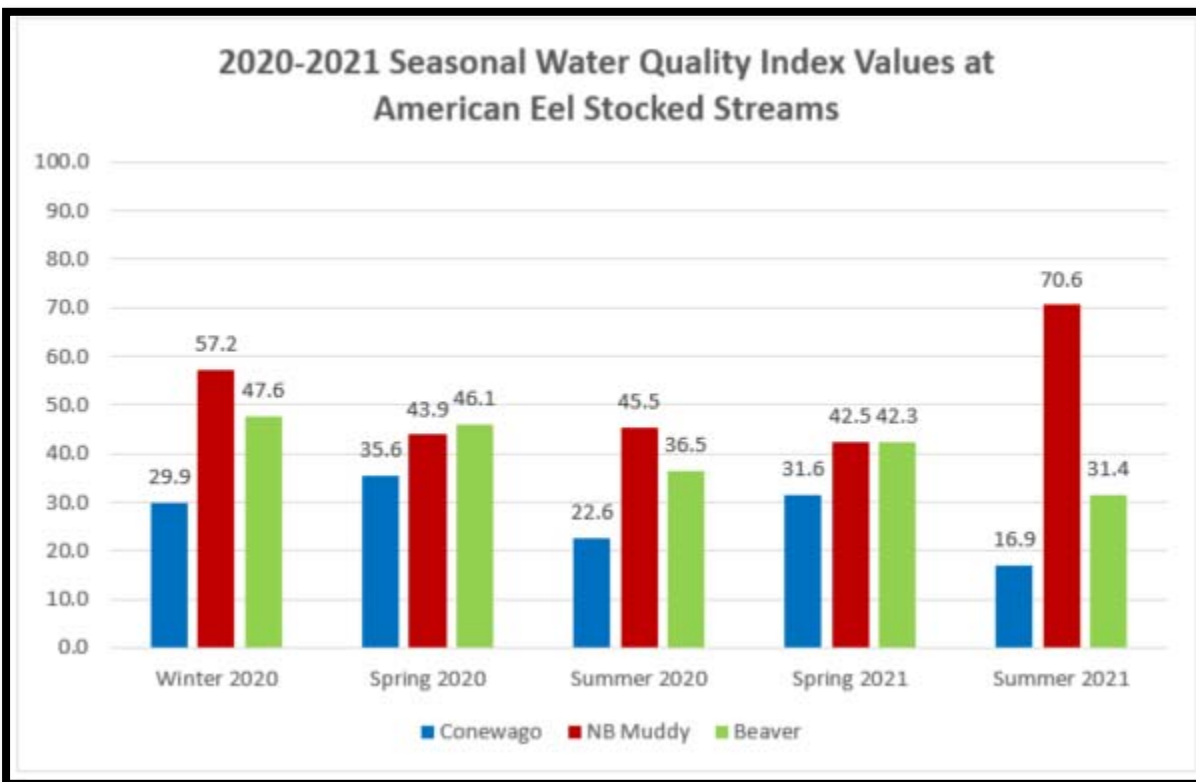
WQI scores at Conewago and Beaver Creeks were lower in Summer 2021 compared to Spring 2021. This pattern existed in Summer and Spring 2020 as well. The lesser water quality at these sites is attributed mainly to the ongoing nutrient enrichment and developmental pressures

within both watersheds. Despite having a higher percentage of agricultural land use in the watershed than the other two sites, nutrient-related water quality impacts are lesser at North Branch Muddy Creek. North Branch Muddy Creek also maintains a persistently higher overall WQI score attributed to lower developmental pressures than the other two sites.

Figure 6. 2020-2021 Seasonal Water Quality Index Values

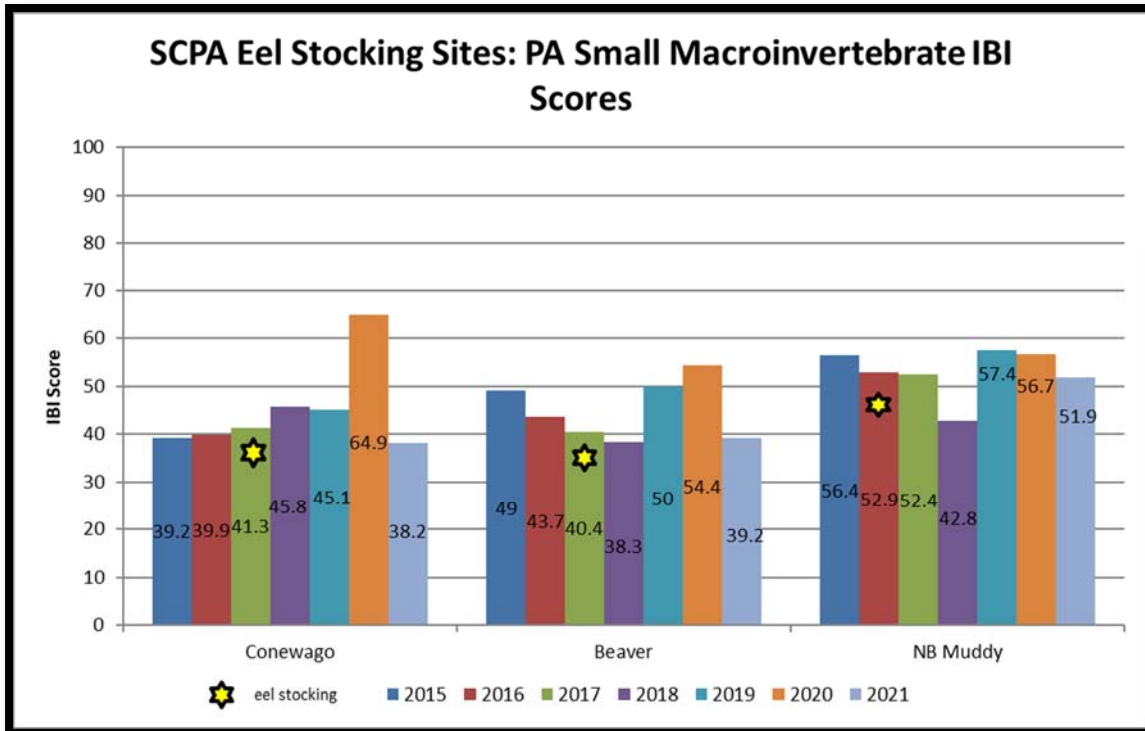
Macroinvertebrate IBI scores in 2021 were consistent with scores observed since 2015 but were lower than scores seen in 2020 (Figure 7).

Figure 7. Macroinvertebrate Index of Biological Integrity (IBI) Scores at American Eel Stocking Sites 2015-2021

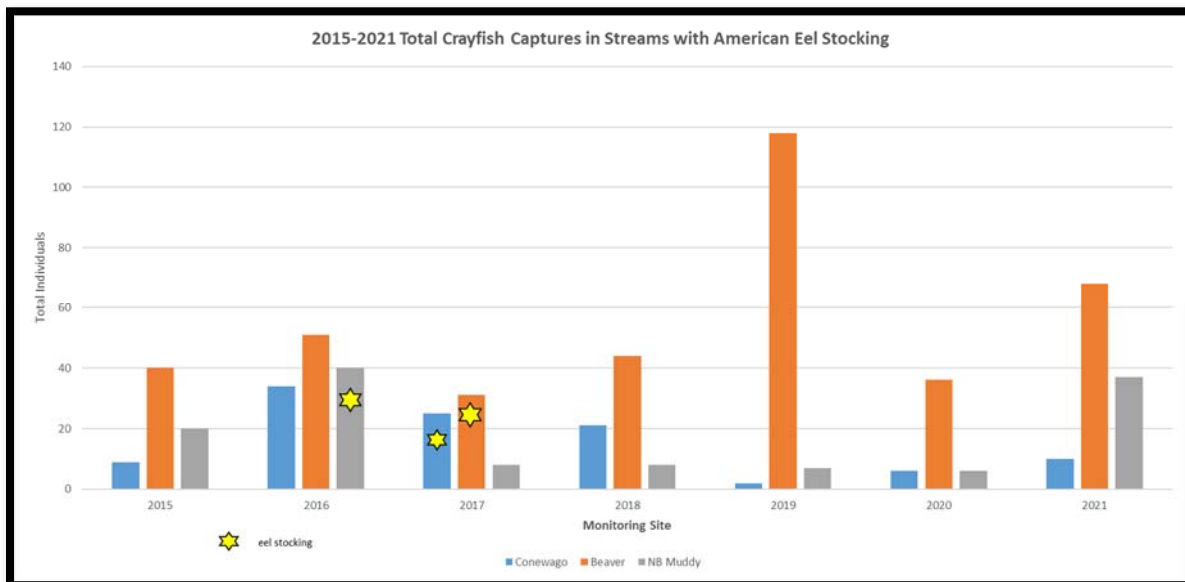
The number of crayfish collected at sites in 2021 were higher than in 2020 (Figure 8). The greatest number of crayfish were again captured in Beaver Creek, which is dominated by rusty crayfish. No rusty crayfish were observed at the other two sites. Other data regarding biomass and density can be found in Appendix A.

Figure 8. Total Annual Crayfish Captures At American Eel Stocked Streams 2015-2021
