**Subject:** Inspection of fishways at Holtwood Hydroelectric Project (FERC #1881)

A seasonal inspection of the fish passage facilities at the Holtwood Hydroelectric Project (Project) was performed at 1:30 pm on Wednesday, 05/06/2015. The Project is owned and operated by the PPL Electric Utilities. The USFWS (Service) review team was led by Sheila Eyler. Consultants from Normandeau Associates, Inc., and personnel from the Maryland Department of Natural Resources and from the Pennsylvania Fish and Boat Commission were also present.

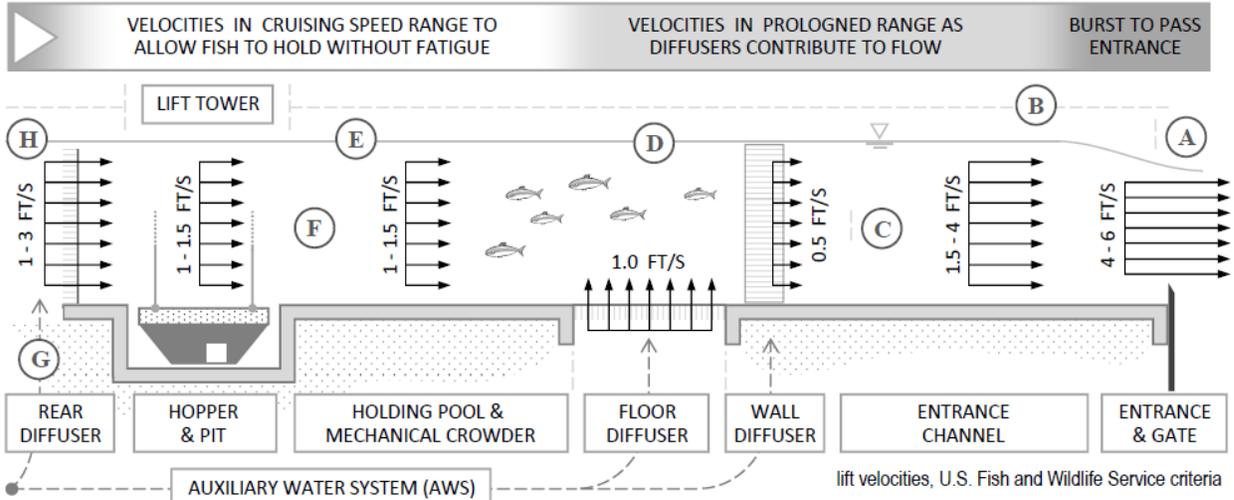
lift velocities, U.S. Fish and Wildlife Service criteria

BIOLOGICAL LIFT CAPACITY

- There was no attraction water supply (AWS) diffuser operating at the fishway channel from the spillway side. All of the fish passage flow was coming from behind the hopper. This could potentially result in water velocities at the crowding pool higher than the recommended by the Service (1 to 1.5 feet per seconds). Velocities at the different stages of the fish lift should be verified and compared with the Service's criteria for hydraulic conditions at a fish lift (see appendix for a *Fish Lift Reference Card*).
