Subject: Inspection of Fishways at Conowingo Hydroelectric Project (FERC #405) on May 5, 2014

This site review included both upstream passage facilities, the east fish lift (EFL) and the west fish lift (WFL). There are no downstream facilities at the Project; historically, downstream movement has occurred through the turbines. There are no upstream eel passes at this barrier. One cycle for each of the lifts was operated during site visit.

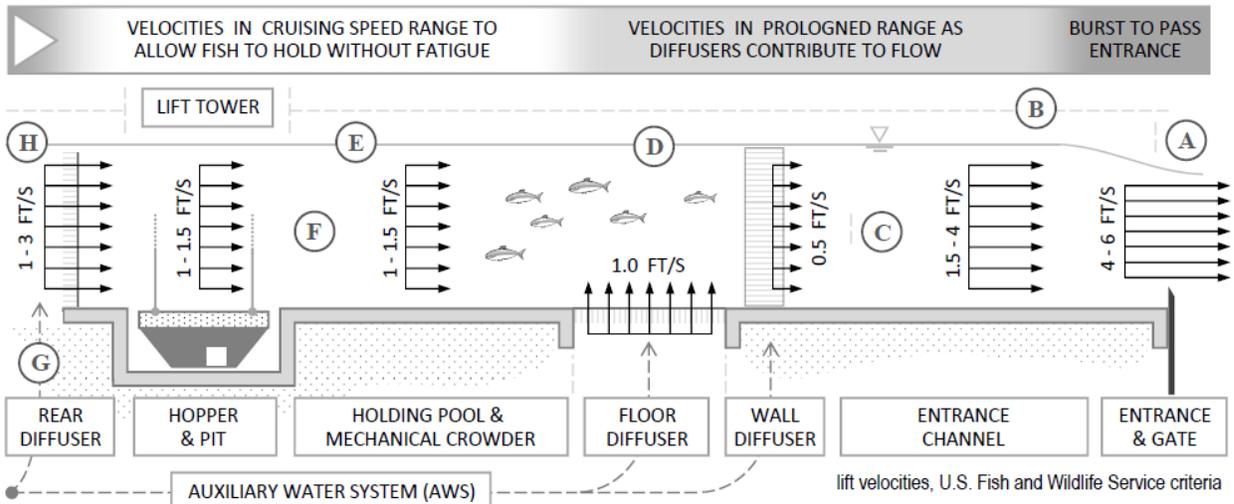
BIOLOGICAL LIFT CAPACITY

$$n_H = V \left(\frac{60 \text{ min}}{1 \text{ hr}} \right) \frac{r}{w_f v_c [1 + C_n]}$$

- Water velocities - Velocities within the fishway do not seem to be meeting the Service criterion on fish lifts (see appendix for a reference sheet on appropriate fish lift water velocities). Even though velocity measurements were not taken during the inspection, water velocities in the entrance channels and the crowding area seem to be lower than desired. The Service recognizes that at 300cfs Exelon is providing 1/3 of the original design flow (i.e., 900 cfs) and causing the water to move slower than originally intended. The Service recommends that water velocities be physically measured to ensure that optimum conditions within the fishway are persistent during all operational flows.
