# STORMWATER BMP SITES IN PAXTON CREEK WATERSHED

## BMP Type: Harrisburg Post Office Retention Basin (Wet Pond)

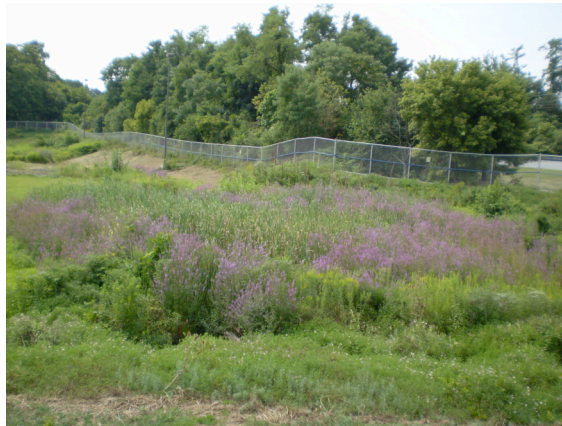
Harrisburg Post Office Retention Basin

The post office retention basin is a large, L-shaped depression near the southwest corner of the site. Only a small area at the end near Crooked Hill Road remains wet, dominated by Narrow Leaf Cattail and Purple Loosestrife vegetation. The basin's stormwater runoff storage capacity is huge (it has not been filled in its 15-years history). The infiltration and water treatment capacity are limited by the small wetland size, shallow porous soils, high bedrock level, and a sloping rather than flat basin bottom. Uncut vegetation greatly enhances the stormwater treatment potential. For safety and security a high chain-link fence surrounds the basin.
